AIRPROX REPORT No 2019273

Date: 13 Sep 2019 Time: 0800Z Position: 5337N 00018W Location: Humberside

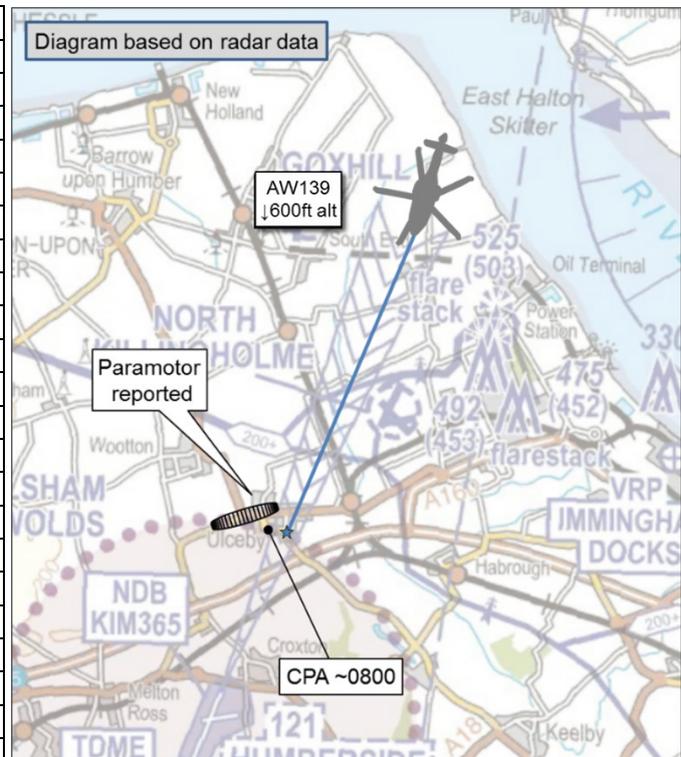
Recorded	Aircraft 1	Aircraft 2
Aircraft	AW139	Paramotor
Operator	Civ Helo	Civ Para
Airspace	London FIR	London FIR
Class	G	G
Rules	IFR	
Service	ACS	
Provider	Humberside	
Altitude/FL		
Transponder	A, C, S	
Reported		Not Reported
Colours	Red, White	
Lighting	NR	
Conditions	VMC	
Visibility	>10km	
Altitude/FL	600ft	
Altimeter	agl	
Heading	203°	
Speed	110kt	
ACAS/TAS	TCAS I	
Alert	None	
Separation		
Reported	0ft V/100m H	
Recorded	NK

THE AW139 PILOT reports that he was on short finals for Humberside, having conducted an ILS, when the left-hand pilot (PM) saw a paramotor at a similar level approximately 300m away. He announced the conflict, but due to the approach speed the paramotor passed quickly down the right-hand side of the aircraft. The late sighting meant that no avoiding action was taken because they were passing the conflict at the point of sighting. ATC were informed and they reported that they could also see it.
