AIRPROX REPORT No 2016008

Date: 24 Jan 2016 Time: 1210Z Position: 5228N 00013W Location: Peterborough/Conington

PART A: SUMMARY OF INFORMATION REPORTED TO UKAB

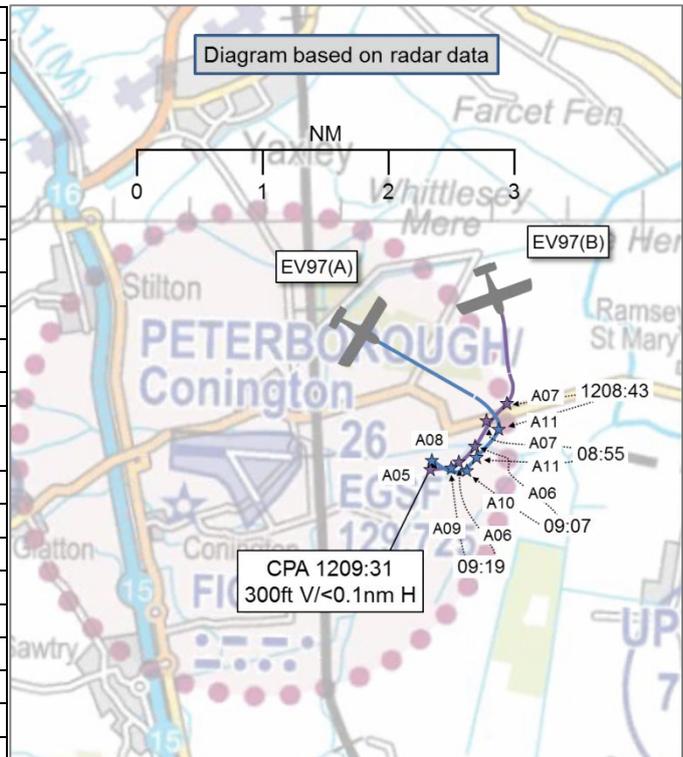
Recorded	Aircraft 1	Aircraft 2
Aircraft	EV97(A)	EV97(B)
Operator	Civ Trg	Civ Club
Airspace	Conington ATZ	Conington ATZ
Class	G	G
Rules	VFR	VFR
Service	AGCS	AGCS
Provider	Conington Radio	Conington Radio
Altitude/FL	800ft	500ft
Transponder	A, C, S	A, C, S
Reported		
Colours	Silver/blue	Blue/white
Lighting	LED landing	Strobe, nav, landing
Conditions	VMC	VMC
Visibility	20km	20km
Altitude/FL	700ft	480ft
Altimeter	QFE (1026hPa)	QFE (1026hPa)
Heading	275°	280°
Speed	56kt	70kt
ACAS/TAS	Not fitted	Not fitted
Separation		
Reported	50-100ft V/0m H	200-250ft V/ 100-150ft H
Recorded	300ft V/<0.1nm H

THE EV97(A) PILOT reports instructing in the circuit at Conington, using RW28R. Whilst on final approach, he heard the EV97(B) pilot call 'descending dead side' and both the student and EV97(A) pilot visually identified it. On the touch-and-go, the Instructor pointed EV97(B) out to his student as it crossed the upwind end of the runway above them. During the climb out, he heard the pilot call 'turning downwind'. Having turned crosswind and then downwind, he could not see EV97(B), but expected him to be well ahead. Having turned final, he was coaching the student to offset for drift and to take landing flap. In the meantime, the EV97(B) pilot called 'Final'. The Instructor checked around but could not see it, and also asked his student, who saw it below them. At the same time the A/G Operator responded to the EV97(B) pilot with 'One other aircraft established on Final'. The Instructor called '[EV97(A) C/S] Final, going around' and, since the student did not respond immediately, he took control, applied full power and climbed. It was only as he did this that he saw EV97(B), overtaking from below and about half a wingspan to the left.

The Instructor discussed the Airprox with the EV97(B) pilot after landing and it was evident that he had inadvertently cut in on the EV97(B) in the circuit. The Instructor was not able to piece together how he caught up with him when flying a standard circuit although he commented that the wind was south-westerly at about 20kt at circuit height and it was possible that EV97(B) may have drifted out downwind. In which case, assuming the EV97(B) tracked parallel to the runway whilst downwind, his long base leg, with a significant headwind component, would explain why the EV97(B) was significantly lower than EV97(A) on base leg. The EV97(A) student was not flying a steady speed downwind, so it was difficult for the Instructor to assess whether their speed may have influenced events. The Instructor further commented that, whatever the reason, his mind-set was that the EV97(B) was well ahead and so he was not keeping a good enough lookout in the area in which they probably came into proximity, which was when he was late downwind with the EV97(B) on base leg,

ahead and below. Once EV97(A) had turned onto base leg, EV97(B) was shielded from his view in the right-hand seat by their wing and fuselage, and the student's workload was fairly high.
