AIRPROX REPORT No 2020165

Date: 25 Nov 2020 Time: ~1515Z Position: 5057N 00256W Location: Merryfield Airfield

PART A: SUMMARY OF INFORMATION REPORTED TO UKAB

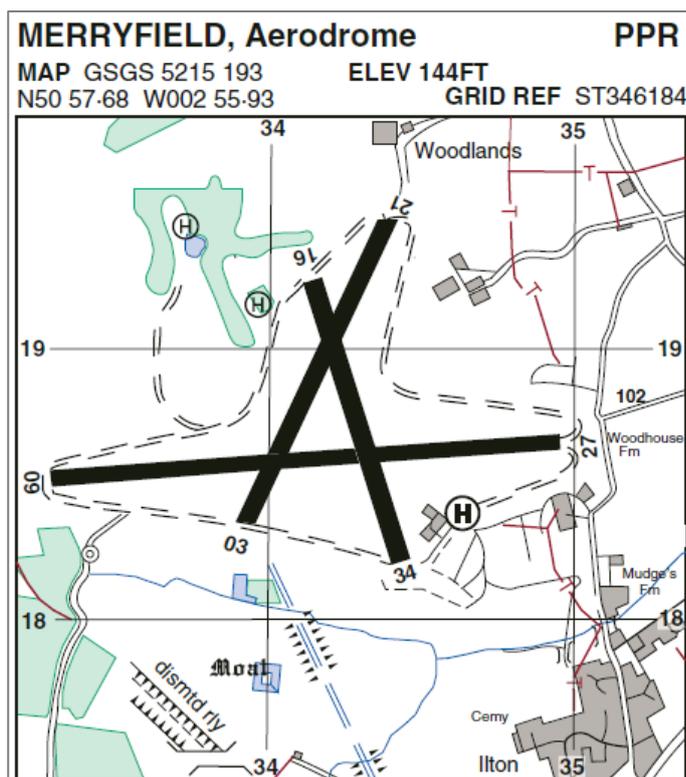
Figure 1: Merryfield Aerodrome Chart

THE MERRYFIELD CONTROLLER reports that the Duty Runway was RW34 with visual left and right hand circuits active. In the left-hand circuit was one wildcat [not the Airprox Wildcat] conducting load lifting to spot Charlie and a Merlin operating to the Old Confined Area. In the right-hand circuit was a Wildcat [the Airprox Wildcat] conducting General Handling. The controller had taken over the Aerodrome Control position about 10min before the incident occurred and was present when the previous controller had instructed both aircraft in the left-hand circuit on additional measures to coordinate and deconflict their adjacent activities. The [Airprox] Wildcat pilot requested the use of the duty runway, the controller instructed them to line up and made an 'All Stations' broadcast that the runway was now in use and positive control was in force. The Merlin pilot was cleared to land in the confined area at their discretion, which they did [he believed]. When the [Airprox] Wildcat pilot called ready for departure the controller checked the climb-out was clear and issued a take-off clearance and surface wind check. As the Wildcat pilot commenced their transition the controller turned to check the load lifting spot with the binoculars, satisfied that all was well they turned to recommence their scan and became aware that the Merlin pilot had lifted from the confined area without a clearance and was completing a tight right-hand turn which had placed them in close proximity to the departing [Airprox] Wildcat, whose pilot was just completing a right-hand turn away from the Merlin. The [Airprox] Wildcat pilot commented on the Merlin pilot turning in front of them and the controller informed the Merlin pilot that the Wildcat pilot was unhappy with their action and reminded them that they were required to call before lifting from the confined area for clearance in accordance with the published local procedure.
