AIRPROX REPORT No 2019055

Date: 10 Apr 2019 Time: 1513Z Position: 5116N 00018W Location: Leatherhead

PART A: SUMMARY OF INFORMATION REPORTED TO UKAB

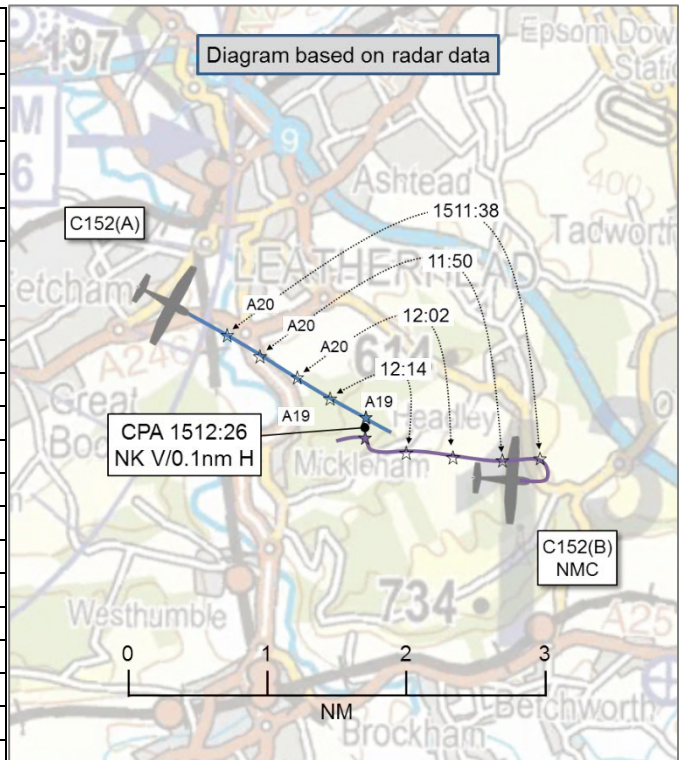
Recorded	Aircraft 1	Aircraft 2
Aircraft	C152(A)	C152(B)
Operator	Civ FW	Civ FW
Airspace	London FIR	London FIR
Class	G	G
Rules	VFR	VFR
Service	Basic	NK
Provider	Farnborough LARS	NK
Altitude/FL	1900ft	NK
Transponder	A, C	A only
Reported		Not reported
Colours	White, red	
Lighting	NK	
Conditions	NK	
Visibility	NK	
Altitude/FL	2100ft	
Altimeter	QNH (1019hPa)	
Heading	~135°	
Speed	90kt	
ACAS/TAS	Not fitted	
Alert	N/A	
Separation		
Reported	<100ft V/ <100m H	Not reported
Recorded	NK V/0.1nm H

The Board noted that neither pilot was in receipt of a FIS that could have provided Traffic Information on other aircraft and, as such, had no SA on the other (**CF3**). Ultimately, they converged to a lateral separation of 0.1nm (radar replay) and <100ft (C152(A) report), and the Board surmised that that was at least in part because the C152(B) pilot probably did not see C152(A) until at a late stage. Members noted that an effective and robust lookout was fundamental for flight in Class G airspace and that this responsibility was especially important when conducting aerobatics or highly dynamic manoeuvres.

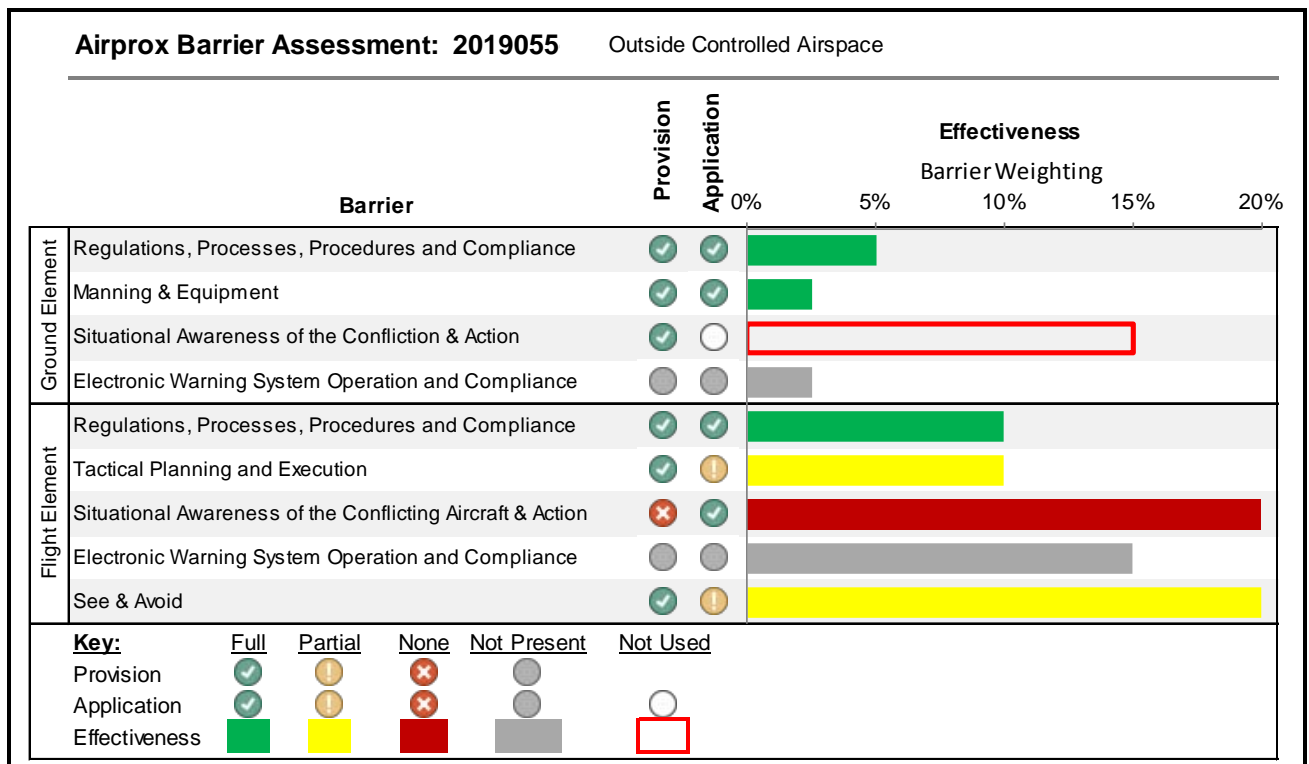
Safety Barrier Assessment⁴

In assessing the effectiveness of the safety barriers associated with this incident, the Board concluded that the key factors had been that:

Ground Elements:

Situational Awareness of the Conflication and Action were assessed as **not used** because neither pilot was in receipt of a FIS that would provide SA.

Flight Elements:

Tactical Planning and Execution was assessed as **partially effective** because the C152(A) pilot continued into conflict despite seeing the C152(B) 'far away'.

Situational Awareness of the Conflicting Aircraft and Action were assessed as **ineffective** because neither pilot was in receipt of a FIS that could provide such SA.

See and Avoid were assessed as **partially effective** because the pilot of C152(A) could have remained clear of the manoeuvring C152(B) by ensuring greater lateral or vertical separation.
