AIRPROX REPORT No 2019268

Date: 08 Sep 2019 Time: 1504Z Position: 5128N 00025W Location: LHR RW27L

PART A: SUMMARY OF INFORMATION REPORTED TO UKAB

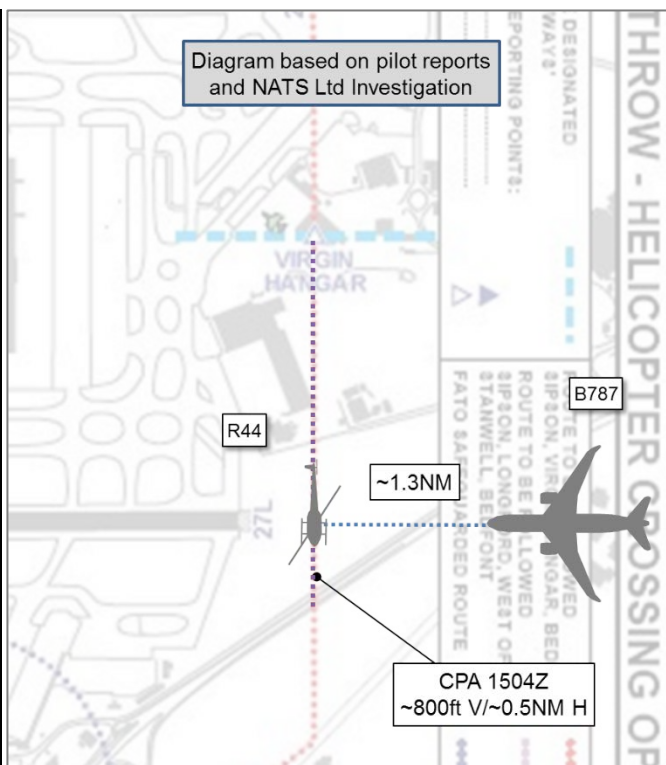
Recorded	Aircraft 1	Aircraft 2
Aircraft	B787	R44
Operator	CAT	Civ Helo
Airspace	London CTR	London CTR
Class	D	D
Rules	IFR	VFR
Service	ACS	ACS
Provider	Heathrow Tower	Heathrow Tower
Altitude/FL	200ft	900ft
Transponder	A, C, S	A, C, S
Reported		
Colours	Company	Silver, grey
Lighting	Landing, nav, strobes	Landing, strobe
Conditions	VMC	VMC
Visibility	20km	10NM
Altitude/FL	700ft	800ft
Altimeter	QNH (NK hPa)	QNH (1022hPa)
Heading	272°	180°
Speed	145kt	0-70kt
ACAS/TAS	TCAS II	Not fitted
Alert	Unknown	None
Separation		
Reported	200ft V/2NM H	1000ft V/1NM H
Recorded	700ft V/0.3NM H ¹

R44 crossed the nose of the B787 at a separation of about 1.3nm and that CPA occurred as the B787 passed behind the R44.

The Board determined from the radar recordings that, ultimately, the R44 crossed about 1.3nm ahead of the B787 thereby not creating an immediate hazard to its approach or potential missed approach. Members noted that the R44 pilot was apparently experienced in such crossings at Heathrow and did not perceive there to have been a conflict (**CF8**), although the B787 pilot (**CF9**) and controller (**CF3**) were understandably concerned by the proximity of the 2 aircraft because they were unsure of the R44 pilot's intentions and situational awareness. In the final analysis, members agreed that the incident warranted a risk rating of Category C in that, although there was no practical risk of collision, safety had been reduced because normal safety procedures had not been complied with.

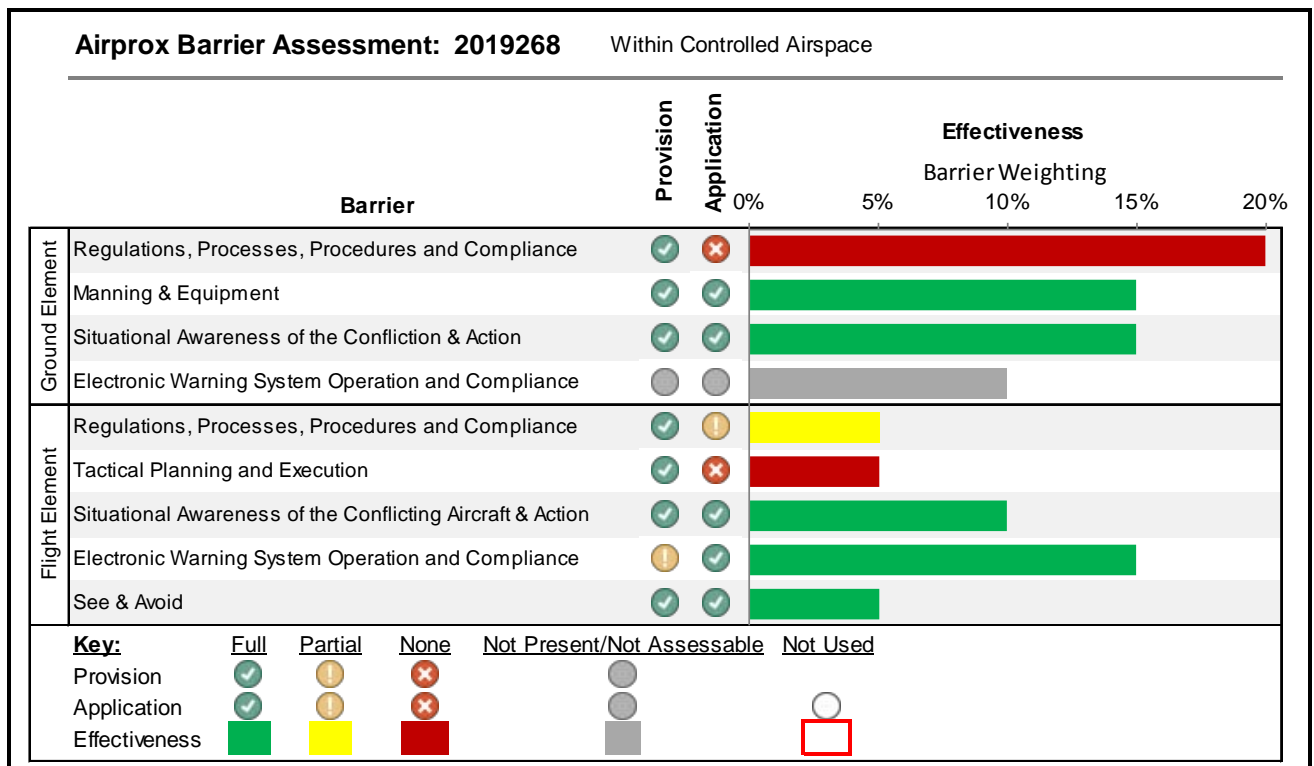
³ The UK Airprox Board scheme for assessing the Availability, Functionality and Effectiveness of safety barriers can be found on the [UKAB Website](#).

Tactical Planning and Execution was assessed as **ineffective** because the R44 pilot did not cross in accordance with his clearance.
