AIRPROX REPORT No 2019282

Date: 19 Sep 2019 Time: 1255Z Position: 5110N 00054E Location: ivo Ashford

PART A: SUMMARY OF INFORMATION REPORTED TO UKAB

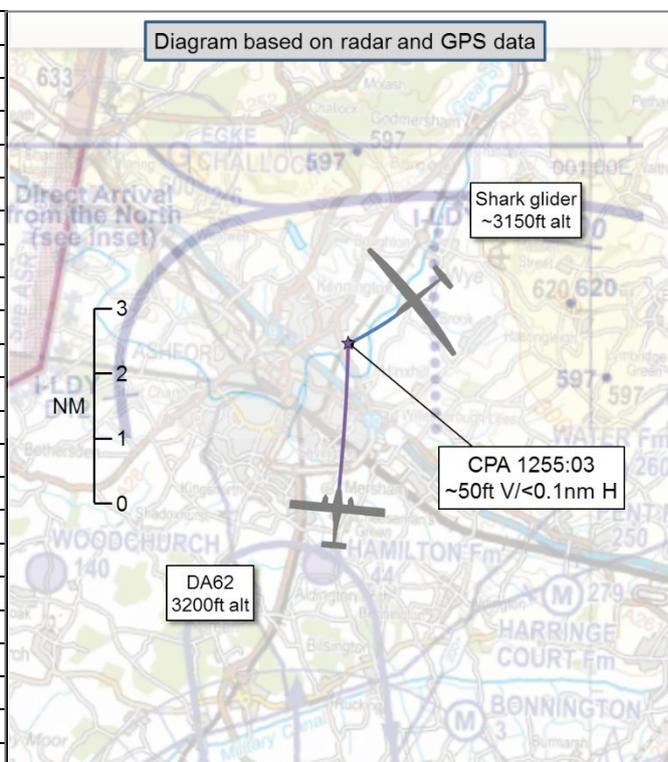
Recorded	Aircraft 1	Aircraft 2
Aircraft	HpH 304 Shark S	DA62
Operator	Civ Glid	Civ Comm
Airspace	London FIR	London FIR
Class	G	G
Rules	IFR	IFR
Service	None	Procedural
Provider	(Challock gliding)	Lydd Information
Altitude/FL	3225ft	3200ft
Transponder	Not fitted	A, C, S
Reported		
Colours	White	Grey, orange
Lighting	Not fitted	Strobes, nav
Conditions	VMC ¹	VMC ¹
Visibility	20km	3km
Altitude/FL	3150ft	3200ft
Altimeter	QNH (1030hPa)	QNH (1031hPa)
Heading	'circling'	350°
Speed	50kt	160kt
ACAS/TAS	FLARM	TAS
Alert	None	None
Separation		
Reported	50-100ft V/0m H	20ft V/10m H
Recorded	~50ft V/<0.1nm H

An Airprox was reported when a HpH 304 Shark S glider and a DA62 flew into proximity near Ashford at 1255Z on Thursday 19th September 2019. Both pilots were operating under IFR in IMC, clear of cloud but in proximity to the cloud base, the DA62 pilot in receipt of a Procedural Service from Lydd and the Shark pilot not in receipt of a FIS but listening out on the Challock gliding frequency.

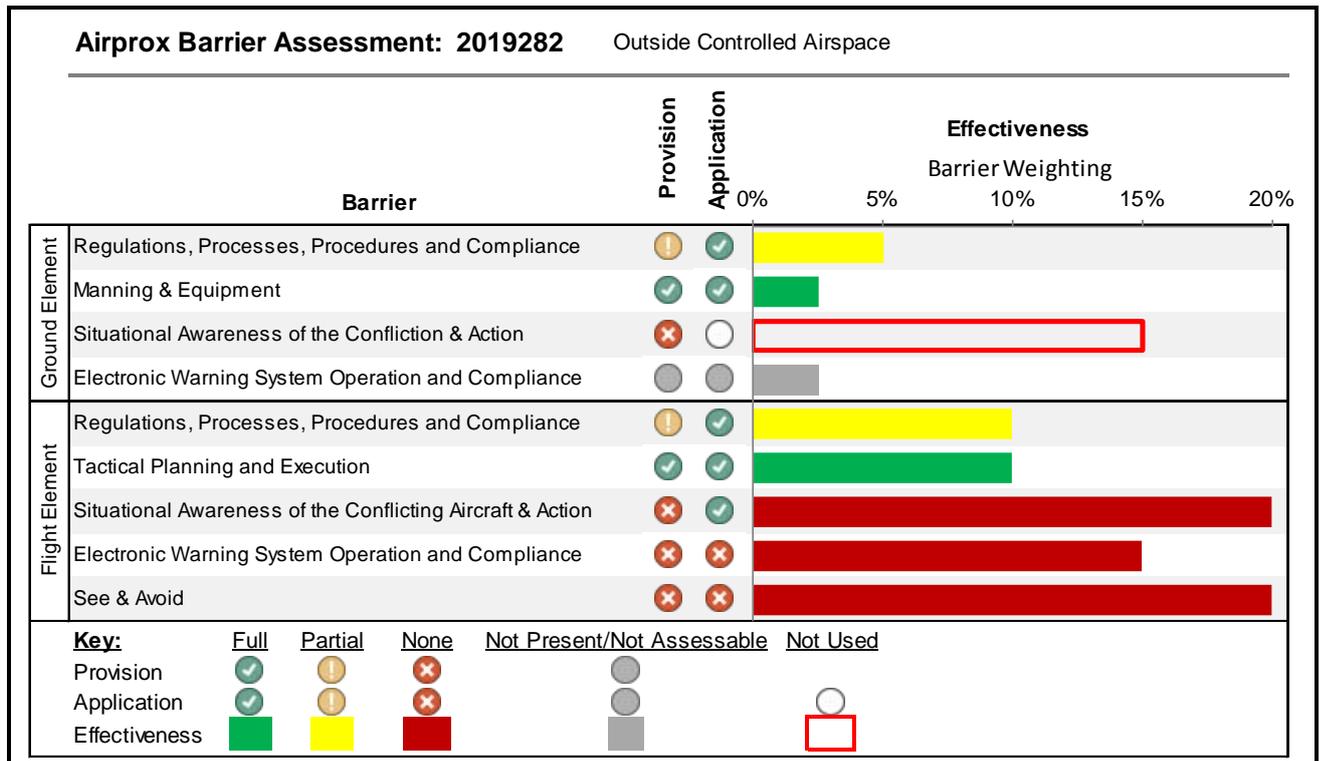
Electronic Warning System Operation and Compliance were assessed as **ineffective** because the aircrafts' warning systems were not compatible.

See and Avoid were assessed as **ineffective** because neither aircraft was sighted until at a very late stage, such that avoiding action had little material effect on increasing separation at CPA.

⁴ The UK Airprox Board scheme for assessing the Availability, Functionality and Effectiveness of safety barriers can be found on the [UKAB Website](#).
