AIRPROX REPORT No 2019304

Date: 23 Oct 2019 Time: 1405Z Position: 5355N 00252W Location: 10NM NE Blackpool

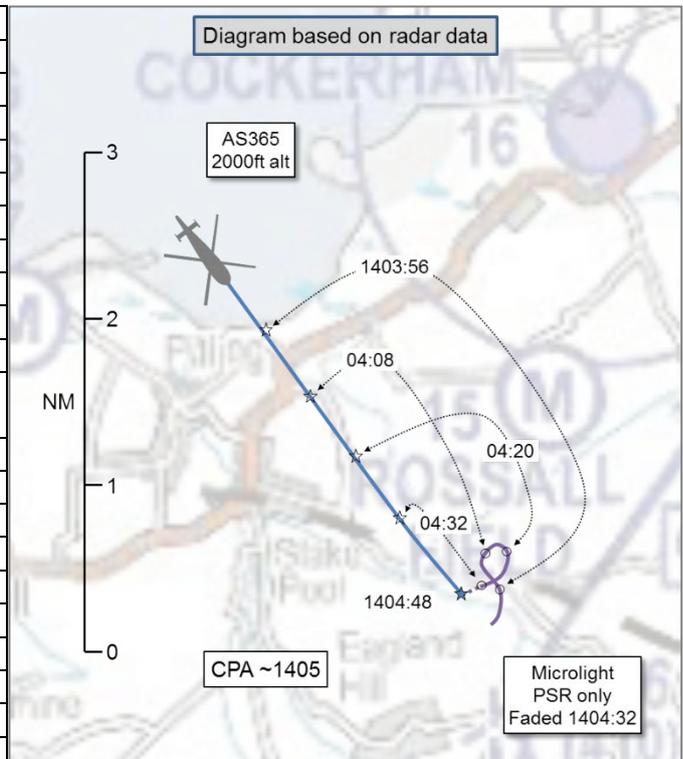
Recorded	Aircraft 1	Aircraft 2
Aircraft	AS365	Weight-shift M/L
Operator	HEMS	Unknown
Airspace	London FIR	London FIR
Class	G	G
Rules	VFR	NK
Service	Basic	NK
Provider	Warton Approach	NK
Altitude/FL	2000ft	NK
Transponder	A, C, S	None
Reported		Not reported
Colours	White, yellow, green	
Lighting	Nav, landing, HISL	
Conditions	VMC	
Visibility	>10km	
Altitude/FL	2000ft	
Altimeter	QNH (1009hPa)	
Heading	150°	
Speed	140kt	
ACAS/TAS	TCAS I	
Alert	None	
Separation		
Reported	200ft V/0m H	NK
Recorded	NK
