# AIRPROX REPORT No 2016092

Date: 29 May 2016 Time: 1127Z Position: 5025N 00341W Location: IVO Totnes

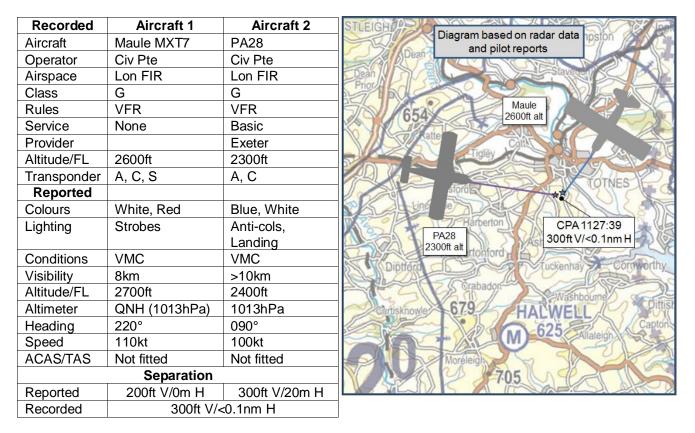
Figure 1 – Swanwick MRT at 1124:37 UTC

At 1124:37 (Figure 1), the Maule pilot (which was still displaying the SSR code allocated by Exeter Radar) reported that he was overhead Torquay and was happy to transfer to his en-route frequency. This was acknowledged by the Exeter Radar controller who instructed him to squawk 7000. According to the recorded surveillance data, at this time the Maule was indicating FL026. The PA28 was 8.7nm west south-west of the Maule tracking east-south-east indicating FL023.
