AIRPROX REPORT No 2015016

Date: 21 Feb 2015 Time: 1350Z Position: 5237N 00102W Location: Leicester aerodrome

PART A: SUMMARY OF INFORMATION REPORTED TO UKAB

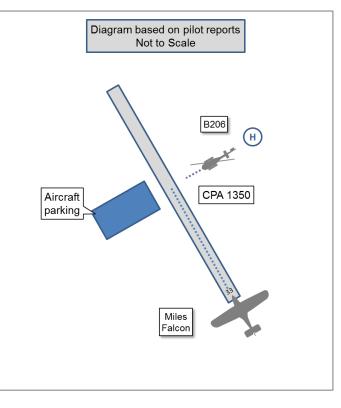
THE MILES FALCON PILOT reports that RW33 was in use at Leicester. He commented that it was rarely used as a runway but was regularly used as a taxiway that was crossed extensively by helicopter traffic proceeding to the helicopter manoeuvring area in the middle of the aerodrome. He back-tracked RW33 and advised the 'Tower' of his impending departure from RW33 'hard', which was acknowledged. He noticed a helicopter in a low hover approximately halfway down the runway, on the grass area, about 100m away. He began his take-off roll and was approximately halfway towards the midpoint when he heard the helicopter pilot report 'return to parking' which was acknowledged. He then saw the helicopter dip its nose and commence a taxi towards RW33. Because he had already reached take-off speed he considered that there was no avoiding action available to him. He reported that, instead, he transmitted a 'Stop' warning which, he thought, had the desired effect of stopping the helicopter some 15m from the runway.

THE BELL 206 (B206) JETRANGER PILOT reports making an approach to the grass strip to the north of RW33. He then called 'hover taxi to parking' which was acknowledged by the 'Tower'. He did not recall initially seeing an aircraft on the runway, nor did he recall hearing any radio calls. He continued hover taxiing. After seeing the departing aircraft, which was rolling along RW33, he stopped his hover taxi some 15m short of the runway.
