AIRPROX REPORT No 2023184

Date: 09 Aug 2023 Time: ~1231Z Position: 5355N 00050W Location: 1.5NM SW Pocklington

PART A: SUMMARY OF INFORMATION REPORTED TO UKAB

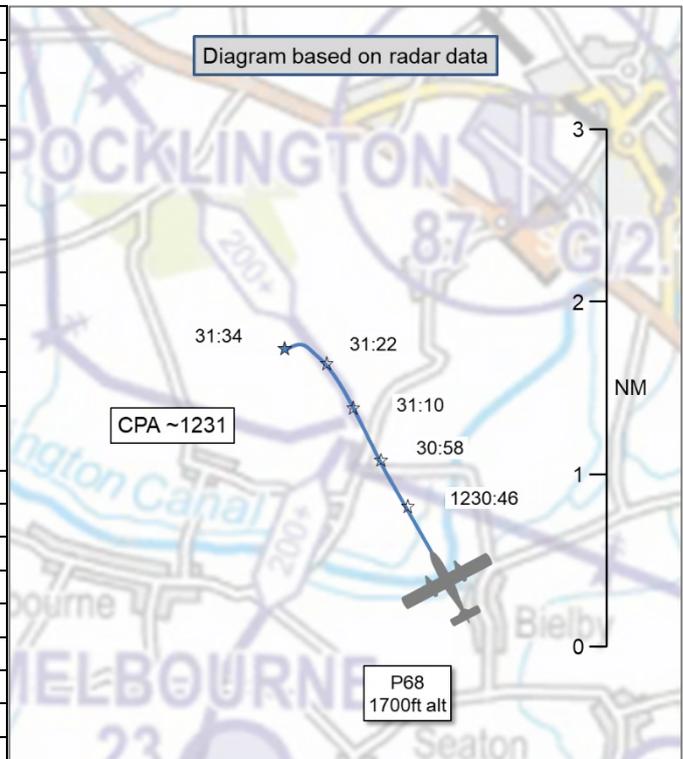
UK glider launch sites are listed in UK AIP ENR 5.5 and labelled on the CAA VFR charts with a "G" symbol, as shown in the chart segment in Part A. A greater density of gliders may be expected nearby at any time during daylight hours, and at any altitude up to cloudbase.
