**AIRPROX REPORT No 2024263**

Date: 23 Oct 2024 Time: 1314Z Position: 5312N 00300W Location: Hawarden aerodrome

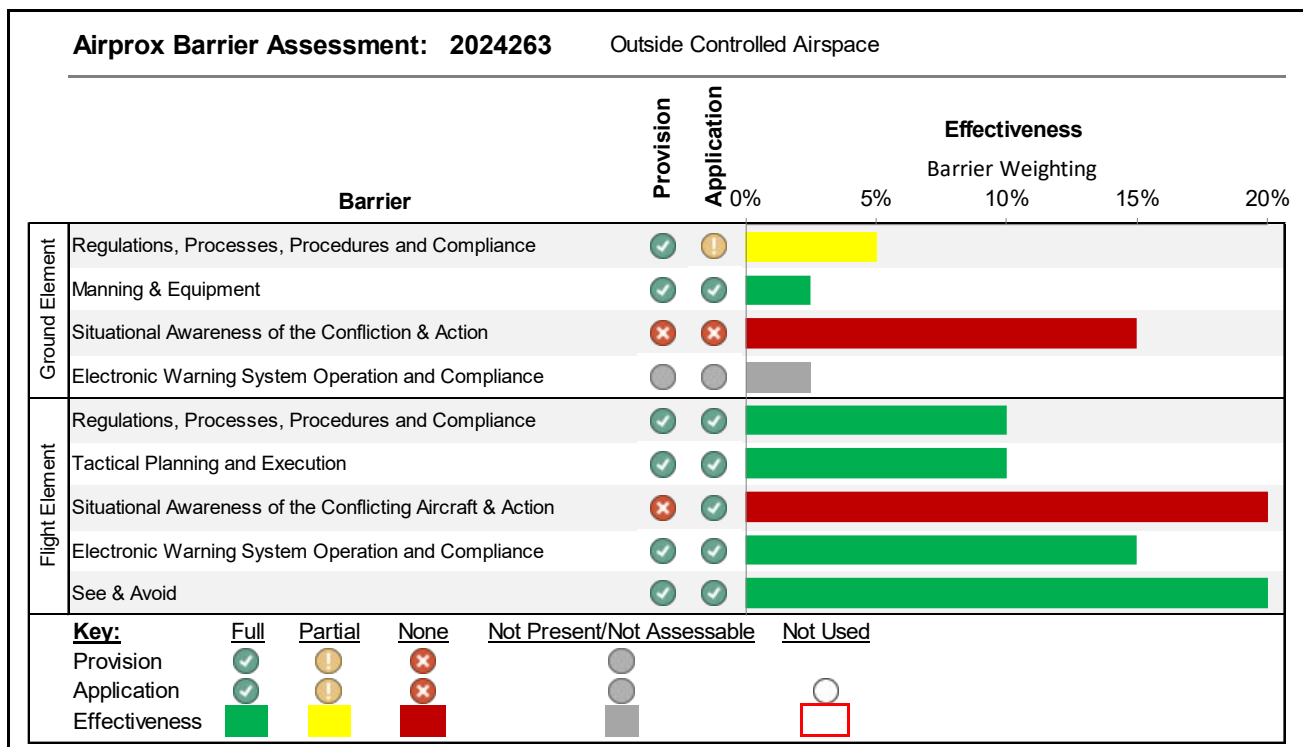
<sup>3</sup> The UK Airprox Board scheme for assessing the Availability, Functionality and Effectiveness of safety barriers can be found on the [UKAB Website](#).

**Flight Elements:**

**Situational Awareness of the Conflicting Aircraft and Action** were assessed as **ineffective** because the Texan II crew had very late situational awareness on the presence and position of the PA28.
