**AIRPROX REPORT No 2024290**

Date: 27 Nov 2024 Time: ~1534Z Position: 5311N 00426W Location: 5NM SE RAF Valley

**PART A: SUMMARY OF INFORMATION REPORTED TO UKAB**

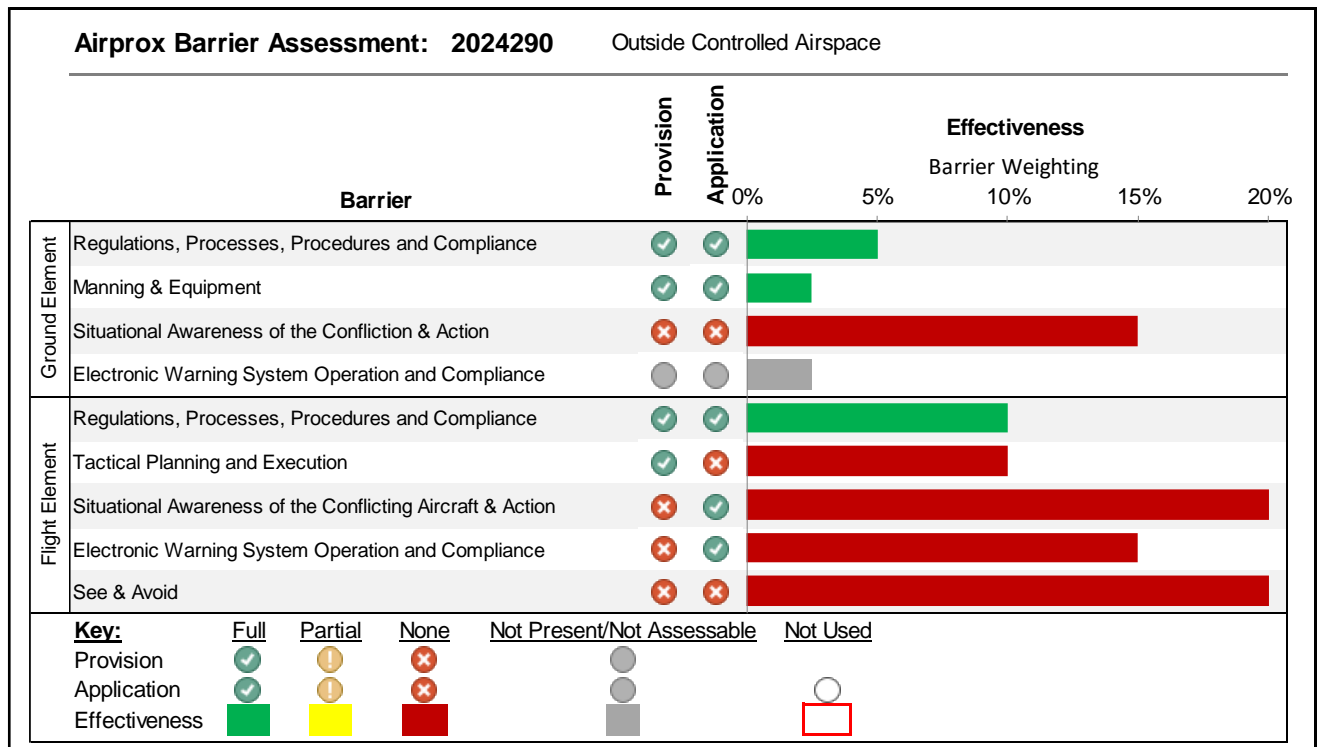
**Electronic Warning System Operation and Compliance** were assessed as **ineffective** because the paramotor had most likely not been EC equipped and could not alert the Hawks' TCAS.

**See and Avoid** were assessed as **ineffective** because the paramotor pilot likely had not seen the Hawks approaching from behind and the Hawk pilot saw the paramotor at about CPA, effectively a non-sighting.
