**UK AIRPROX BOARD**

# **Analysis of Airprox in UK Airspace**

**Report Number 20  
January 2008 – June 2008**

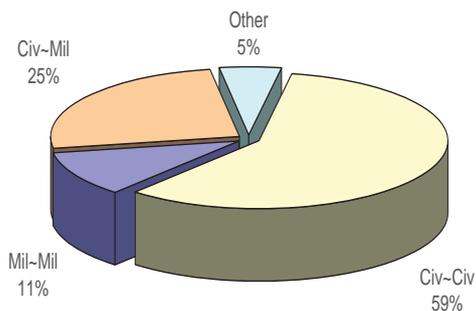
Figure 1

User Group Mix: January - June 2007

A total of 87 Airprox were reported and opened for full investigation in the period 1 January to 30 June 2008. Tables 1 and 2 below give month-by-month data for the main three airspace user groups, the corresponding figures in the columns headed 'Totals' then being converted into percentages which are shown in pie-chart format in Figures 1 and 2. From these Figures, it can be seen that although the number of Airprox where civil aircraft met military aircraft (Civ~Mil) is unchanged (at 19), the increase in the overall total number of Airprox has resulted in the 'Civ~Mil' proportion being a few percentage points lower, year on year. Although the absolute number of Airprox in respect of military encounters with other military aircraft (Mil~Mil) has increased from nine to 10, the percentages remain the same, at 11%. In the category Civ~Civ, both the absolute numbers and the corresponding percentages have risen: 44 to 55, 59% to 64%. A more detailed analysis follows later in this Report.

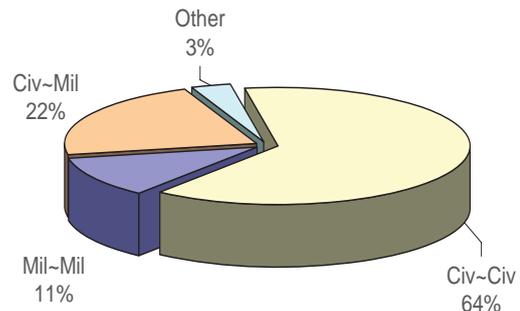
Figure 2

User Group Mix: January - June 2008

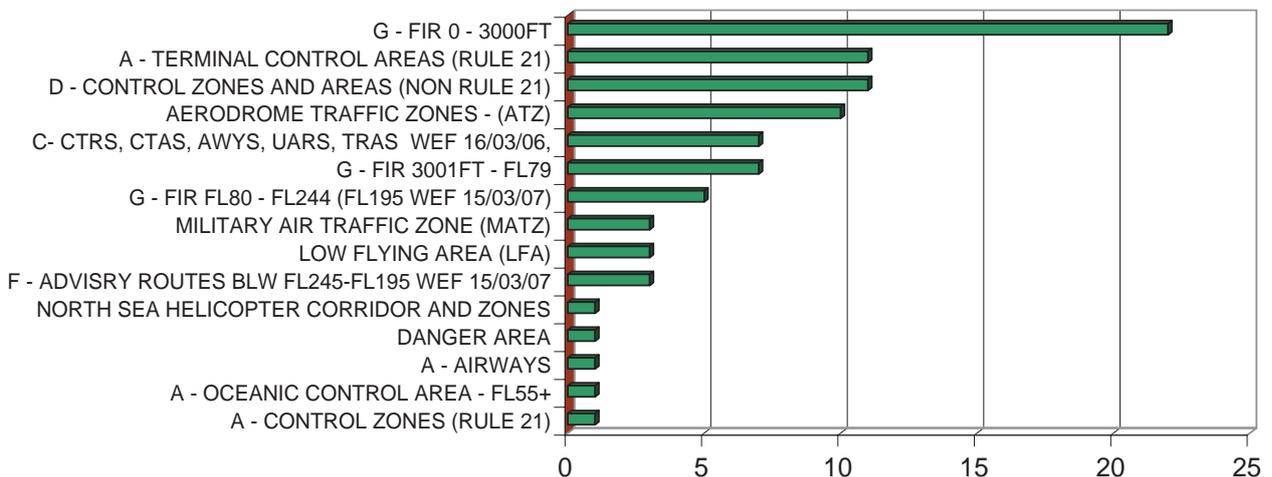
Figure 3 (below) shows the various classes of airspace within which the reporter's aircraft was situated when Airprox events occurred during the first six months of 2008. When comparing Jan-Jun 2008 with the same period in 2007, the number of incidents in Class G airspace, the 'Open FIR', in the altitude band from ground level to 3,000ft has changed little with a decrease of three to 22. The proportion of Airprox occurring in Class G airspace (considered as including LFA; ATZ; MATZ etc) is comparable with previous years, being 60% in 2008 as against 64% of the total in 2007.

Two points are worthy of mention here. Firstly, the figure for Airprox events occurring inside Class A Terminal Control Areas increased from eight to 11, each of these Airprox involving two CAT aircraft. Whereas in 2007 one of the events was assessed as Risk B - the other six being Risk C - all 11 in Jan~Jun 2008 were Risk C, no risk of collision.

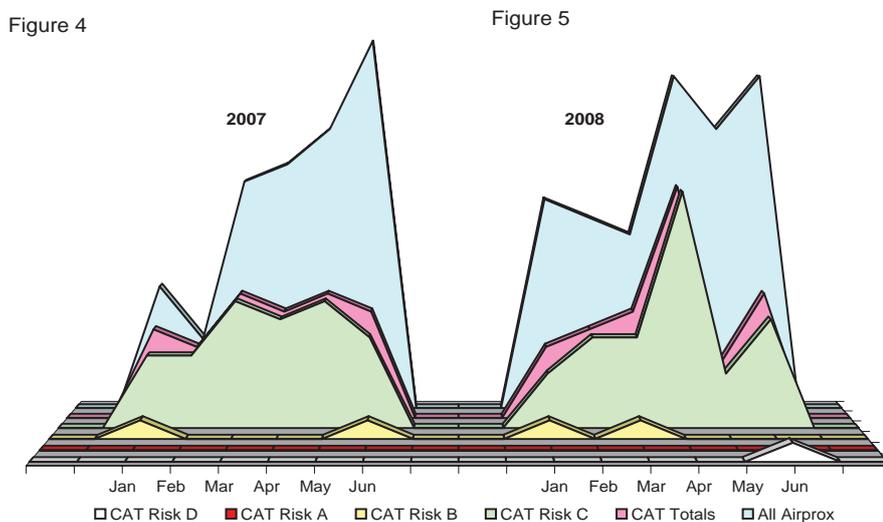
CAT Involvement in Airprox: January - June in 2007 and 2008

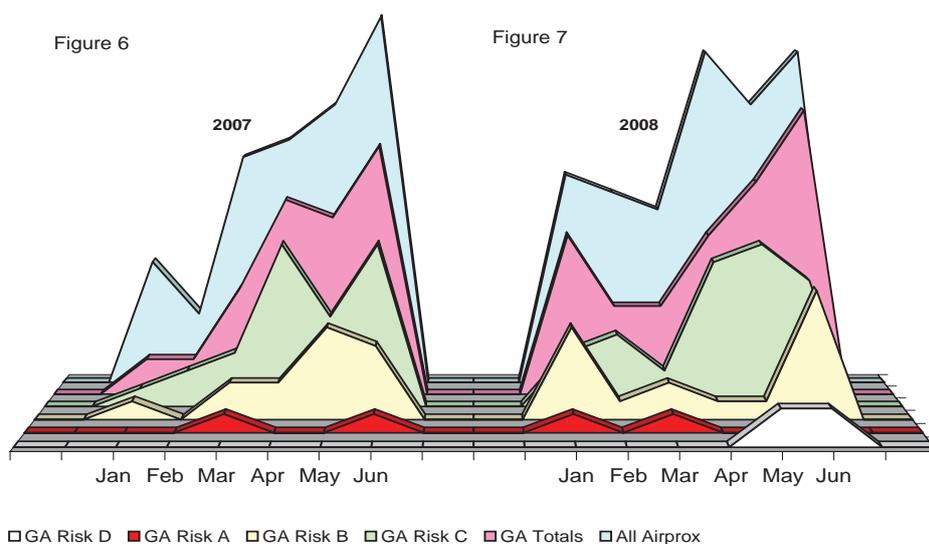
**GA Involvement in Airprox: January - June in 2007 and 2008**

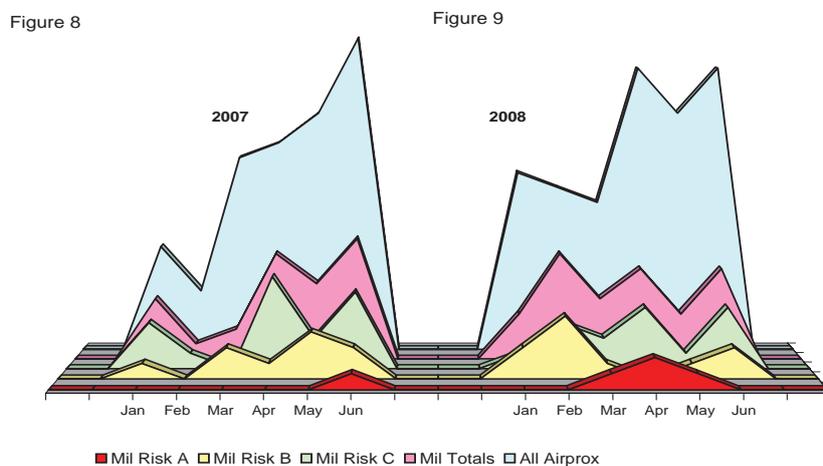
**Military Involvement in Airprox: January - June in 2007 and 2008**

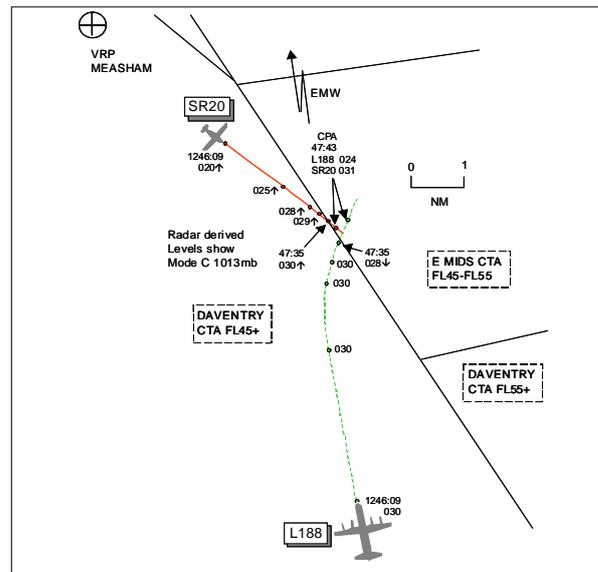
Reported Separation:  
300ft V/<2nm H 700ft V/NK H

Recorded Separation:  
700ft V/0.3nm H

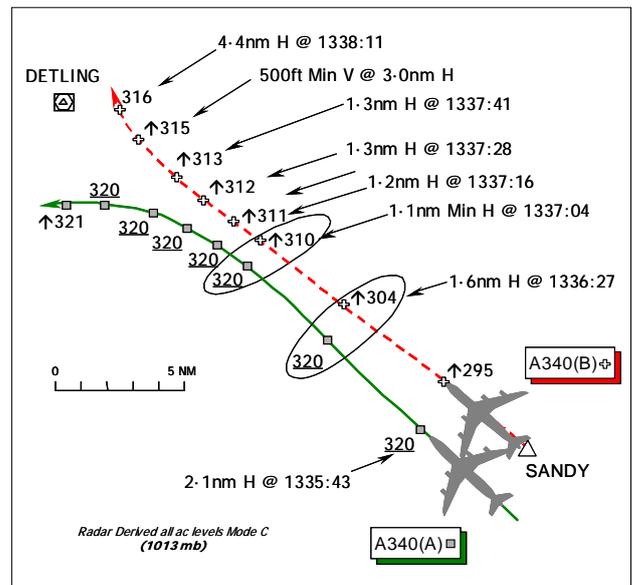
500ft Min V @ 3nm H

1.1nm Min H @ 1000ft V

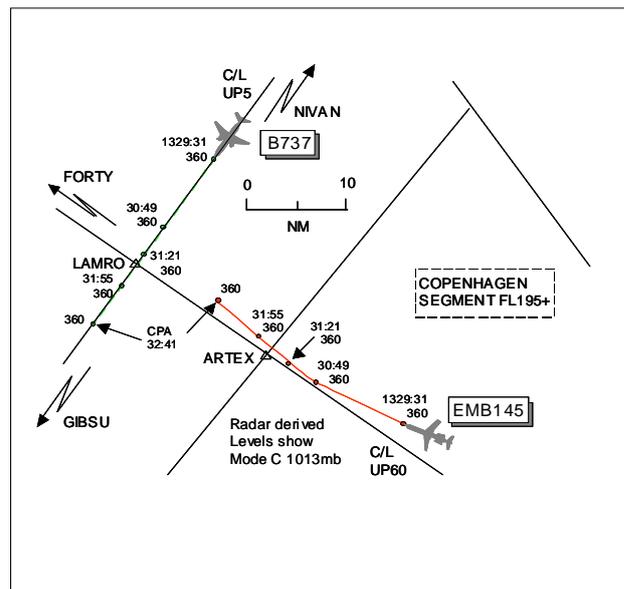
Recorded Separation:

Nil V/12.2nm H

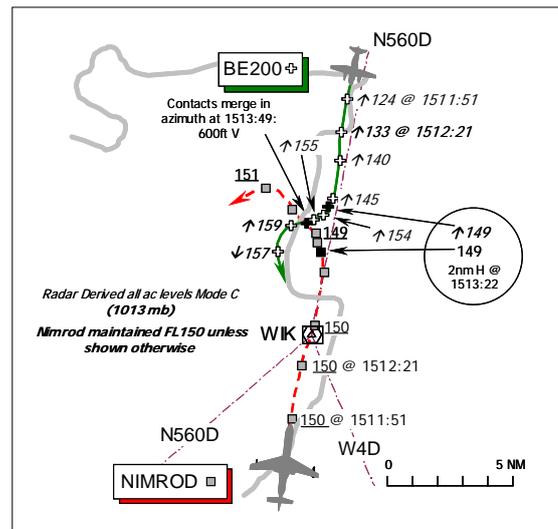
Recorded Separation:

600ft V @ nil H/2nm H @ nil V

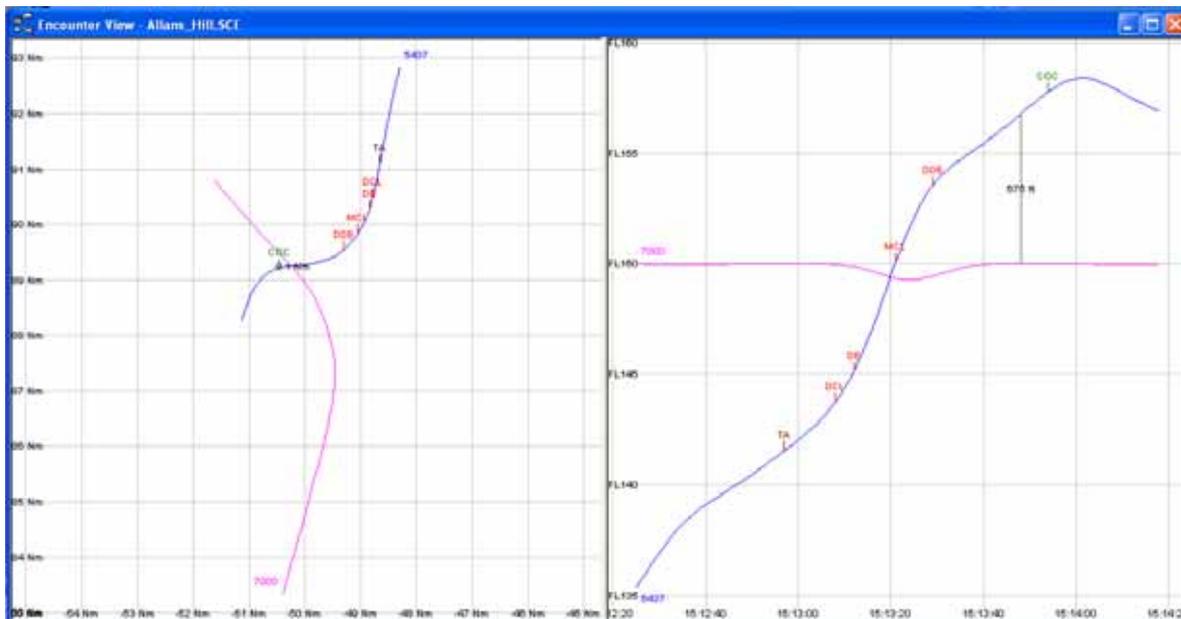
UKAB Note (2): NATS Systems Safety Department conducted a TCAS simulation of this event using the InCAS simulator. Depending on the location of the Airprox and its proximity to ground based Mode S monitoring devices, down-linked Mode S data can also be presented to reinforce the simulation data. However, in this instance no independently recorded Mode S data was available to replicate the actual TAs and RAs enunciated to the BE200

crew during this event. Moreover, only the BE200 was fitted with TCAS. Nevertheless, there is no evidence to suggest that the NATS TCAS simulation of these events using this standard simulation device was in error.

The simulation indicated that the BE200 crew (A5437) received a TCAS Traffic Alert (TA) as the ac climbed towards FL150 where the Nimrod (A7000) was in level flight at FL150. At the time of the TA the aircraft were separated by 5.55nm laterally. As the BE200 continued to climb the crew was issued with an “ADJUST VERTICAL SPEED” Resolution Advisory (RA) instructing the pilot that the aircraft should NOT climb. The radar tracks indicate that the BE200 increased its RoC, whereupon the alert changed to a “DESCEND” RA. The simulation indicates that 4sec passed between the initial “ADJUST VERTICAL SPEED” RA and the “DESCEND” RA. One way in which the RAs could be communicated to the BE200 pilot is via the Instantaneous Vertical Speed Indicator (IVSI). The simulated IVSI indications for the BE200 at the time of the RA alerts are shown below.

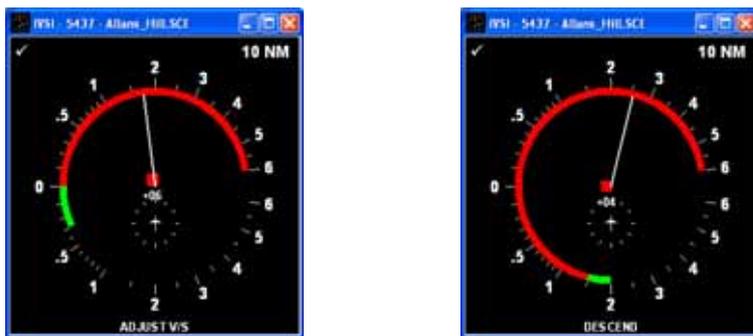
The simulated IVSI above shows that, at the time of the initial “Adjust Vertical Speed” RA, the BE200 was climbing at approximately 1600ft/min and that the RA required a negative vertical rate. By the time of the subsequent “DESCEND” RA the aircraft’s RoC had increased to 2500ft/min, while the RA now required a rate of descent of not less than 1500 ft/min.

The simulation indicates that as the BE200 climbed through FL150, where the Nimrod was in level flight, the RA changed again to a “MAINTAIN VERTICAL SPEED” RA instructing the pilot that the aircraft should maintain the current RoC. At the time of this RA the ac were horizontally separated by 2.4nm. The BE200 continued to climb and the RA weakened to an “ADJUST VERTICAL SPEED” RA instructing the BE200 pilot that the ac should not

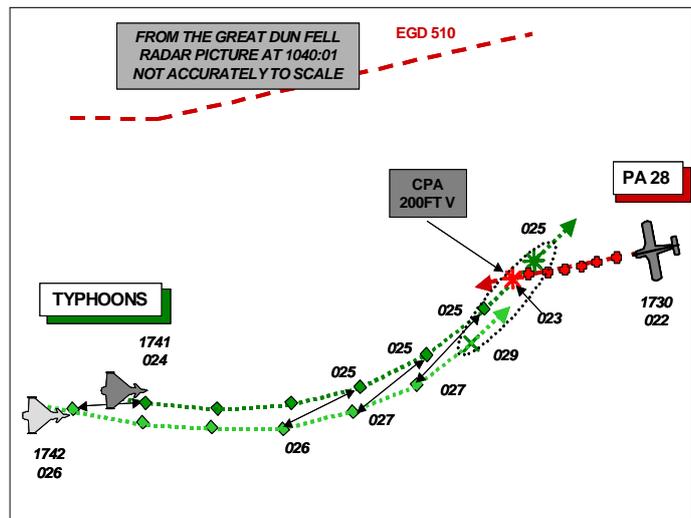
Recorded Separation:

200ft V/ 0H (projected between sweeps but confirmed by leader's HUD recording)

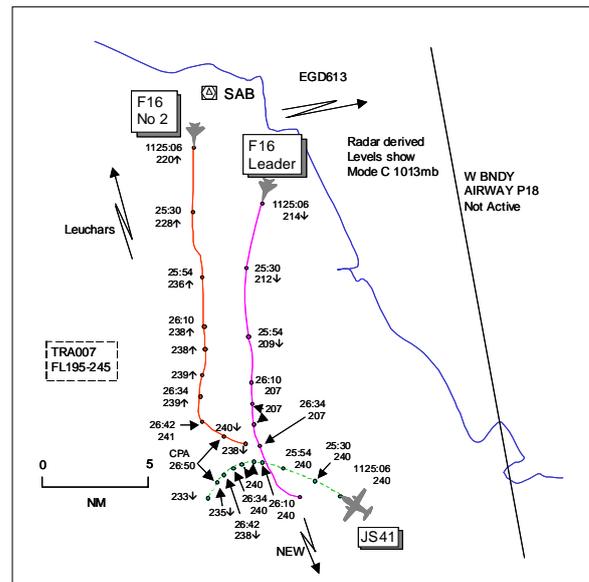
v Leader 3300ft V/1.6nm H

v No 2 500ft V/2.3nm H

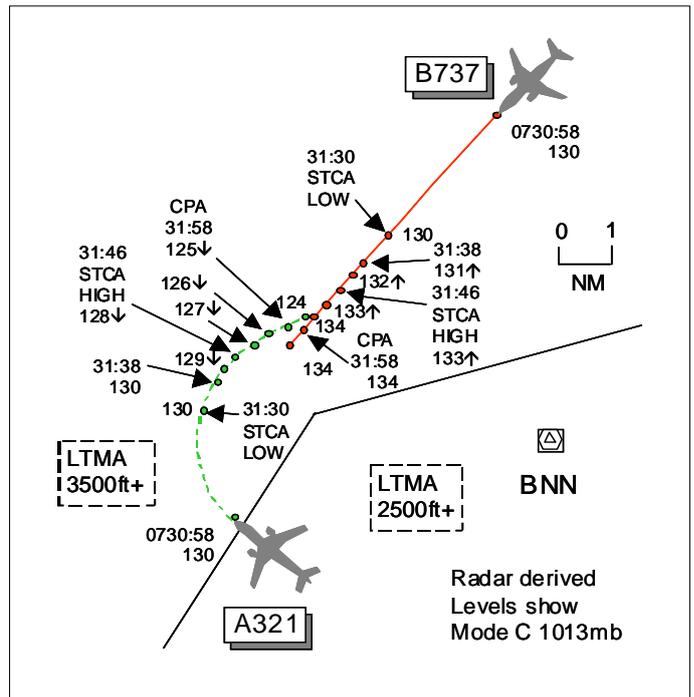
**AIRPROX REPORT NO 015/08**

Date/Time: 5 Jan 0732 (Saturday) (TWIL)  
Position: 5146N 00041W (5nm NW BNN)  
Airspace: LTMA (Class: A)  
Reporting Ac Reported Ac  
Type: A321 B737-800  
Operator: CAT CAT  
Alt/FL: FL130 FL130  
Weather VMC CLOC VMC CLOC  
Visibility: >10km 5000m  
Reported Separation:  
 700ft V/3nm H 300ft V/2.5nm H  
Recorded Separation:  
 900ft V/0.3nm H

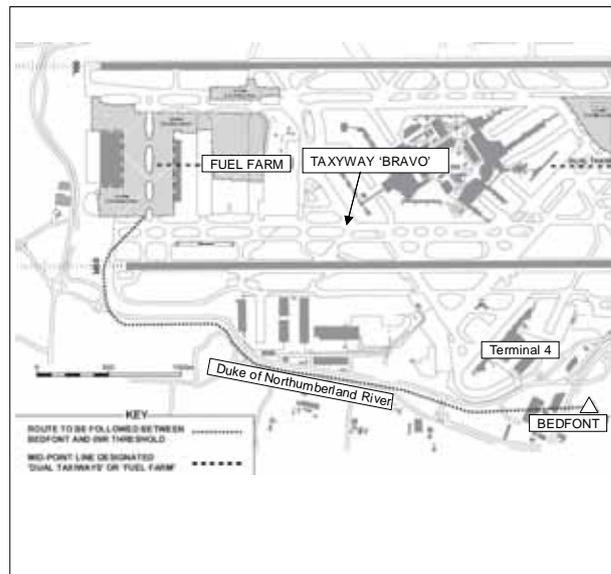
Date/Time: 11 Feb 1532  
Position: 5128N 00027W (London/Heathrow Airport - elev 83ft)  
Airspace: Heathrow ATZ (Class: A)  
Reporting Ac Reported Ac  
Type: A321 Enstrom 480B  
Operator: CAT Civ Pte  
Alt/FL: Take-off↑ 800ft  
QNH QNH (1032mb)  
Weather VMC Ovc VMC In haze  
Visibility: 10km 10km  
Reported Separation:  
400ft V/200-300m H 800ft V/500m H  
Recorded Separation:

Also see diagram at page 72

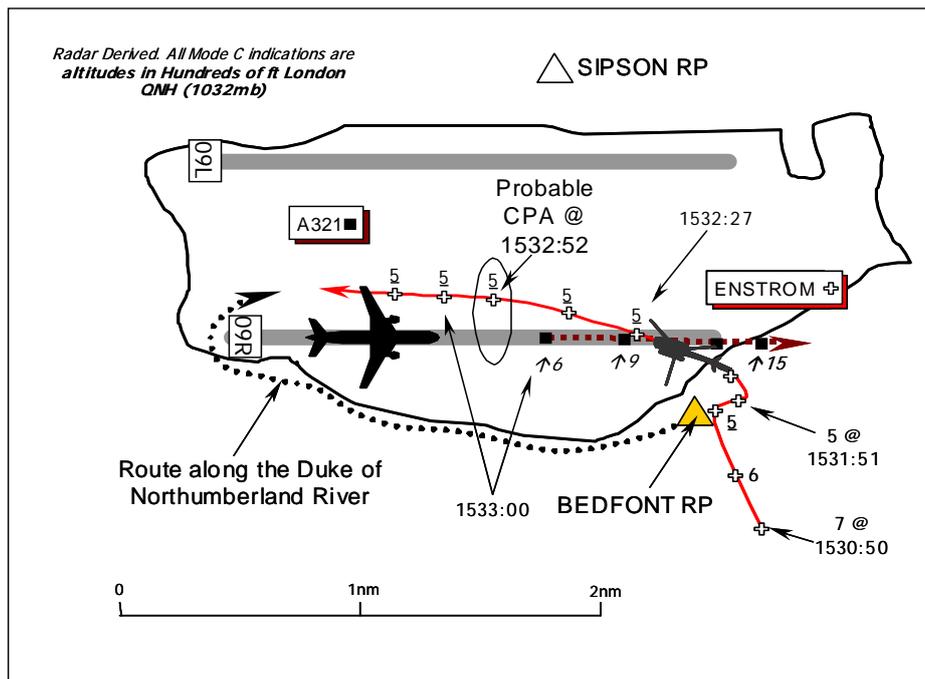
UKAB Note (1): The Heathrow 10cm radar recording does not illustrate this Airprox clearly as the A321 is understandably not shown until airborne. The Enstrom helicopter is shown approaching the vicinity of BEDFONT Reporting Point following H9 in a slow descent through 700ft London QNH (1032mb). Thereafter the helicopter levelled at 500ft London QNH – about 417ft aal - which is maintained throughout the encounter as the Enstrom pilot holds at BEDFONT reducing speed to a radar GS of <20kt. After 1531:51, the moment that both the A321 crew was cleared for take-off and the Enstrom pilot was instructed to “...route the Duke of Northumberland River to the west of the 0-9 right threshold...”, the helicopter is shown turning L to steady WNW'ly. Crossing RW09R at about 1532:27, indicating 500ft QNH at a radar GS of 85kt, the Enstrom steadies on a westerly course displaced some 300yd to the N of RW09R at 1532:52 which is probably when the CPA occurred as the ac passed port-to-port during the A321’s take-off. The airliner is not shown for a further two sweeps until it climbs into coverage through 600ft QNH the first contact being shown at 1533:00, by which time the Enstrom is drawing astern into the airliner’s 7 o’clock at a range of ½nm a radar GS of >90kt.

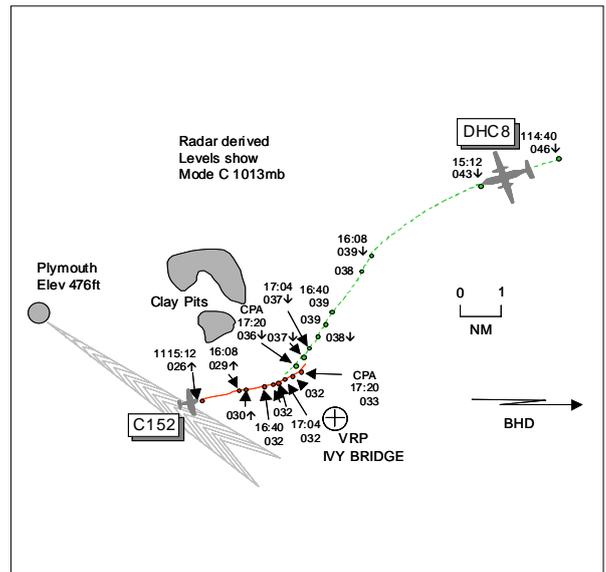
**AIRPROX REPORT NO 017/08**

Date/Time: 11 Feb 1117  
Position: 5024N 00357W (6-5nm ESE Plymouth - elev 476ft)  
Airspace: LFIR (Class: G)  
Reporting Ac Reported Ac  
Type: DHC8 C152  
Operator: CAT Civ Trg  
Alt/FL: 4300ft↓ ↑5000ft  
(QNH 1030mb) (NR)  
Weather VMC CLOC VMC NR  
Visibility: 10km NR  
Reported Separation:  
500ft V/2-300ft H>1000ftV/>0.5nm H  
Recorded Separation:  
300ft V/0.2nm H

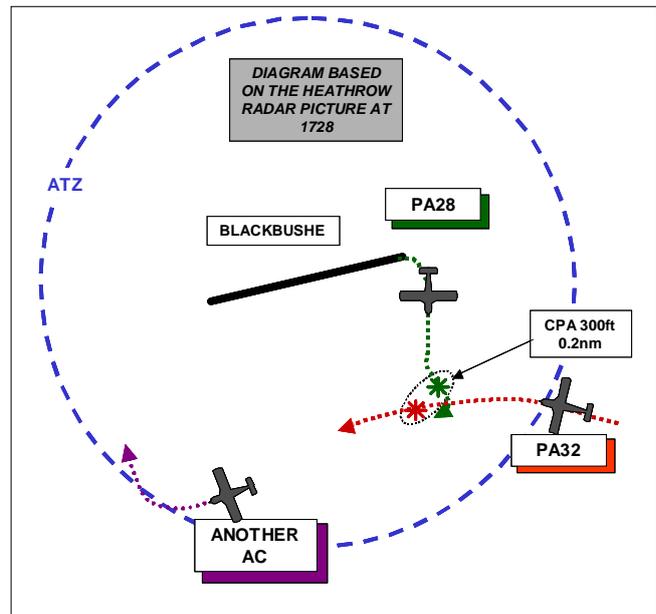
300ft V/0.2nm (360m) H

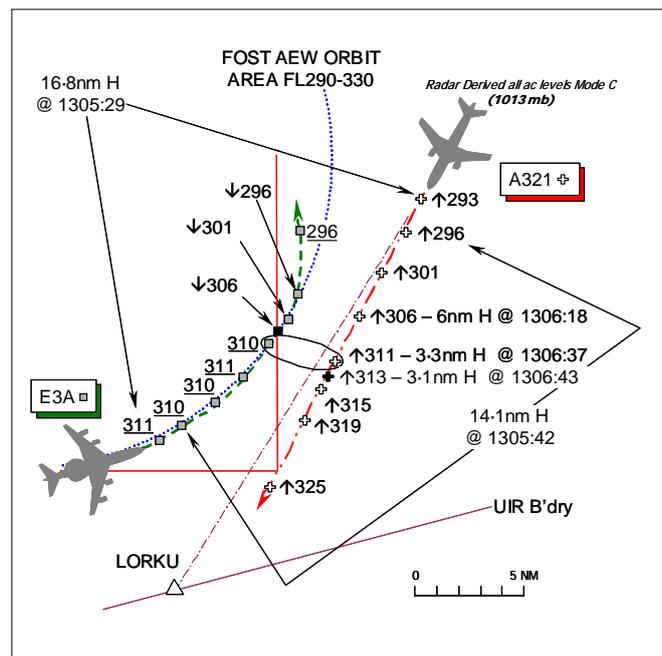
| | 100ft V @ 3.3nm H |
| | 3.1nm Min H @ 700ft V |

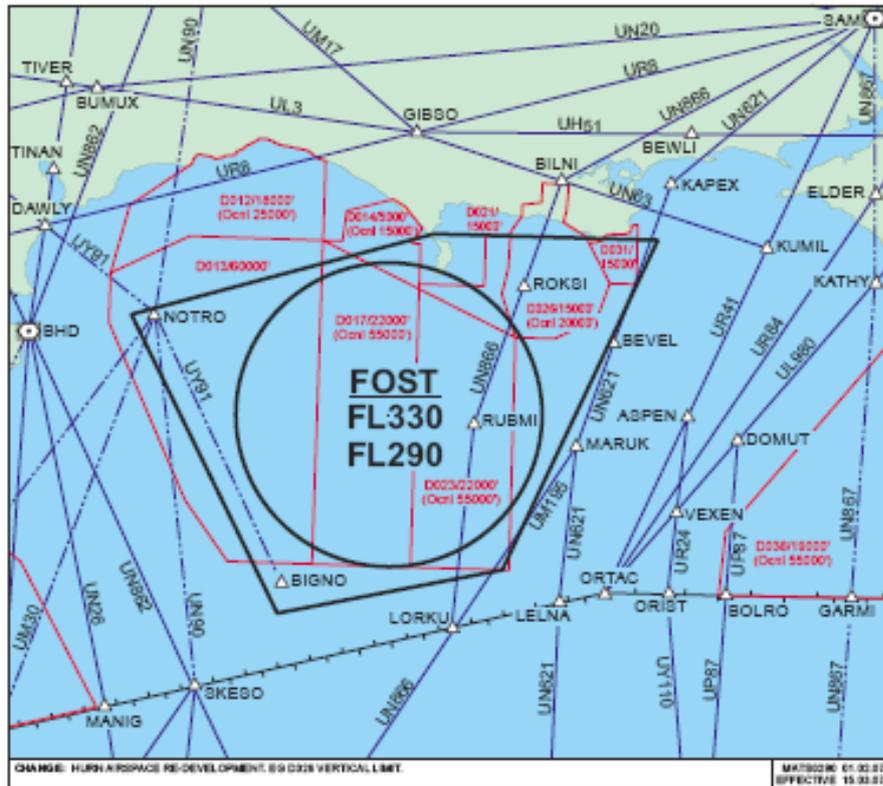
The location of the FOST E3 orbit area is shown in the diagram below:

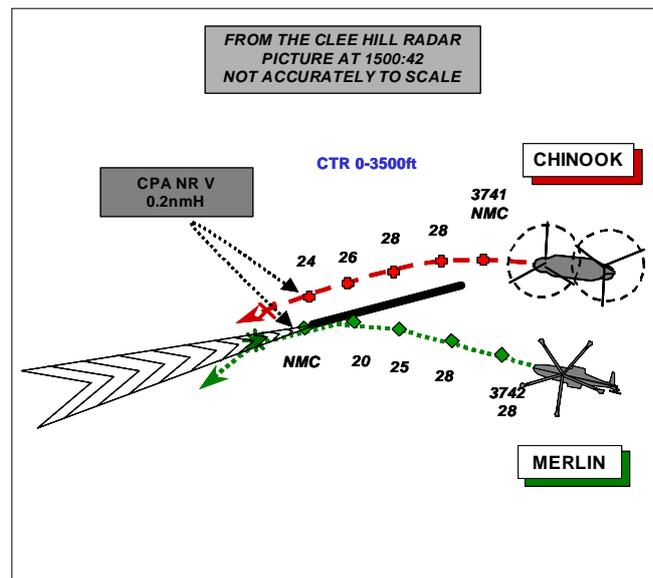
Reported Separation:  
500ft V/100m H Nil V/400m H

Recorded Separation:  
~400ft V/0.2nm H

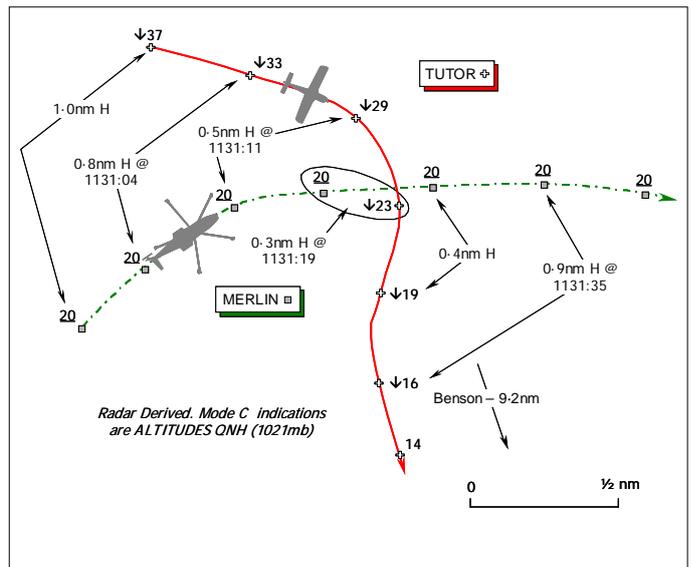
**AIRPROX REPORT NO 022/08**

Date/Time: 21 Feb 1131  
Position: 5145N 00110W (9nm NNW of Benson - elev 203ft)  
Airspace: Oxford AIAA (Class: G)  
Reporting Ac Reported Ac  
Type: Merlin HC3 Grob Tutor  
Operator: HQ JHC HQ AIR TRG  
Alt/FL: 1800ft 1800ft↓  
 QFE (1014mb) QFE (1014mb)  
Weather IMC IICL VMC CLOC  
Visibility: 1000m 10km  
Reported Separation:  
 100ft V/100m H 200ft V/6-800m H  
Recorded Separation:  
 300ft V @ 0.3nm H

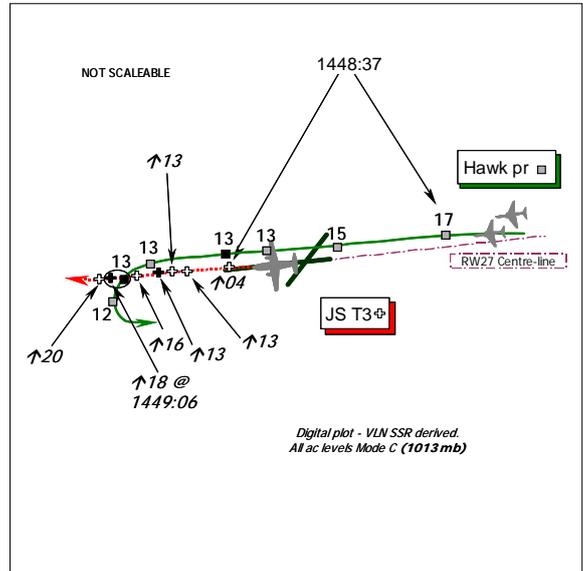
**AIRPROX REPORT NO 023/08**

Date/Time: 26 Feb 1449  
Position: 5101N 00238W (Yeovilton RW27 cct - elev 75ft)  
Airspace: MATZ/ATZ (Class: G)  
Reporting Ac Reported Ac  
Type: Hawk T1 pair Jetstream T3  
Operator: COS Avn COS Avn  
Alt/FL: 1000ft Departing  
 QFE (1006mb) QFE (1006mb)  
Weather VMC CAVOK VMC NR  
Visibility: >10km 10km  
Reported Separation:  
 Nil V/200m H NK  
Recorded Separation:  
 Not scaleable

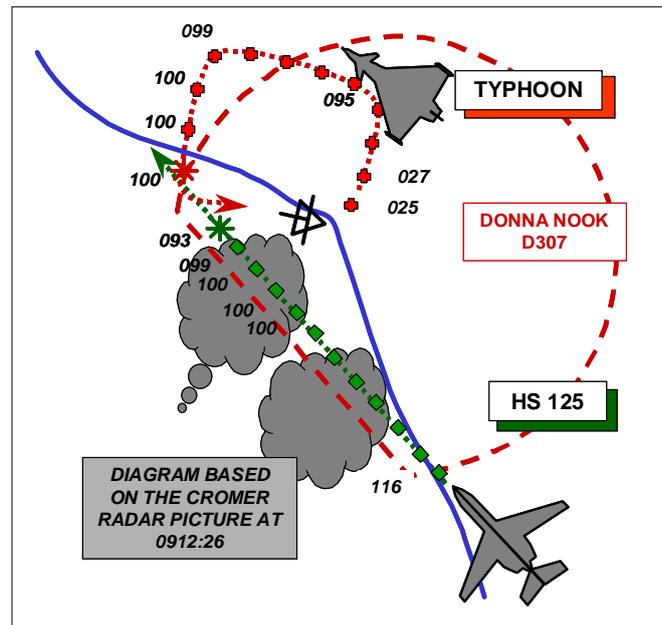
### AIRPROX REPORT NO 024/08

Date/Time: 6 Mar 0913  
Position: 5329N 00010E (Donna Nook Range)  
Airspace: DF307 (Class: G)  
Reporting Ac Reported Ac  
Type: HS125 Typhoon T Mk3  
Operator: Civ Pte HQ AIR (Ops)  
Alt/FL: FL100 8000ft  
SPS (QFE 1019mb)  
Weather IMC (in and out of cloud)  
Clear of Cloud  
Visibility: NR 5km to SW  
50km to SE  
Reported Separation:  
NR 2000ft V/½nm H  
Recorded Separation:  
<0.1nm H (see Notes)

UKAB Note (1): The TCAS **simulation** conducted by NATS on behalf of the UKAB calculates the CPA V to be 13ft and the CPA H to be 75m at 0912.32. For technical reasons the simulation used the Clee Hill radar, which is 120nm from the incident position and is therefore less accurate (at that extreme range) than either the Cromer or the Claxby, which are much closer.

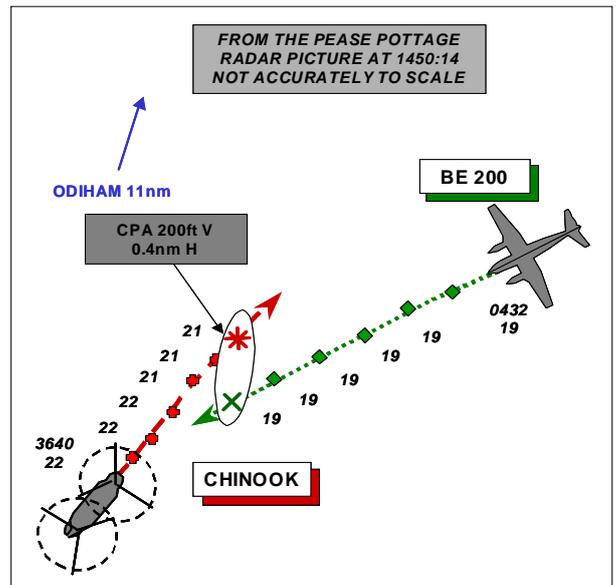
**AIRPROX REPORT NO 026/08**

Date/Time: 7 Mar 1450  
Position: 5106N 00058W (6nm S Lasham)  
Airspace: London FIR (Class: G)  
Reporting Ac Reported Ac  
Type: Chinook HC Mk2 Beech 200  
Operator: JHC Civ Comm  
Alt/FL: 2000ft 2000ft  
 (QNH 1012mb) (RPS 986mb)  
Weather VMC NR VMC NR  
Visibility: >20km 10km  
Reported Separation:  
 0ft V/200m H 500ft V/1000m H  
Recorded Separation:  
 200ft V/0.4nm H

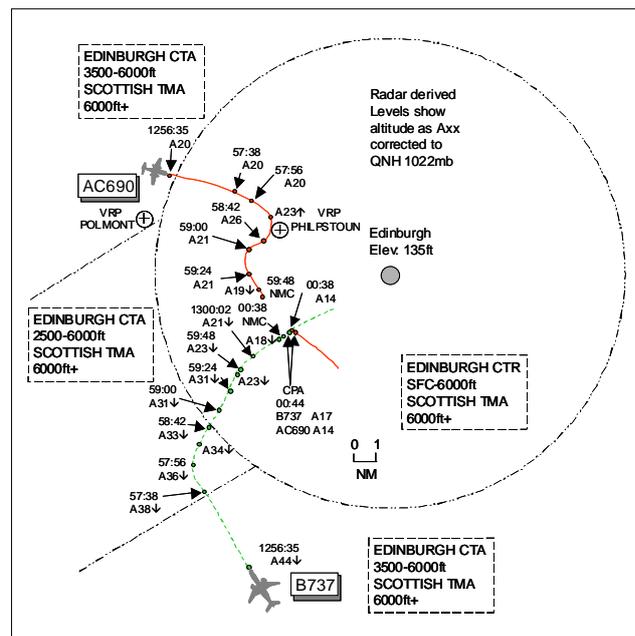
300ft V/ 0.2nm H

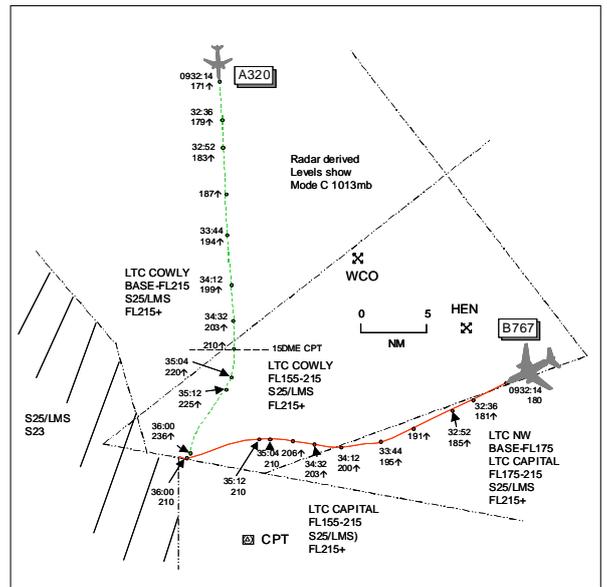
Reported Separation:  
 400ft V/3nm H      1000ft V/1-2nm H

Recorded Separation:  
 1000ft V/5.5nm H OR  
 2600ft V/0.4nm H

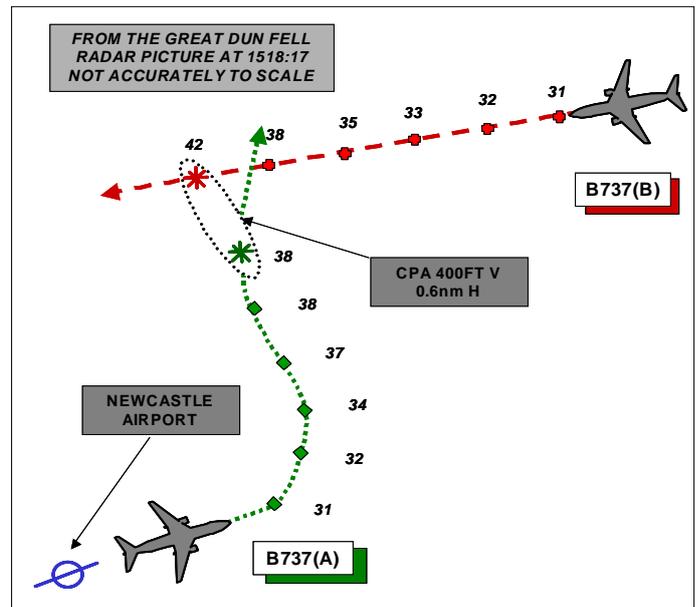
**AIRPROX REPORT NO 031/08**

Date/Time: 21 Mar 1510  
Position: 5506N 00137W (3nm NNE NEW - elev 266ft)  
Airspace: Newcastle CTR (Class: D)  
Reporting Ac Reported Ac  
Type: B737-800 B737-700  
Operator: CAT CAT  
Alt/FL: 3500ft 2500-5000ft↑  
 (990mb) (QNH 990mb)  
Weather NR IMC  
 Sct Cloud KLWD  
Visibility: NR 0nm  
Reported Separation:  
 600ft V/1nm H 200ft V/1m H  
Recorded Separation:  
 400ft V/0.6nm H

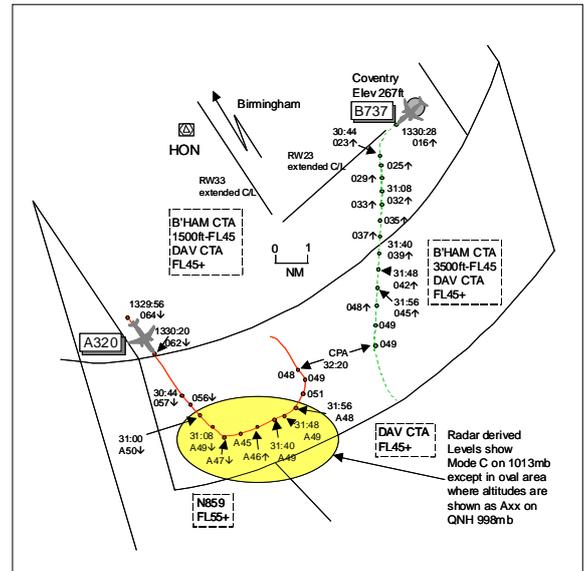
**AIRPROX REPORT NO 032/08**

Date/Time: 26 Mar 1332  
Position: 5214N 00132W (15nm SE Birmingham)  
Airspace: B'HAM/DAV CTA (Class: D/A)  
Reporting Ac Reported Ac  
Type: B737-500 A320  
Operator: CAT CAT  
Alt/FL: FL45↑ 4700ft↓  
 (QNH 998mb)  
Weather IMC IICL IMC KLWD  
Visibility:  
Reported Separation:  
 Nil V/2.5nm H 200ft V/3nm H  
Recorded Separation:  
 100ft V/2.4nm H

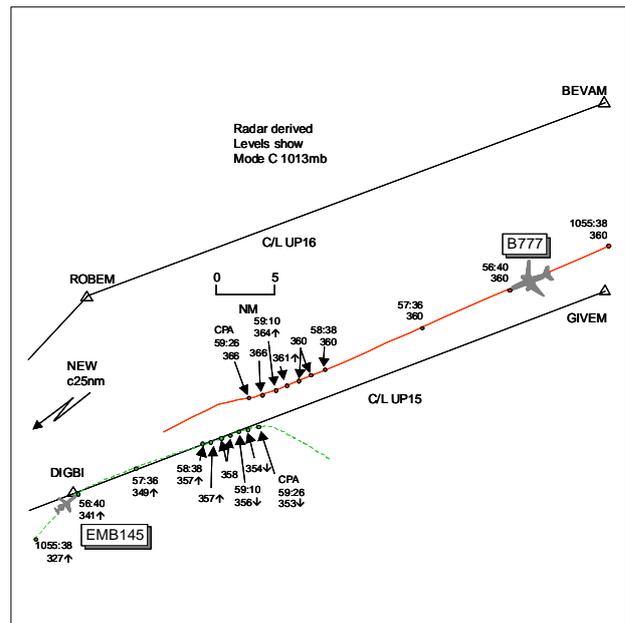
Date/Time: 19 Mar 1059  
Position: 5518N 00038W (40nm ENE Newcastle)  
Airspace: UAR UP15 (Class: C)  
Reporting Ac Reported Ac  
Type: EMB145 B777-300  
Operator: CAT CAT  
Alt/FL: FL358↑ FL360

Weather VMC CLAC IMC  
Visibility: >20nm  
Reported Separation:  
500-2000ft V/ 300ft V/  
1-2nm H 4-5nm H  
Recorded Separation:  
800ft V/4-5nm H OR  
1300ft V/2-8nm H

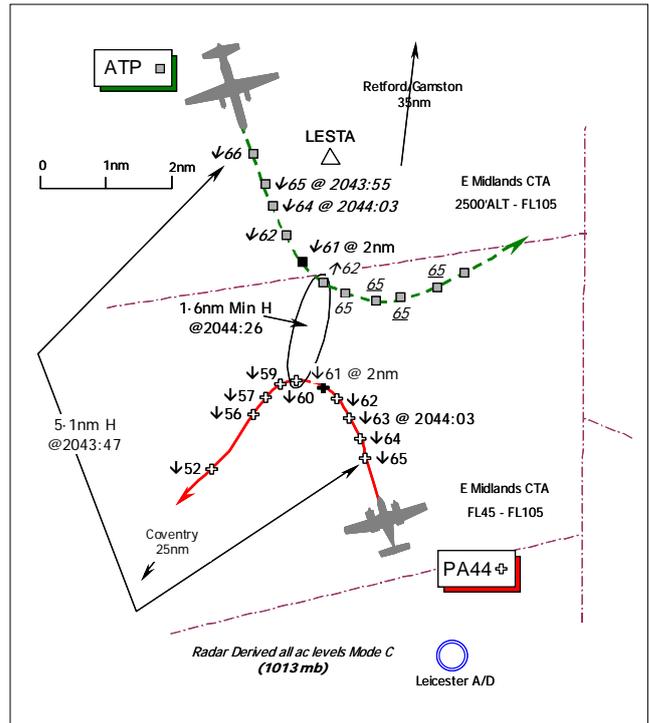
**AIRPROX REPORT NO 035/08**

Date/Time: 8 Apr 2044 NIGHT  
Position: 5242N 00104W (12nm SE East Midlands - elev 306ft)  
Airspace: EMA CTA (Class: D)  
Reporter: EMA APR  
1st Ac 2nd Ac  
Type: BAe ATP PA44  
Operator: CAT Civ Trg  
Alt/FL: FL62↓ ↓3000ft  
 QNH (1001mb)  
Weather VMC 'tween layers VMC NR  
Visibility: 10km+ 100km  
Reported Separation:  
EMA APR:  
2nm H  
 500ft V/3m H Nil V/<2nm H  
Recorded Separation:  
 Nil V @2nm H  
 1.6nm Min H/200ft V

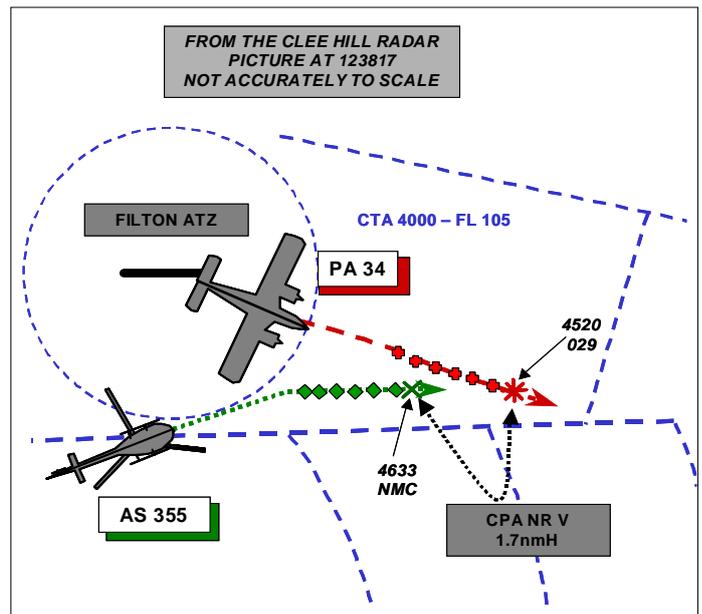
Recorded Separation:

NR V/1.7nm H (see ATSI report)

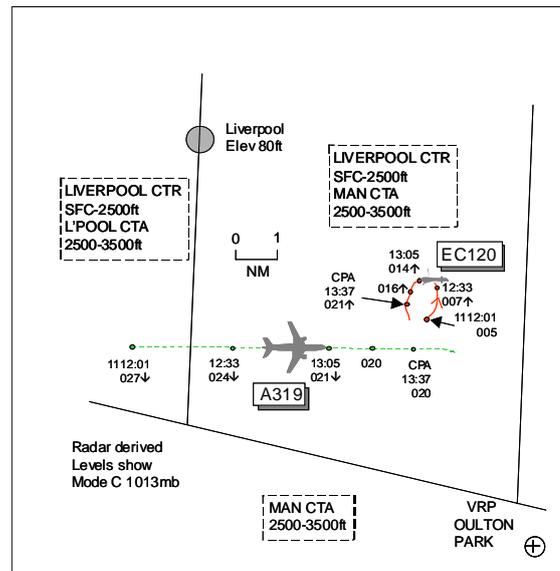
Reported Separation:  
Nil V/1nm H Not seen

Recorded Separation:  
100ft V/1nm H

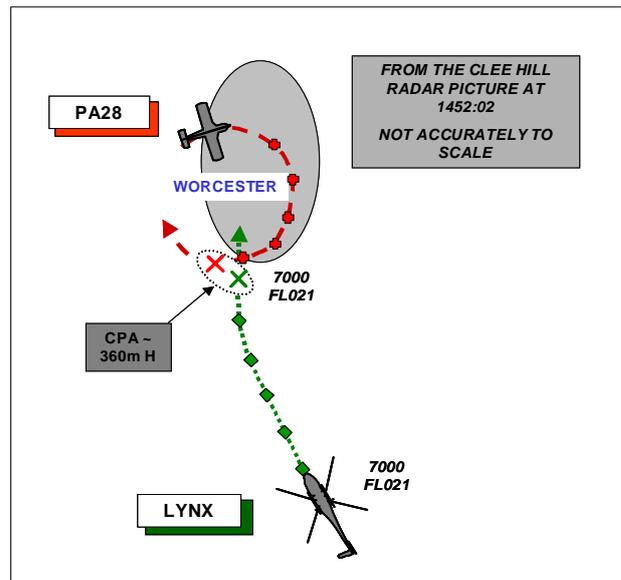
### AIRPROX REPORT NO 039/08

Date/Time: 9 Apr 1452  
Position: 5209N 00213W (½nm S Worcester)  
Airspace: London FIR (Class: G)  
Reporting Ac Reported Ac  
Type: Lynx Mk7 PA28  
Operator: JHC Civ Pte  
Alt/FL: 1500ft 1500ft  
(RPS 998mb) (QNH)  
Weather VMC CLBC VMC RAIN  
Visibility: >10km >10km  
Reported Separation:  
0ft V/200m H NR  
Recorded Separation:  
NR V/0.2nm (360m) H

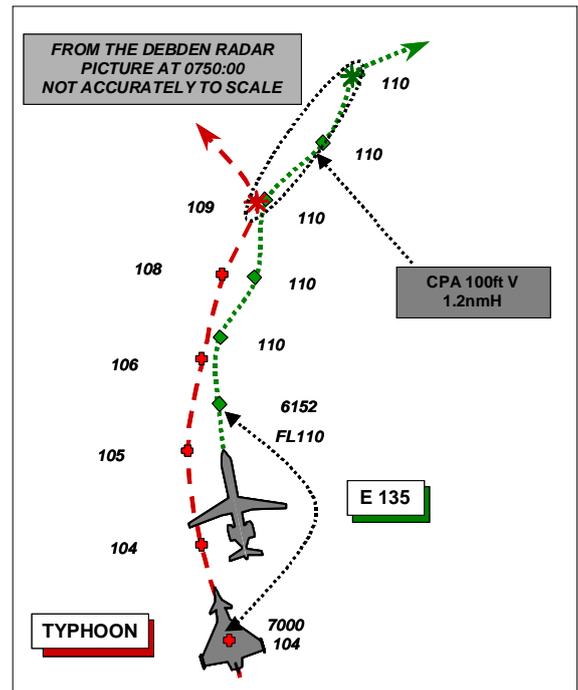
**AIRPROX REPORT NO 040/08**

Date/Time: 10 Apr 0750  
Position: 5245N 00100W  
Airspace: London FIR (Class: G)  
Reporting Ac Reported Ac  
Type: Embraer 135 Typhoon  
Operator: CAT HQ AIR (Ops)  
Alt/FL: FL110↑ FL 110  
Weather VMC CAVOK VMC  
Visibility: >50nm 30km  
Reported Separation:  
0ft V/½nm H 1000ftV/7500ft  
(1.25nm) H  
Recorded Separation:  
100ft V/ 1.2nm H

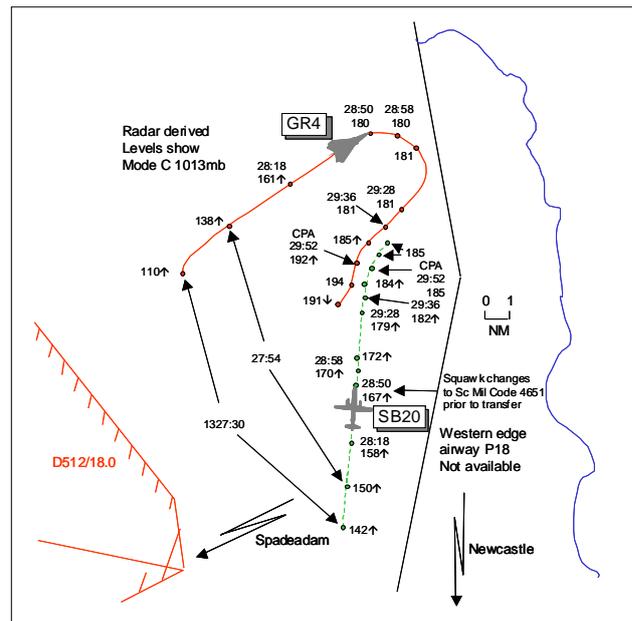
Reported Separation:  
800ft V/300m H 1000ft V/1nm H

Recorded Separation:  
700ft V/0.7nm H

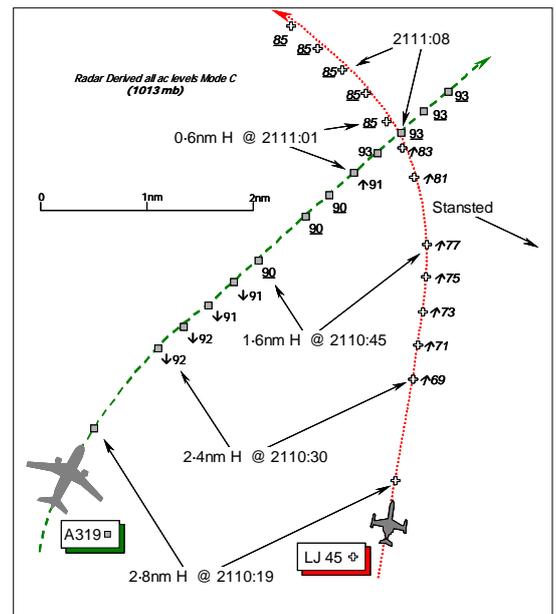
| <u>Recorded Separation:</u> | |
| 600ft V/0.6nm H | |

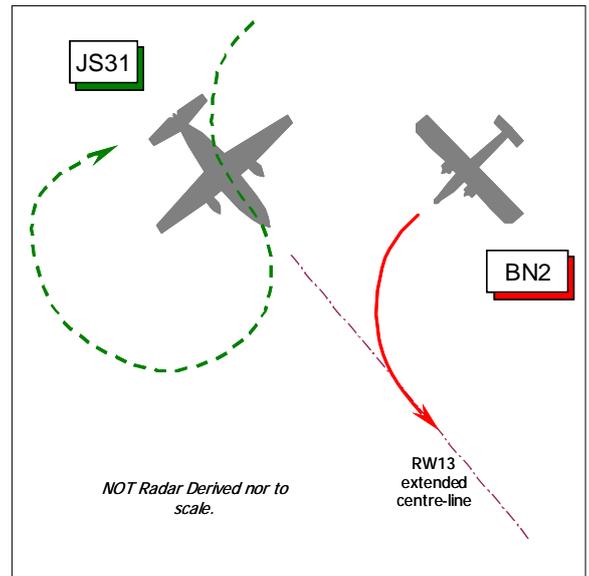
**AIRPROX REPORT NO 043/08**

Date/Time: 16 Apr 1326  
Position: 5026N 00407W (Plymouth Airport cct - elev 476 ft)  
Airspace: Plymouth ATZ/FIR (Class: G)  
Reporting Ac            Reported Ac  
Type: Jetstream 31            Islander BN2  
Operator: CAT                    Civ Comm  
Alt/FL: 2000ft↓                    NR  
                   QNH (1016mb)            QFE (998mb)  
Weather VMC NR                    VMC CAVOK  
Visibility: 10km+                    30nm  
Reported Separation:  
                   500ft V/800m H            NR  
Recorded Separation:  
                   Not recorded

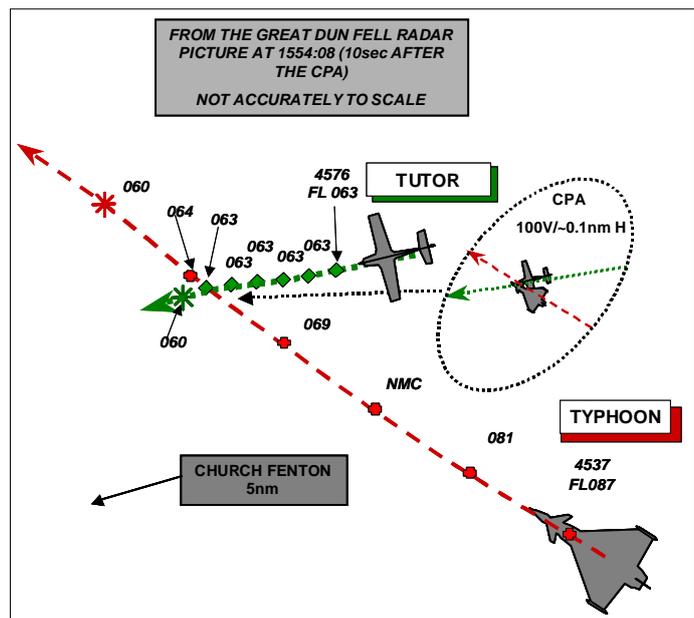
Recorded Separation:

100ft V/<0.1nmH

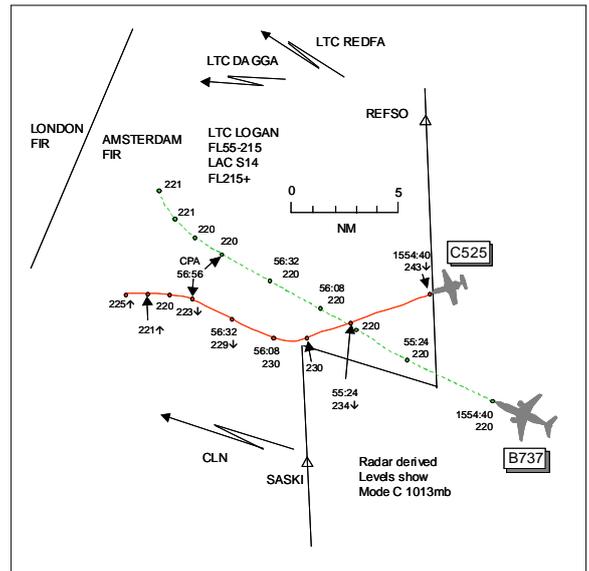
**AIRPROX REPORT NO 047/08**

Date/Time: 17 Apr 1557  
Position: 5142N 00222E (13nm SW REFSO)  
Airspace: AWY L608/P20 (Class: C)  
Reporting Ac Reported Ac  
Type: B737-700 C525  
Operator: CAT Civ Comm  
Alt/FL: FL220 FL220↓  
Weather VMC CLOC VMC CLBL  
Visibility: 50km  
Reported Separation:  
 Nil V/2-5nm H 1-2000ft V/6nm H  
Recorded Separation:  
 300ft V/2-5nm H

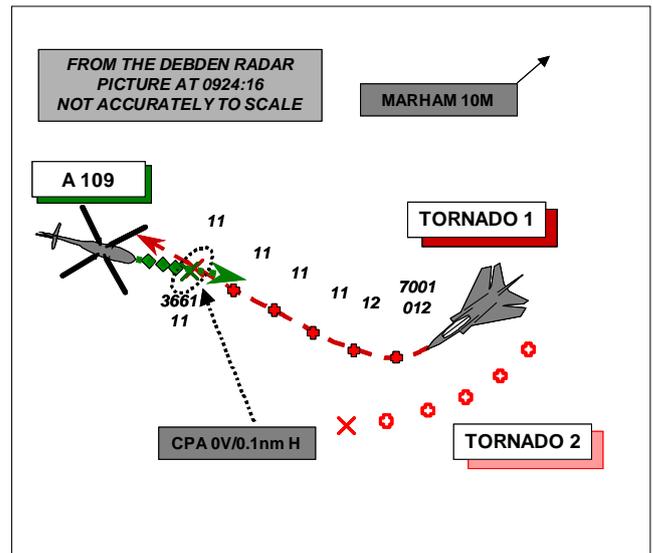
Recorded Separation:

0V/0.1nm H (<185m) H [Note: The vertical separation as the radar contacts merged was 0 but it was 200ft on the next radar sweep after the A109 had descended]

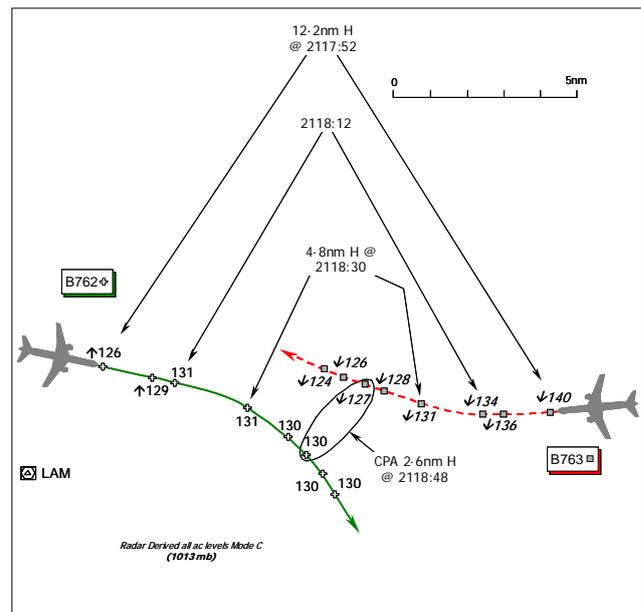
### AIRPROX REPORT NO 049/08

Date/Time: 24 Apr 2118 NIGHT  
Position: 5140N 00023E (9nm E of LAM VOR)  
Airspace: LTMA (Class: A)  
Reporting Ac Reported Ac  
Type: B767-200 A2 B767-300  
Operator: CAT CAT  
Alt/FL: FL125↑ ↓FL130  
SAS SAS  
Weather VMC CLBL VMC  
Visibility: 10km NR  
Reported Separation:  
300ft V/3-4nm H NR  
Recorded Separation:  
Nil V @ 4-8nm H  
Min H 2-6nm @  
300ft V

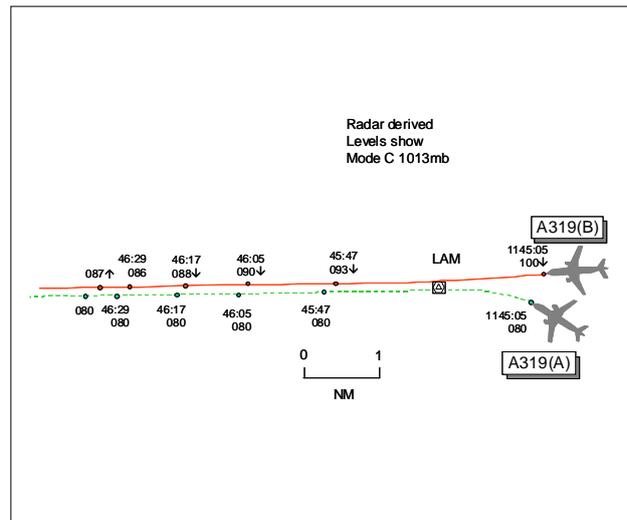
**AIRPROX REPORT NO 050/08**

Date/Time: 26 Apr 1147 (Saturday)  
Position: 5139N 00001E (5nm W LAM)  
Airspace: LTMA (Class: A)  
Reporting Ac Reported Ac  
Type: A319(A) A319(B)  
Operator: CAT CAT  
Alt/FL: FL80 ↓FL80  
Weather VMC NR VMC NR  
Visibility: >10km 10km  
Reported Separation:  
 500ft V NR  
Recorded Separation:  
 600ft V/0.2nm H

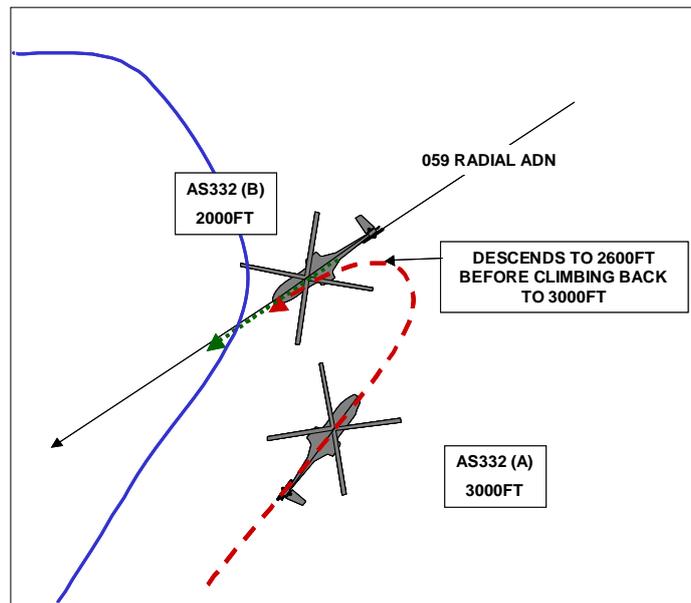
Reported Separation:  
600ft V / 0.5nm H      NK

Recorded Separation:  
600ft V / 1.6nm H (from ATSI report)

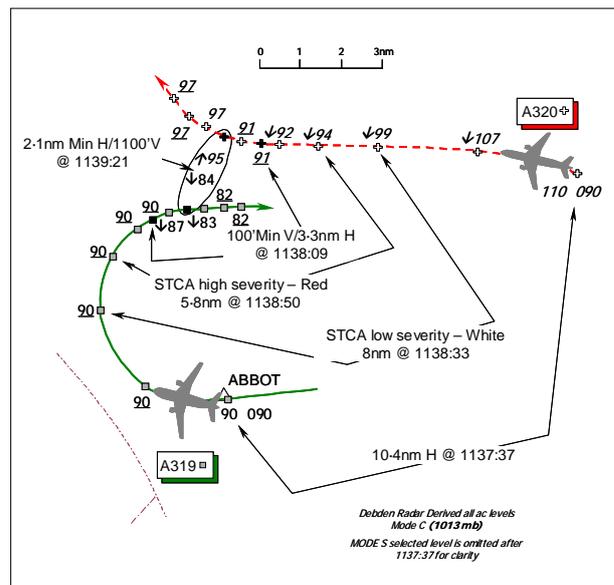
## AIRPROX REPORT NO 052/08

Date/Time: 30 Apr 1139  
Position: 5207N 00035E (5½nm N of ABBOT)  
Airspace: London TMA (Class: A)  
Reporting Ac Reported Ac  
Type: A319 A320  
Operator: CAT CAT  
Alt/FL: FL90 ↓FL90  
Weather IMC In Cloud IMC In Cloud  
Visibility: Nil NR  
Reported Separation:  
200ft V/Nil H 400ft V/2.5nm H  
Recorded Separation:  
100ft Min V @ 3.3nm H  
2.1nm Min H @ 1100ft V

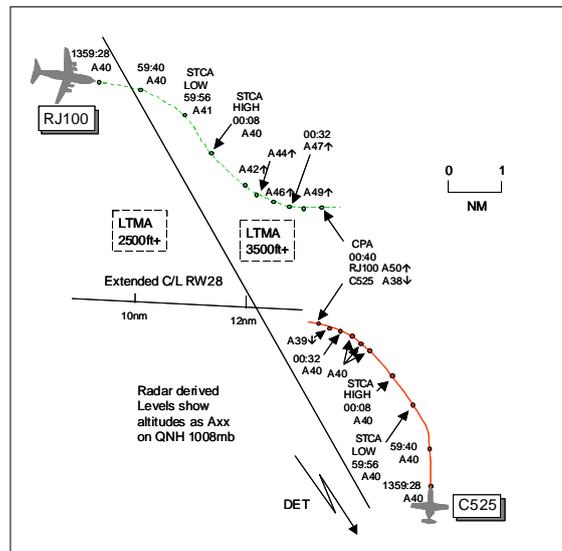
## AIRPROX REPORT NO 054/08

Date/Time: 1 May 1401  
Position: 5130N 00028E (12nm NW DET)  
Airspace: LTMA (Class: A)  
Reporting Ac Reported Ac  
Type: RJ100 C525  
Operator: CAT Civ Comm  
Alt/FL: 4000ft 4000ft  
(QNH 1008mb) (QNH)  
Weather VMC CLOC VMC NR  
Visibility: 15km  
Reported Separation:  
Nil V/3nm H Not seen  
Recorded Separation:  
1200ft V/2.1nm H
