**UK AIRPROX BOARD**

# **Analysis of Airprox in UK Airspace**

**Report Number 20  
January 2008 – June 2008**

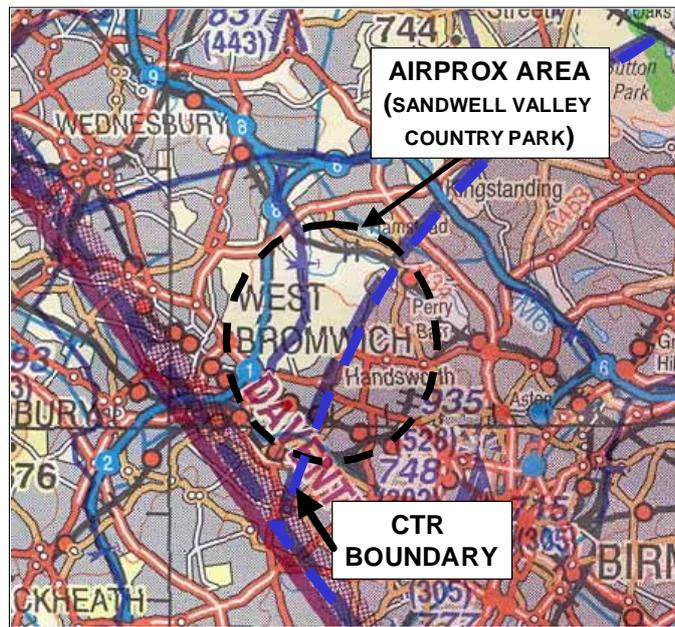
Date/Time: 2 May 2150  
Position: 5232N 00156W (8nm NW of BHX)  
Airspace: Lon FIR/B'ham CTR (Class: G/D)  
Reporting Ac            Reported Ac  
Type: EC135                Unknown  
Operator: Civ Pol            NK  
Alt/FL: 1500ft                NK  
(QNH 1022mb)  
Weather VMC CAVOK  
[no cloud, no moon wind 4kt]

Visibility: >30km  
Reported Separation:  
NR  
Recorded Separation:  
NR

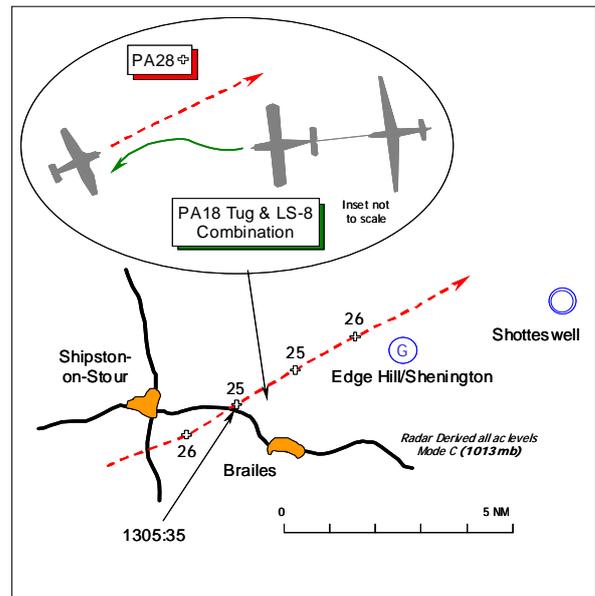
Reported Separation:  
Nil V/300ft H ~300ft V/200m H

Recorded Separation:  
Not recorded

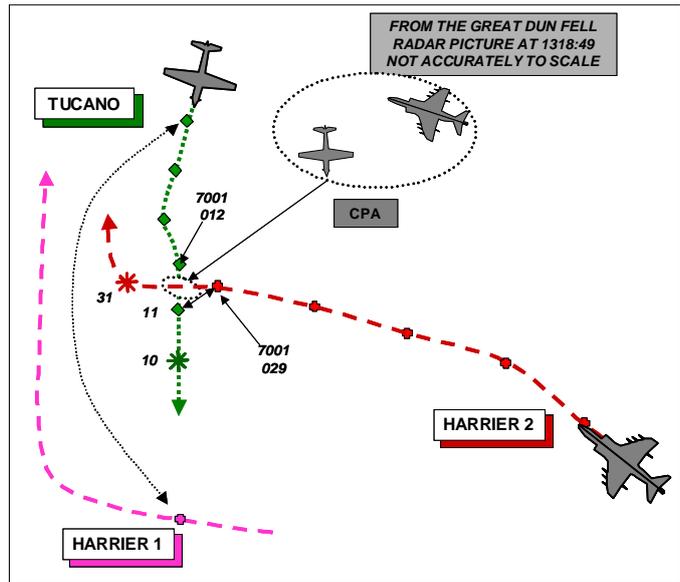
## AIRPROX REPORT NO 057/08

Date/Time: 8 May 1319  
Position: 5424N 00221W (13nm NE Kendal)  
Airspace: UKDLFS (Class: G)  
Reporting Ac Reported Ac  
Type: Tucano TMk1 Harrier GR9  
Operator: HQ AIR (Trg) HQ AIR (Ops)  
Alt/FL: 270ft AGL 250ft AGL  
(RPS 1014mb) (RPS 1010mb)  
Weather VMC Haze VMC Haze  
Visibility: 8km 6km  
Reported Separation:  
10-20ft V/ 50ft V/300m H  
100-150m H  
Recorded Separation:  
1600ft V/ ½nm H

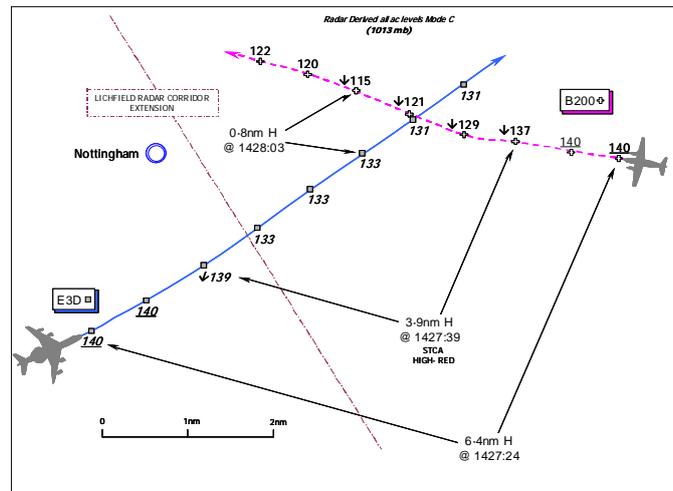
Recorded Separation:

Nil V @ 5.2nm H 1800ft V @ 0.8nm Min H

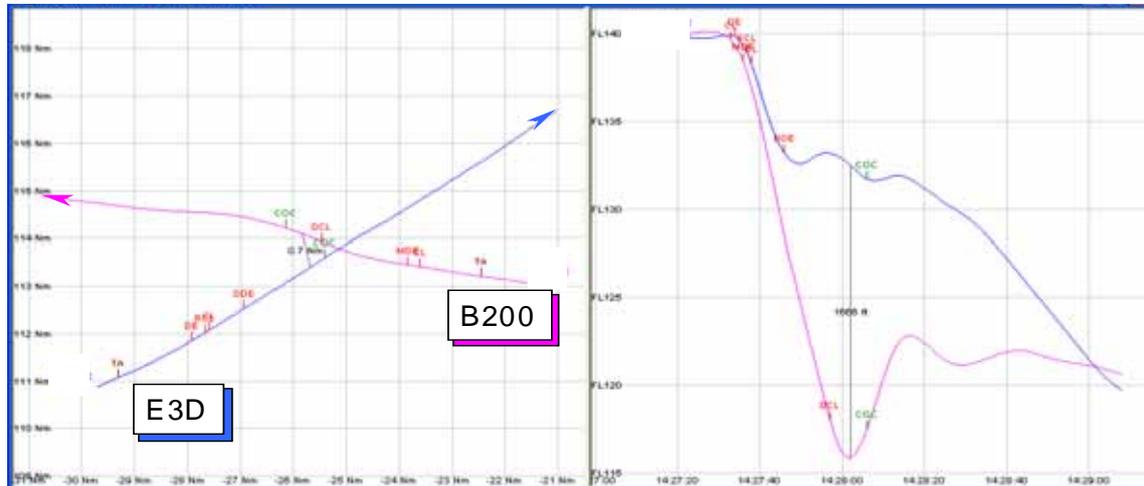
#### UKAB Note (1) TCAS ANALYSIS

At UKAB's request NATS Ltd helpfully conducted a TCAS analysis of this occurrence utilising the ATM Safety Monitoring Tool (ASMT), which is a EUROCONTROL software tool used by the Operational Analysis department for the monitoring of TCAS events. The tool receives downlinked Mode-S messages and extracts the TCAS information. The tool is currently connected to the Pease Pottage Radar. The ASMT recorded information regarding this encounter and this data, along with the InCAS (Interactive Collision Avoidance Simulator) simulation, has been used as the basis of this assessment.

The simulation indicates that at 1427:17 both ac received TCAS TAs whilst in level flight at FL140. At the time of the alerts the aircraft were separated laterally by 7.2nm and on crossing headings. As the ac closed, the simulation suggests that the B200 began to descend reaching a rate of ~1500ft/min when it was issued with a "CLIMB" RA at 1427:33. The simulation suggests that the E3D was issued with a "DESCEND" RA 1sec later at 1427:34. The first RA downlink reports from both ac were received at 1427:36 which confirmed these alerts.

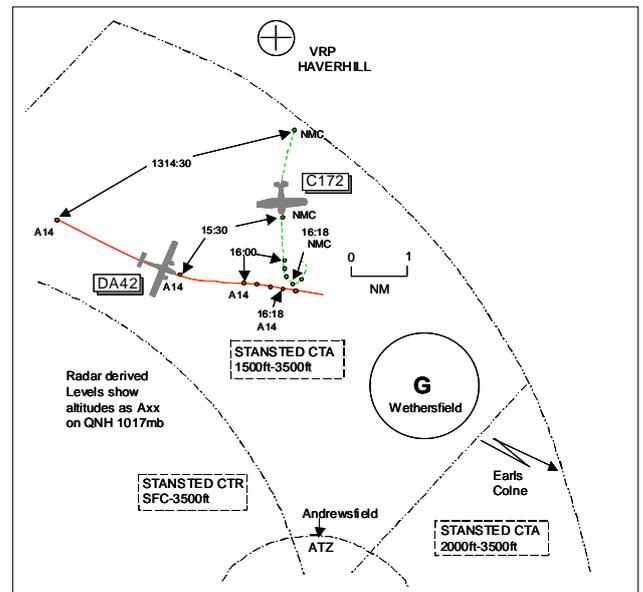
**AIRPROX REPORT NO 059/08**

Date/Time: 10 May 1316 (Saturday)  
Position: 5200N 00026E (10.5nm NE Stansted)  
Airspace: LFIR (Class: G)  
Reporting Ac Reported Ac  
Type: C172 DA42  
Operator: Civ Pte Civ Pte  
Alt/FL: 1300ft 1400ft  
 (QNH 1016mb) (QNH)  
Weather VMC CLOC VMC CLOC  
Visibility: 40km >10km  
Reported Separation:  
 50ft V/400m H Not seen  
Recorded Separation:  
 0.2nm H

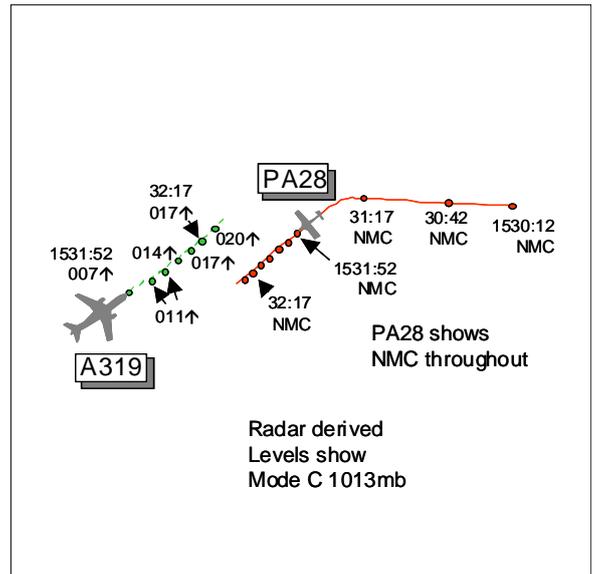
**AIRPROX REPORT NO 060/08**

Date/Time: 16 May 1532  
Position: 5732N 00403W (O/H RW05 Inverness - elev 31ft)  
Airspace: ATZ (Class: G)  
Reporting Ac Reported Ac  
Type: A319 PA28  
Operator: CAT Civ Pte  
Alt/FL: 1000ft↑ 1000ft↓  
 (QNH 1011mb) (QFE)  
Weather VMC CLBC VMC HAZE  
Visibility: >30km 6nm  
Reported Separation:  
 Nil V/<500m H Nil V/800m H  
Recorded Separation:  
 c0-5nm

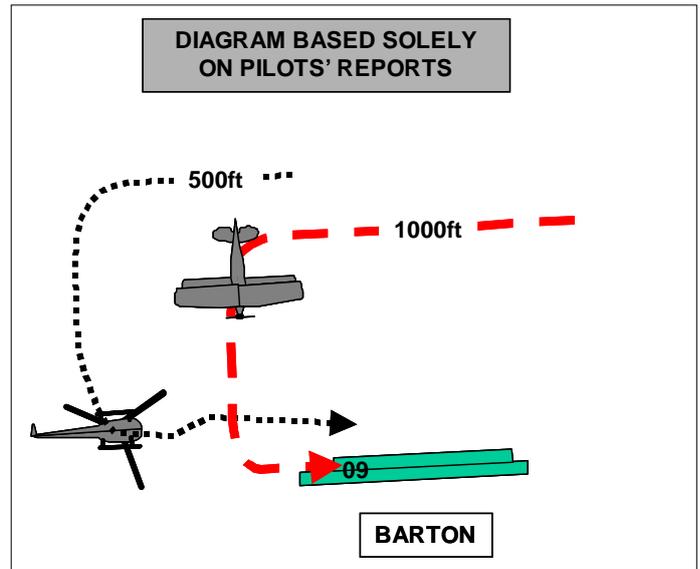
**AIRPROX REPORT NO 061/08**

Date/Time: 15 May 1210  
Position: 5228N 00224W (Final Approach  
 RW09 Barton Airfield - elev 73ft)  
Airspace: Barton ATZ (Class: G)  
Reporting Ac Reported Ac  
Type: Enstrom 280Fx DH82 Tiger Moth  
Operator: Civ Trg Civ Trg  
Alt/FL: ↓500ft ↓800ft  
 (QFE) (QFE)  
Weather VMC NR VMC NIL  
Visibility: CAVOK >5km  
Reported Separation:  
 Nil V/150-200ft H N/A V/800m H  
Recorded Separation:  
 NR

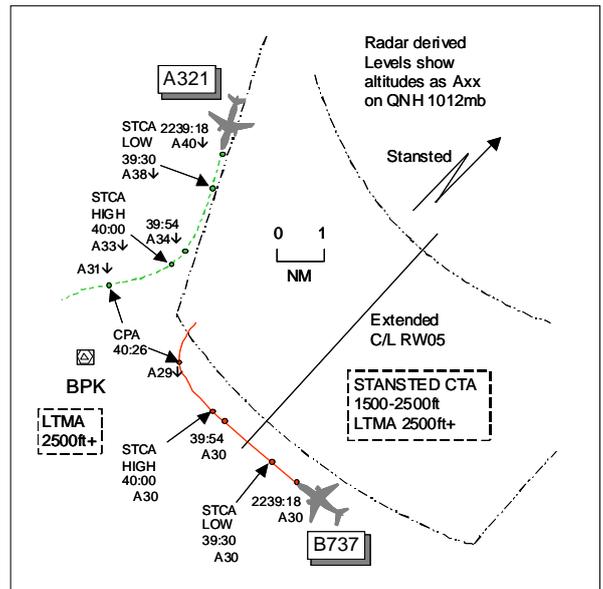
**AIRPROX REPORT NO 063/08**

Date/Time: 17 May 2240 (Saturday) NIGHT  
Position: 5145N 00004W (14nm SW Stansted)  
Airspace: LTMA (Class: A)  
Reporting Ac Reported Ac  
Type: A321 B737-800  
Operator: CAT CAT  
Alt/FL: 3000ft 3000ft  
(QNH) (QNH)  
Weather VMC CLNC VMC CLOC  
Visibility: 25km 10km  
Reported Separation:  
Nil V/3nm H 300ft V/3nm H  
Recorded Separation:  
200ft V/2-3nm H

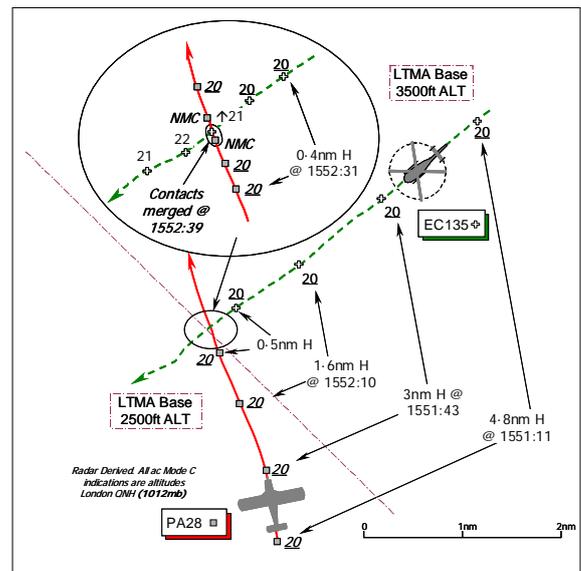
## AIRPROX REPORT NO 064/08

Date/Time: 14 May 1552  
Position: 5137N 00017E (5nm ESE of Stapleford)  
Airspace: London FIR (Class: G)  
Reporting Ac Reported Ac  
Type: EC135 T2 PA28  
Operator: Civ Com Civ Pte  
Alt/FL: 2000ft 1800ft  
QNH (1012mb) amsl  
Weather NK CAVOK VMC Haze  
Visibility: 40km+ 10nm  
Reported Separation:  
100ft V/30m H 150ft V/250m H  
Recorded Separation:  
Contacts merged/~100ft V

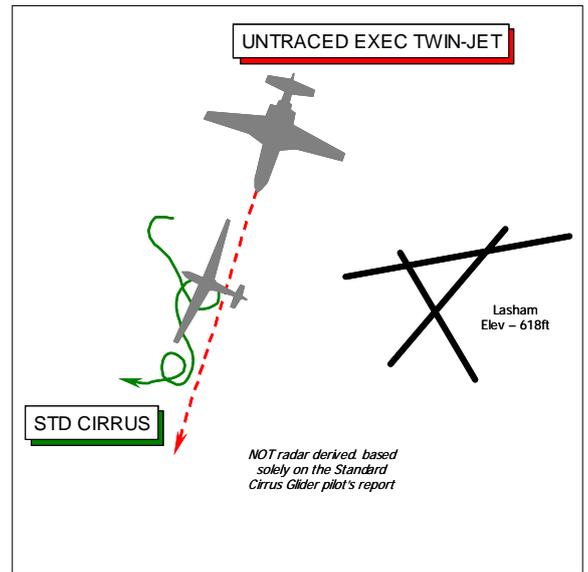
**AIRPROX REPORT NO 067/08**

Date/Time: 21 May 1210  
Position: 5111N 00103W (1nm W of Lasham - elev 618ft)  
Airspace: London FIR (Class: G)  
Reporting Ac Reported Ac  
Type: Cirrus glider Untraced twin-jet  
Operator: Civ Pte N/K  
Alt/FL: 2100ft N/K  
 QFE (995mb)  
Weather VMC Haze N/K  
Visibility: 10km N/K  
Reported Separation:  
 Nil V/100m H NR  
Recorded Separation:  
 Not recorded

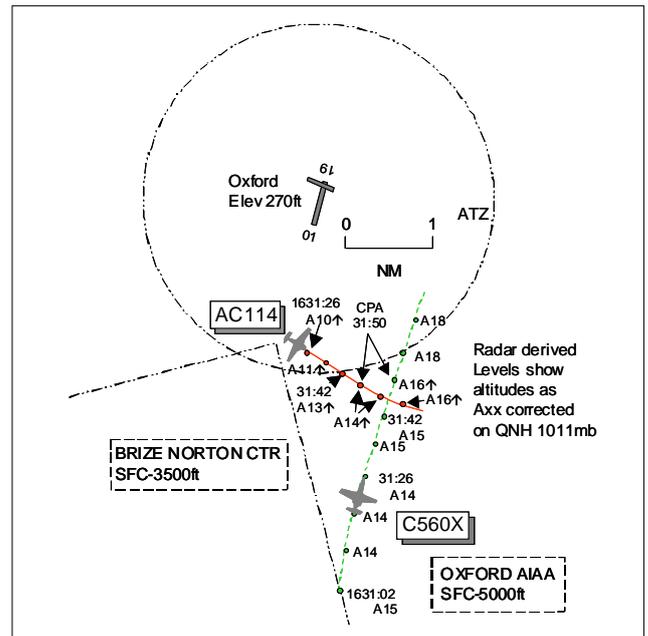
**AIRPROX REPORT NO 068/08**

Date/Time: 23 May 1632  
Position: 5148N 00118W (2.25nm SSE Oxford - elev 270ft)  
Airspace: ATZ/Oxford AIAA (Class: G)  
Reporting Ac Reported Ac  
Type: C560X Citation AC114  
Operator: Civ Pte Civ Pte  
Alt/FL: 1500ft 800ft↑  
(QNH 1011mb) (QNH)  
Weather VMC CLOC VMC CLBC  
Visibility: >10km 6km  
Reported Separation:  
200ft V/Nil H 300ft V/0.5nm H  
Recorded Separation:  
200ft V/0.4nm H

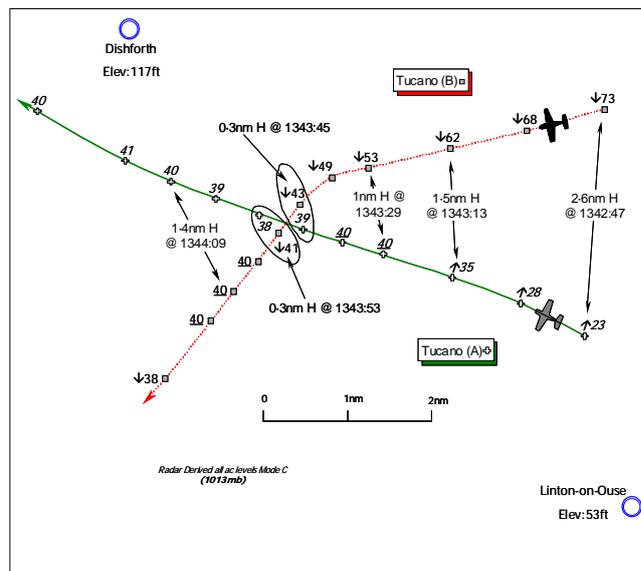
Recorded Separation:

Nil V @ 1.4nm H/0.3nm Min H @ 300ft V

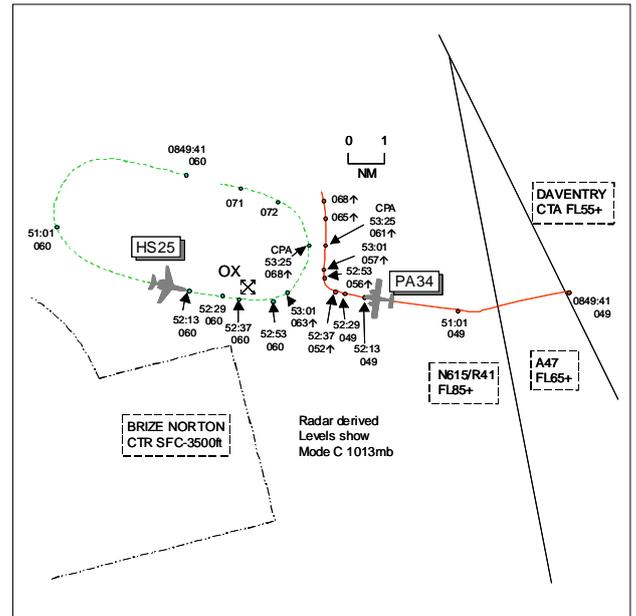
**AIRPROX REPORT NO 072/08**

Date/Time: 30 May 0853  
Position: 5151N 00116W (2nm NE Oxford Airport  
 - elev 270ft)  
Airspace: Oxford AIAA (Class: G)  
Reporting Ac Reported Ac  
Type: HS25 PA34  
Operator: Civ Pte Civ Trg  
Alt/FL: FL60 ↑FL70  
Weather IMC KLWD IMC KLWD  
Visibility:  
Reported Separation:  
 400ft V/1nm H NR  
Recorded Separation:  
 700ft V/0.5nm H

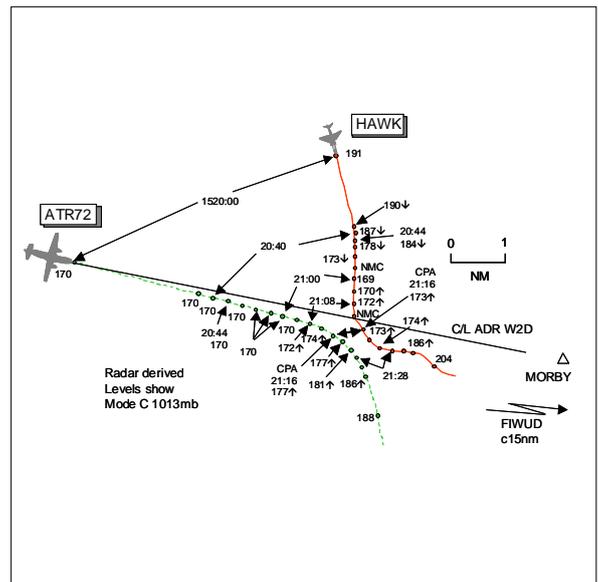
Date/Time: 5 Jun 1521  
Position: 5356N 00336W (23nm WNW Blackpool)  
Airspace: ADR/Warton RASA (Class: F/G)  
Reporting Ac                      Reported Ac  
Type: ATR72                              Hawk  
Operator: CAT                              MOD DE&S  
Alt/FL: FL170                              FL180↓

Weather                      VMC CLOC                      VMC CLBL  
Visibility: 20km                              >15nm  
Reported Separation:  
    NR                              2-300ft V/1-2nm H  
Recorded Separation:  
    400ft V/0-5nm H

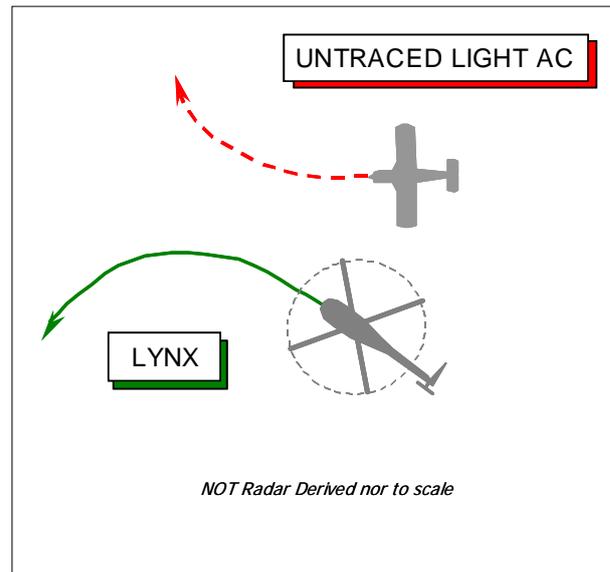
Recorded Separation:

Not recorded

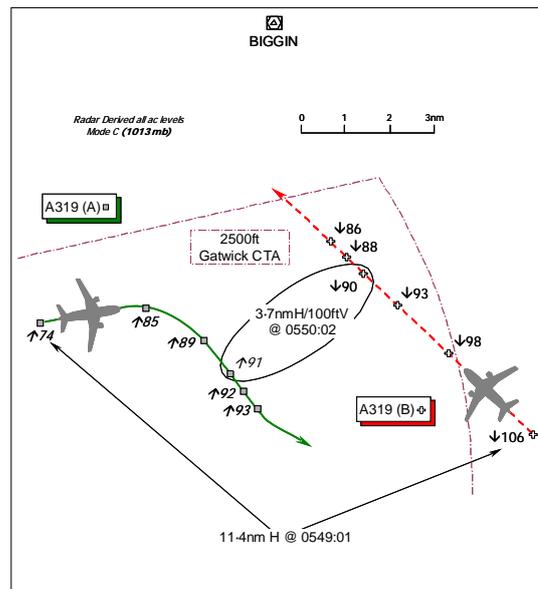
## AIRPROX REPORT NO 077/08

Date/Time: 6 Jun 0550  
Position: 5113N 00003E (7nm S of BIGGIN)  
Airspace: London TMA (Class: A)  
Reporting Ac Reported Ac  
Type: A319 A319  
Operator: CAT CAT  
Alt/FL: ↑FL100 ↓FL80  
Weather VMC NR  
Visibility: NR NR  
Reported Separation:  
Nil V/3nm NR  
Recorded Separation:  
100ft V/3-7nm H

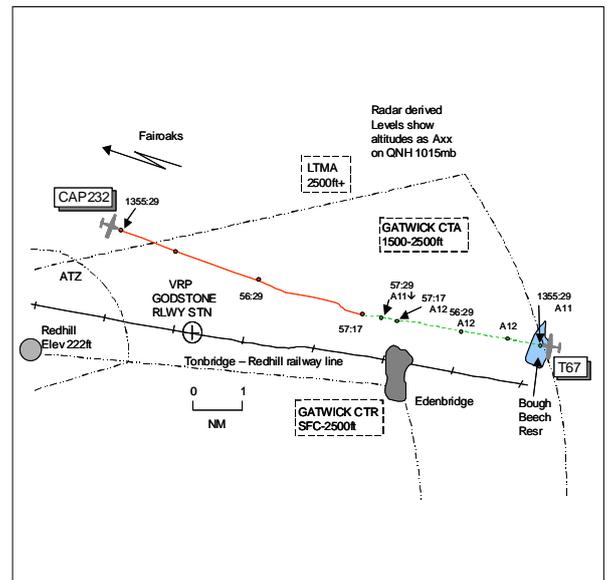
**AIRPROX REPORT NO 083/08**

**Date/Time:** 14 Jun 1357 (Saturday)  
**Position:** 5113N 00003E (7nm E Redhill - elev 222ft)  
**Airspace:** LFIR (Class: G)  
**Reporting Ac** *Slingsby T67* **Reported Ac** *CAP232*  
**Type:** Slingsby T67  
**Operator:** Civ Pte  
**Alt/FL:** 1300ft (QFE 1007mb) 1500ft (QNH)  
**Weather** VMC CLBC VMC NR  
**Visibility:** >40km NR  
**Reported Separation:** 50ft V/ Nil H Not seen  
**Recorded Separation:** NR

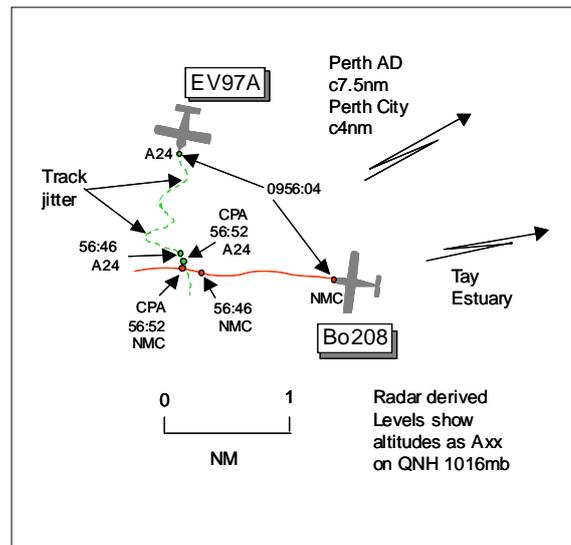
### AIRPROX REPORT NO 084/08

Date/Time: 21 Jun 0957 (Saturday)  
Position: 5622N 00334W (4nm SW Perth City)  
Airspace: ScFIR (Class: G)  
Reporting Ac Reported Ac  
Type: EV97A Eurostar Bo208 Junior  
Operator: Civ Pte Civ Pte  
Alt/FL: 2000ft 1500-2000ft  
(QNH 1016mb) (RPS)  
Weather VMC CLBC VMC NR  
Visibility: >10km NR  
Reported Separation:  
30ft V/Nil H Not seen  
Recorded Separation:  
<0.1nm

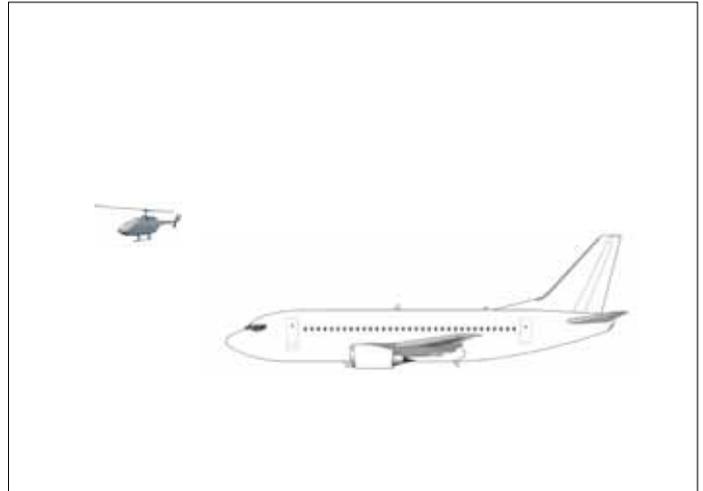
**AIRPROX REPORT NO 085/08**

Date/Time: 22 Jun 1032 (Sunday)  
Position: 5157N 00019E (5nm NE Stansted)  
Airspace: Stansted CTR (Class: D)  
Reporting Ac Reported Ac  
Type: B737 Untraced  
 (Model) Helicopter  
Operator: CAT NK  
Alt/FL: ↓2000ft NK  
 (QNH 1008mb) NK  
Weather VMC CLBL NK  
Visibility: 10km NK  
Reported Separation:  
 300ft NK  
Recorded Separation:  
 NR

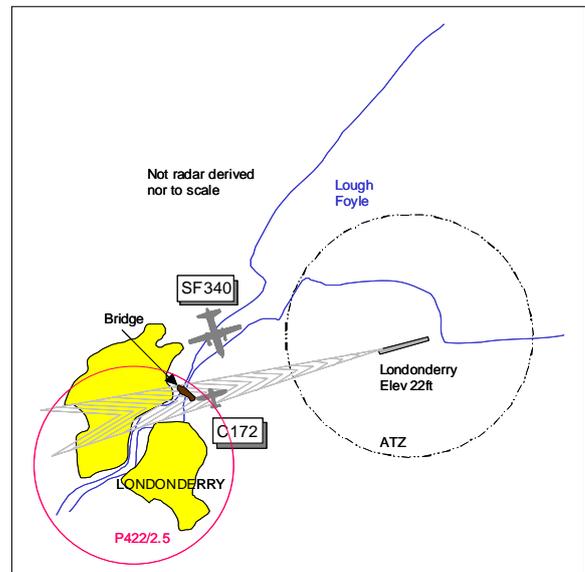
## AIRPROX REPORT NO 087/08

Date/Time: 21 Jun 1319 (Saturday)  
Position: 5502N 00715W (3-5nm W Londonderry Airport - elev 22ft)  
Airspace: ScFIR (Class: G)  
Reporting Ac Reported Ac  
Type: SF340 C172  
Operator: CAT Civ Pte  
Alt/FL: 1600ft 1200ft  
(QNH 1011mb) (QNH)  
Weather VMC CLOC VMC CLOC  
Visibility: 30km >10km  
Reported Separation:  
100ft V/100m H 700ft V/2nm H  
Recorded Separation:  
NR

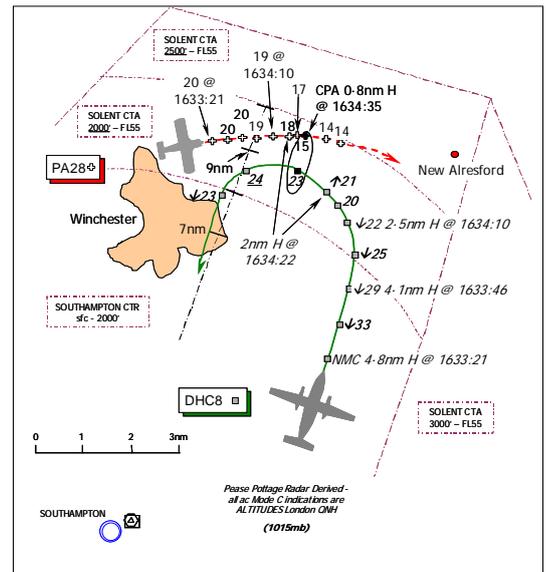
**AIRPROX REPORT NO 088/08**

**Date/Time:** 24 June 1634  
**Position:** 5105N 00115W (9.5nm NNE of Southampton - elev: 44ft)  
**Airspace:** Solent CTA/FIR (Class: D/G)  
**Reporting Ac** **Reported Ac**  
**Type:** DHC8D PA28  
**Operator:** CAT Civ Pvt  
**Alt/FL:** 2200ft↓ <2000ft  
 QNH (1015mb) QNH (1015mb)  
**Weather** VMC NR VMC NK  
**Visibility:** 25km NK  
**Reported Separation:**  
 200ft V/1.5nm H NK  
**Recorded Separation:**  
 800ft V @ 0.8nm Min H

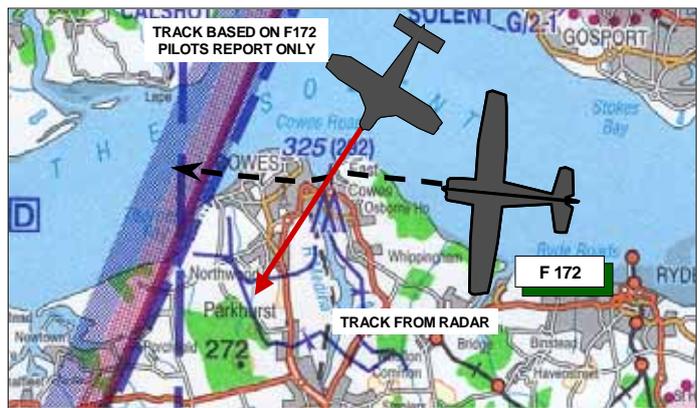
### AIRPROX REPORT NO 089/08

Date/Time: 24 Jun 1050  
Position: 5047N 00118W  
(N ABM COWES - IOW)  
Airspace: London FIR (Class: G)  
Reporting Ac Reported Ac  
Type: F172N Single engine  
monoplane  
Operator: Civ Pte N/K  
Alt/FL: 1900 NR  
(QNH 1016mb)  
Weather VMC CAVOK NR  
Visibility: >20km NR  
Reported Separation:  
100ft V/ 40m H NR  
Recorded Separation:  
NR

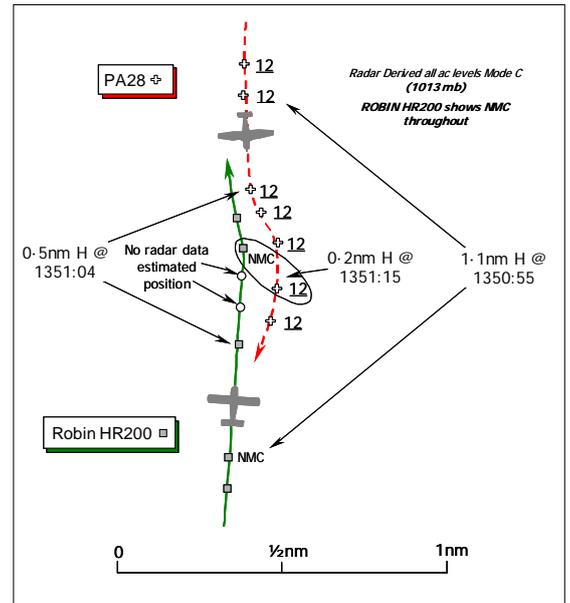
**AIRPAIRPROX REPORT NO 092/08**

Date/Time: 28 Jun 1351 (Saturday)  
Position: 5315N 00233W (4½nm NE of WHITEGATE)  
Airspace: Manchester L-L (Class: D)  
 Route  
 Reporting Ac Reported Ac  
Type: Robin HR200 PA28-181 Archer  
Operator: Civ Pte Civ Pte  
Alt/FL: 1200ft 1250ft  
 QNH (1015mb) QNH  
Weather VMC CLBC VMC Good VFR  
Visibility: >10km 20km  
Reported Separation:  
 Nil V/200yd H nil V/1200m H  
Recorded Separation:  
 ~300yd H
