UK AIRPROX BOARD

Analysis of Airprox in UK Airspace

**Report Number 26
January 2011 – June 2011**

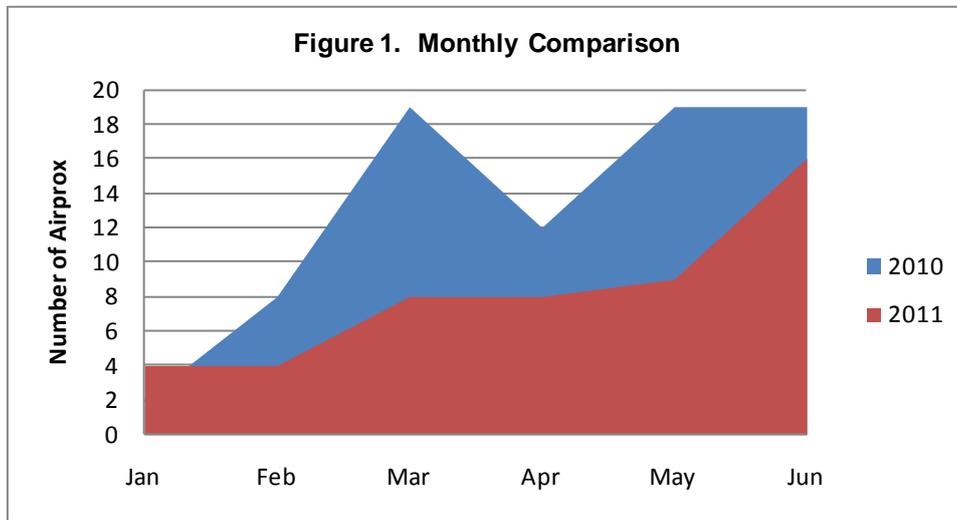
The profile of Airprox occurrences month by month is shown in Figure 1. Both 2010 and 2011 started slowly due to bad winter weather and the sharp decline in Apr 2010 reflects the reduced flying due to volcanic ash.

The profile of Airprox occurrences month by month is shown in Figure 1. Both 2010 and 2011 started slowly due to bad winter weather and the sharp decline in Apr 2010 reflects the reduced flying due to volcanic ash.

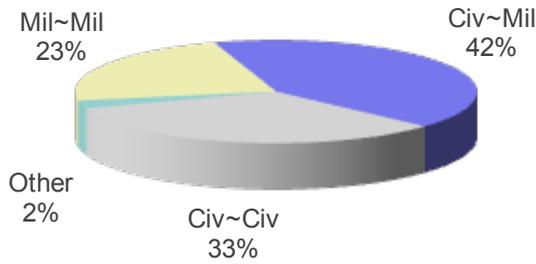
The breakdown is shown graphically in Figures 2 and 3 below. The category 'Other' is used when one of the aircraft is untraced and it cannot be determined whether it was civil or military. For obvious reasons, this is most common with gliders and light aircraft.

The breakdown is shown graphically in Figures 2 and 3 below. The category 'Other' is used when one of the aircraft is untraced and it cannot be determined whether it was civil or military. For obvious reasons, this is most common with gliders and light aircraft.

Figure 2.
User Group Mix Jan - Jun 2010

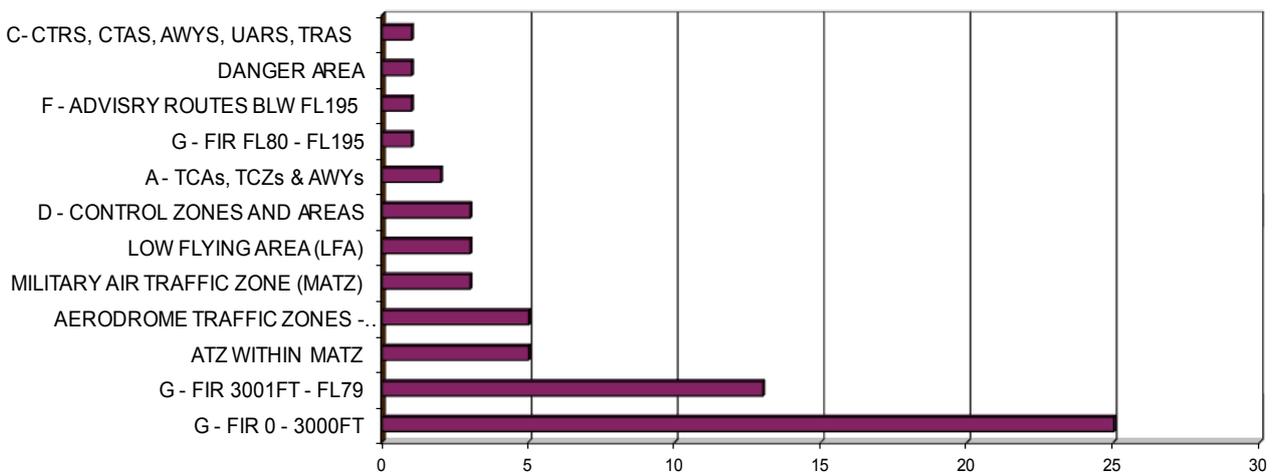
Figure 4 shows the breakdown of Airprox by airspace. The distribution profile is almost identical to that of the previous year.

Figure 4 shows the breakdown of Airprox by airspace. The distribution profile is almost identical to that of the previous year.

Figure 4. Airprox by Airspace Jan - Jun 2011

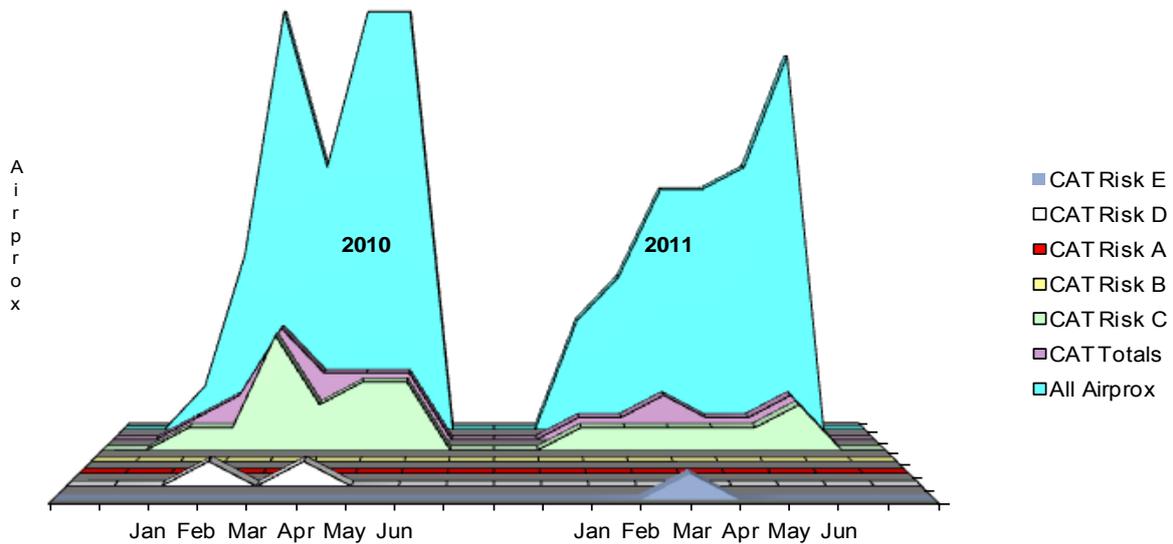
CAT Involvement in Airprox: Jan - Jun in 2010 and 2011

There was a reduction in the number of Airprox involving CAT between 2010 and 2011 and none of them in either year was assessed to be risk-bearing. Tables 5 and 6 and Figures 5 and 6 show the distribution was even throughout the period. For coherence between the years, Risk Categories C and E in 2011 should be added together and compared with Risk Category C in 2010.

There was a reduction in the number of Airprox involving CAT between 2010 and 2011 and none of them in either year was assessed to be risk-bearing. Tables 5 and 6 and Figures 5 and 6 show the distribution was even throughout the period. For coherence between the years, Risk Categories C and E in 2011 should be added together and compared with Risk Category C in 2010.

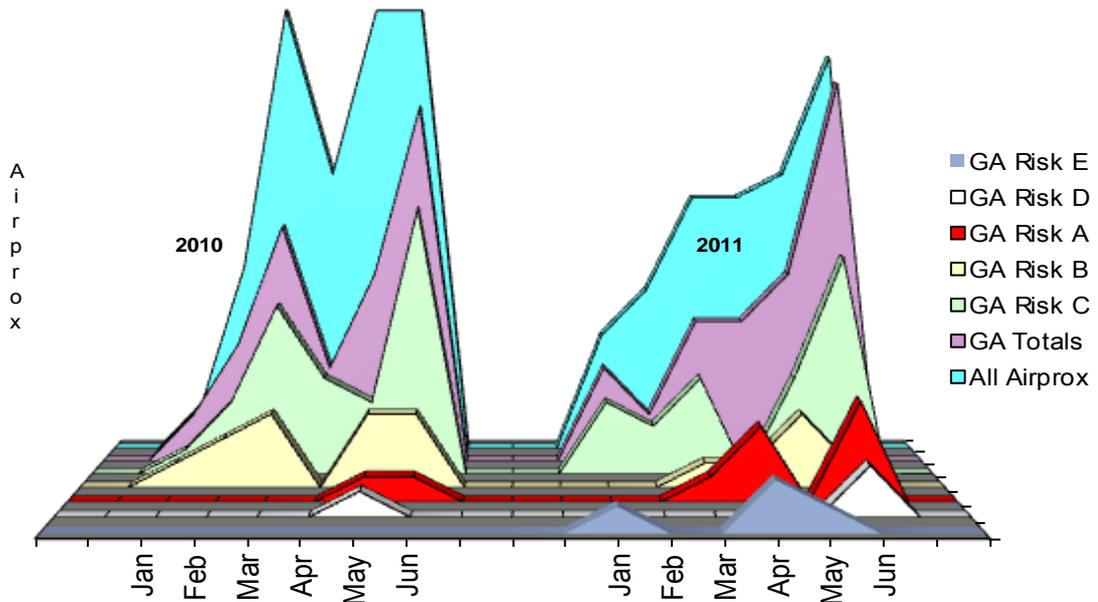
GA Involvement in Airprox: January - June in 2010 and 2011

The number and distribution of GA Airprox during Jan-Jun 2011 was very similar to 2010. Furthermore the number of risk-bearing events was exactly the same in both years, albeit that there was a greater number of Risk Category A events in 2011. The details are in Tables 8 and 9 and Figures 7 and 8.

The number and distribution of GA Airprox during Jan-Jun 2011 was very similar to 2010. Furthermore the number of risk-bearing events was exactly the same in both years, albeit that there was a greater number of Risk Category A events in 2011. The details are in Tables 8 and 9 and Figures 7 and 8.

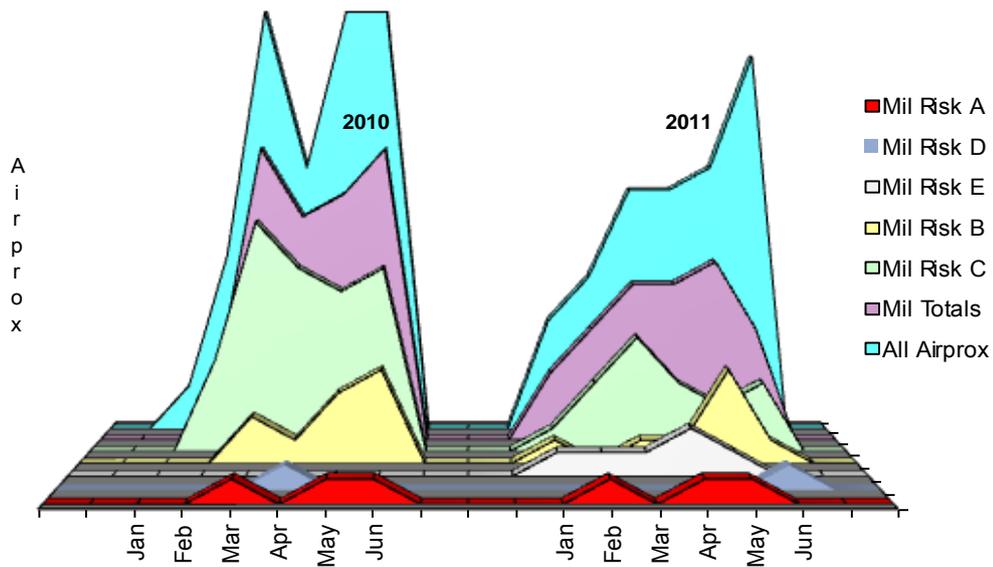
Military Involvement in Airprox: January - June in 2010 and 2011

Tables 11 and 12 and Figures 9 and 10 show there was a welcome reduction in the number of Airprox involving military aircraft from 51 to 35 comparing periods Jan-Jun 2010 with Jan-Jun 2011. Most of this reduction was in Risk Category C events with the number of Risk category A events remaining constant (3) and the number of Risk Category B events falling slightly from 10 to 8. The introduction of Risk Category E enables us to separate genuine Airprox from those which that are determined to be entirely benign or which it would be misleading to consider as Airprox events. The comparatively high number of Risk Category E events involving military aircraft is partially explained by the routine reporting of TCAS RA events in Class G airspace as Airprox.

Tables 11 and 12 and Figures 9 and 10 show there was a welcome reduction in the number of Airprox involving military aircraft from 51 to 35 comparing periods Jan-Jun 2010 with Jan-Jun 2011. Most of this reduction was in Risk Category C events with the number of Risk category A events remaining constant (3) and the number of Risk Category B events falling slightly from 10 to 8. The introduction of Risk Category E enables us to separate genuine Airprox from those which that are determined to be entirely benign or which it would be misleading to consider as Airprox events. The comparatively high number of Risk Category E events involving military aircraft is partially explained by the routine reporting of TCAS RA events in Class G airspace as Airprox.

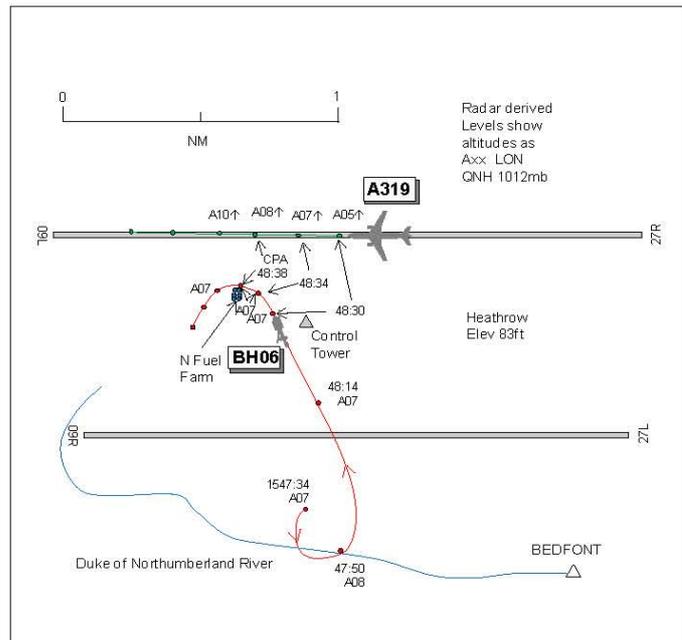
Reported Separation:
300ft V/ $<$ 300m H NR

Recorded Separation:
100ft V/0.2nm H

THE A319 PILOT reports outbound from Heathrow RW27R, IFR and in communication with Heathrow Tower, squawking with Modes S and C. Just after rotation, heading 271° at 140kt, Tower advised of a helicopter operating to the S of the aerodrome. As they climbed through 300ft the Capt visually acquired a black helicopter approx 300m to the forward/L of their ac at about 600ft moving towards the extended C/L of RW27R. Both pilots were ready to take avoiding action if required. The helicopter made a very sharp L turn by which time they were approximately 300ft higher than it. Neither a TCAS TA nor RA warning was received at any time and he assessed the risk as medium.

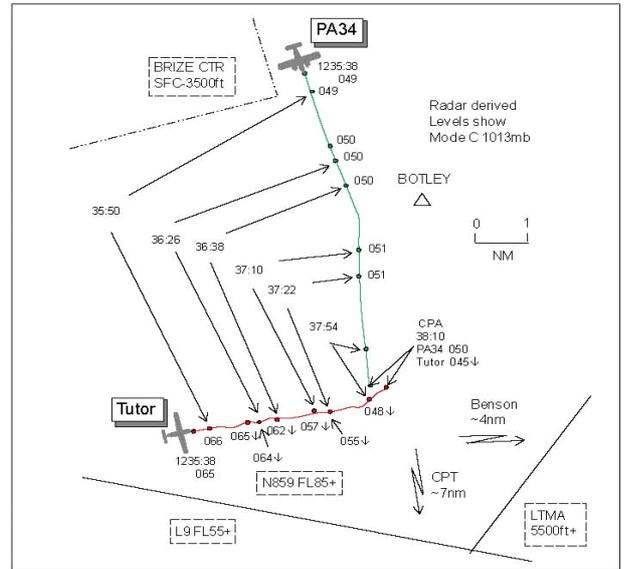
Date/Time: 20 Jan 2011 1238Z
Position: 5138N 00115W (8.5nm N CPT)
Airspace: Oxford AIAA (Class: G)
Reporter: LTC SW

<u>1st Ac</u>	<u>2nd Ac</u>
<u>Type:</u> PA34	Grob TutorTMk1
<u>Operator:</u> Civ Trg	HQ AIR (TRG)
<u>Alt/FL:</u> FL50	4500ft↓ (NR)
<u>Weather:</u> IMC IICL	VMC CLAC
<u>Visibility:</u> 10km	>10km
<u>Reported Separation:</u> Not seen	NR
<u>Recorded Separation:</u> 500ft V/0.3nm H

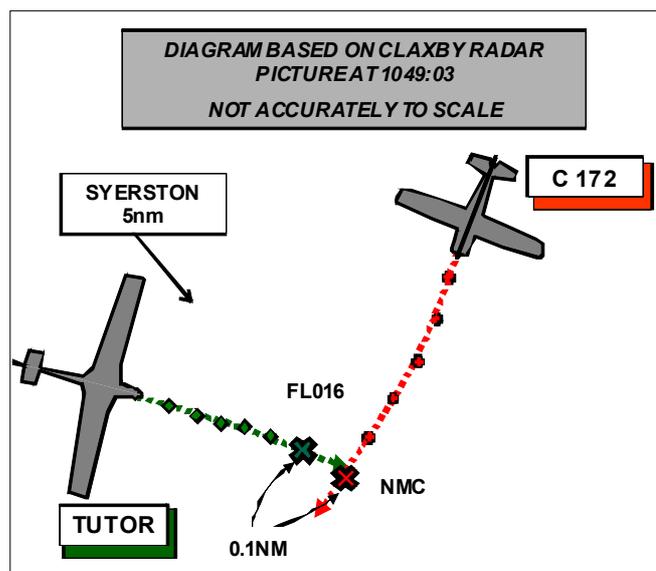
AIRPROX REPORT NO 2011005

Date/Time: 28 Jan 2011 1049Z
Position: 5310N 00100W
(5nm NW Syerston)
Airspace: Lon FIR (Class: G)
Reporting Ac **Reported Ac**
Type: Grob Tutor T Mk1 C172
Operator: HQ AIR (Trg) Civ Pte
Alt/FL: 1500ft 2000ft
(RPS 1022mb) (QNH)
Weather: VMC CLBC VMC CAVOK
Visibility: 10km >10km
Reported Separation:
150ft V/250ft H 200ft V/20m H
Recorded Separation:
NR V (est 350ft) /0.1nm H

THE TUTOR PILOT reports flying an instructional sortie in a white ac with all lights switched on, initially in receipt of a BS from Waddington ZONE, with the student as handling pilot. They were 5nm NW of Syerston, heading 100° in the climb out from a PFL and passing 1300ft when he (the instructor) cancelled the BS and changed freq to Cranwell APP. Passing 1700ft and before gaining contact with Cranwell, the student pilot pushed forward abruptly and reported an ac above, he gained visual contact with the ac, 400ft away, by moving his head forward and right to clear the area obscured by the canopy arch then took control, noting the height as being 1650ft. The conflicting ac was a white high-wing Cessna with a blue registration mark and was in straight and level flight heading about 195° and he assessed the vertical separation to be 150ft.

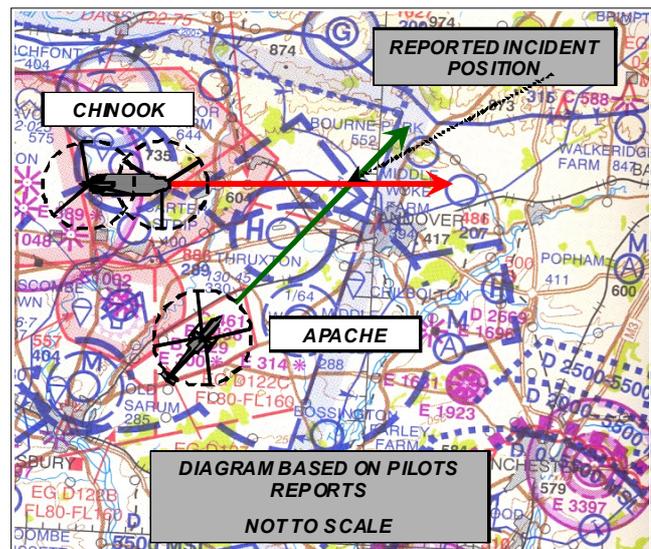
AIRPROX REPORT NO 2011006

Date/Time: 24 Jan 2011 2047Z
Position: 5115N 00132W (2nm NW Andover)
Airspace: UKNLFS (Class: G)
Reporting Ac Reported Ac
Type: Chinook Apache
Operator: HQ JHC HQ JHC
Alt/FL: 800ft NR
(RPS 1024mb) (NK)
Weather: VMC NR NK NR
Visibility: 10km NR
Reported Separation:
100ft V/0ft H NR
Recorded Separation:
NR

THE CHINOOK PILOT reports that they were Reversionary Night Flying (RNF) [not on NVGs], transiting in the Night Rotary Region 1 from Lugershall to Odiham at 800ft on the Cotswold RPS [1024mb], routing to the A34 before climbing for a radar pickup for an approach at Odiham. They had all lights switched on and were heading 090° at 130kt approaching Andover and had reselected the radios and IFF [squawking 3646] from SPTA in preparation for the climb and approach to Odiham. The NHP called "break" and at the same time he saw an Apache helicopter crossing from right to left in level flight about 50ft below and 100ft in front of them. He cyclically climbed the ac to avoid the Apache which disappeared under their nose. The No1 crewman picked up the Apache as it cleared to their 9 o'clock and saw it continue away without manoeuvring. RT calls were made to try and establish comms with the Apache on Middle Wallop Approach, low level common and Guard UHF but there was no response.

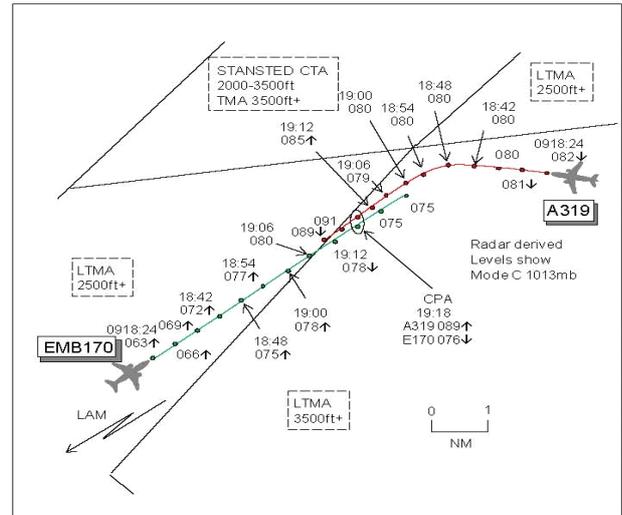
100ft V/1.9nm H or

1300ft V/0.2nm H

THE EMB170 PILOT reports outbound from London/City, IFR and in communication with London on 118.825MHz, squawking with Modes S and C. About 10nm NE of LAM, heading 050° at 250kt climbing through FL70 for FL90, both crew noticed a descending ac on TCAS range 10nm on a reciprocal heading. The traffic quickly became 'proximate' and was visually acquired as they were 2000ft above cloud in VMC. They then received instructions from ATC with avoiding action to 'level-off' and within a few seconds received a TCAS RA to climb. The PF actioned the RA and the PNF informed ATC "EMB170 c/s TCAS RA". PNF had the ac visual at 12 o'clock same level and watched it pitch up rapidly and climb. The PNF commanded PF to descend and within a second TCAS commanded a reversal rapid RA descent. The other ac passed 100ft higher and slightly to their L, about 1nm away. He assessed the risk as high. TCAS was very useful in that they acquired the traffic visually before an RA was issued. ATC issued avoiding action at the same time as the TCAS RA so TCAS was followed. The crew was surprised by the reversal command from the TCAS.

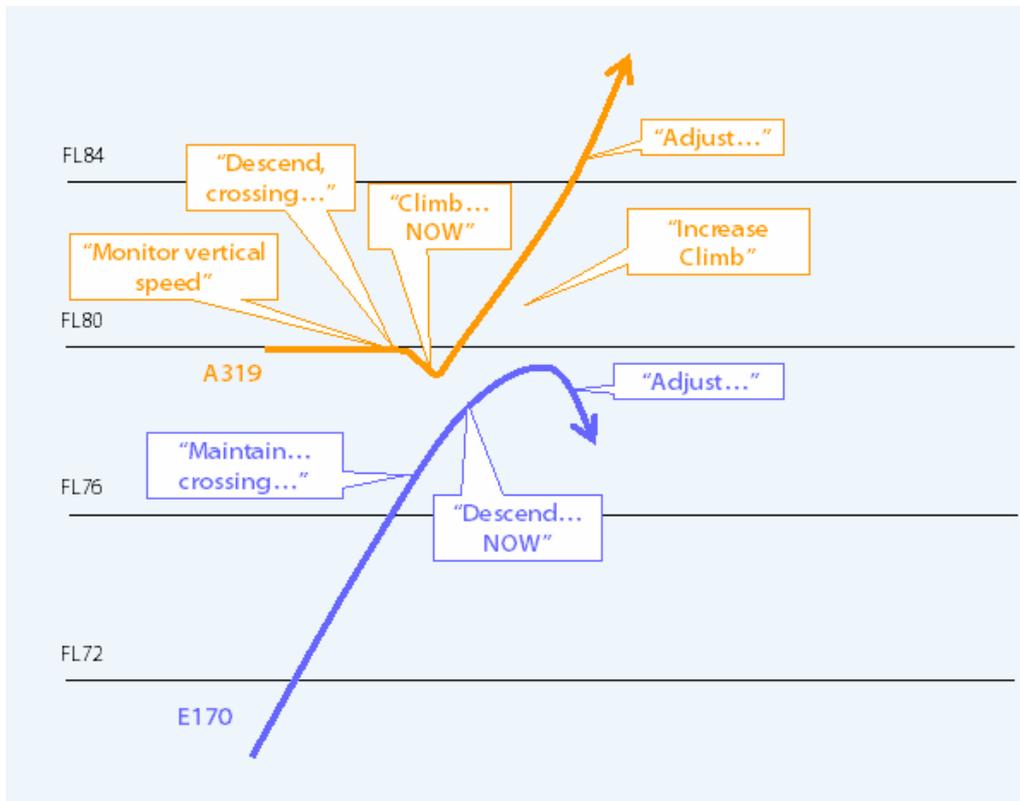
Graphic above courtesy of Eurocontrol from an ACAS II Bulletin.

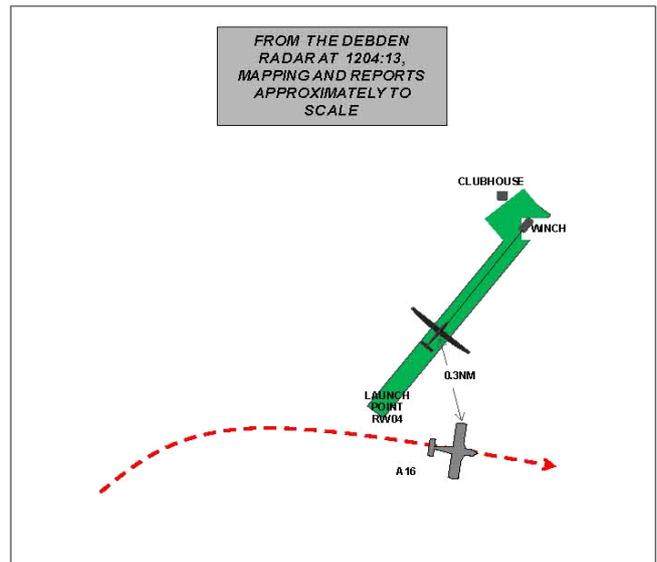
Reported Separation:
0ft V/250m H 500ft V/500m H

Recorded Separation:
Est 550ft V/0.3nm H

THE SCHLEICHER ASK21 PILOT (K21) (the Deputy CFI) reports flying as HP on a training flight heading 040° at 70kt on a winch launch and in communication with Gransden Lodge Radio; FLARM was fitted and serviceable. He was informed after the flight by the Duty Instructor that he had been involved in Airprox but he did not see the other ac as it passed behind his glider; the other ac's engine was not heard due to increased noise during the winch launch. Although he did not see the ac, from other information he assessed the risk as being Medium.

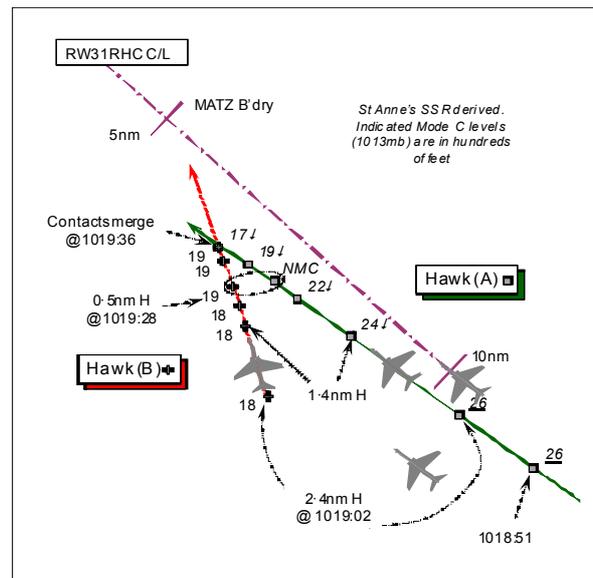
AIRPROX REPORT NO 2011009

Date/Time: 1 Feb 2011 1019Z
Position: 5310N 00424W
(6½nm SE of Valley - elev 36ft)
Airspace: London FIR (Class: G)
Reporting Ac **Reporting Ac**
Type: Hawk T Mk1 x3 Hawk T Mk1
Operator: HQ Air (Trg) HQ Air (Trg)
Alt/FL: 2000ft ↓ 2000ft
QFE (1021mb) QFE (1020mb)
Weather: VMC CLBC VMC CLBC
Visibility: 20km >10km
Reported Separation:
Nil V/<100ftH 200ft V/nil H
Recorded Separation:
200ft V/SSR contacts merged

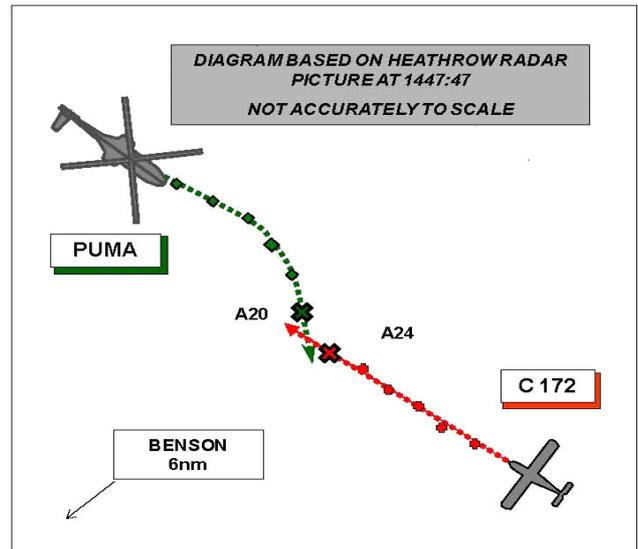
AIRPROX REPORT NO 2011010

Date/Time: 8 Feb 2011 1048Z
Position: 5140N 00056W
 (6nm NE RAF Benson)
Airspace: Lon FIR (Class: G)
Reporting Ac **Reported Ac**
Type: Puma C172
Operator: HQ JHC Civ Trg
Alt/FL: 2000ft 2400ft
 (RPS 1013mb) (1023mb)
Weather: VMC CAVOK VMC CAVOK
Visibility: 10km 40km
Reported Separation:
 100-200ft V/NR H 400ft V/0.5nm H
Recorded Separation:
 400ft V/O H

THE PUMA PILOT reports flying a camouflage green helicopter with no TCAS fitted but with strobes and nav lights switched on, on a GH sortie, in receipt of a BS from Benson APP, squawking as directed with Modes C and S. While he (the LHS QHI) was positioning the ac for a PFL near Stokenchurch, in straight and level flight at 2000ft on the RPS, heading 170° (he reported out of sun) at 120kt, the RHS pilot called 'break left' for a light ac that was a possible conflict. The ac was a white, high-wing, single-engine Cessna type, 100-200ft above them, also in a straight and level flight and was crossing them from the 11 o'clock to the 4 o'clock position. He started the break but quickly acquired the light ac visually and determined that there was no direct conflict and so he remained straight and level and allowed the light ac to pass overhead.

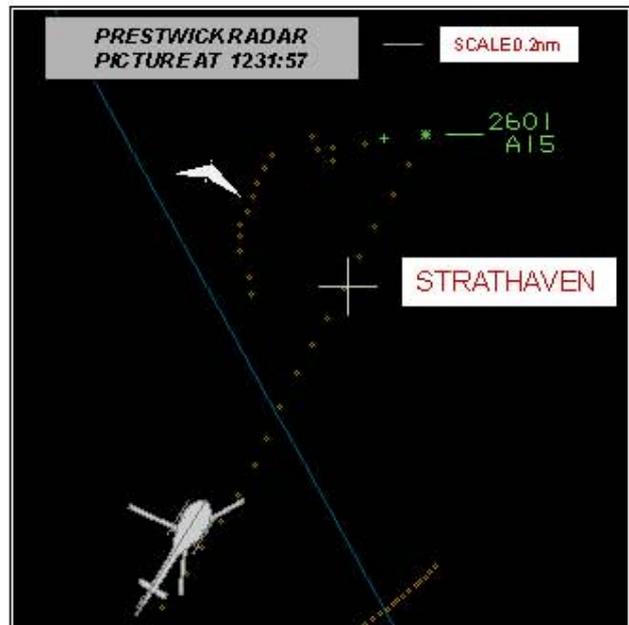
Est 200ft (See ATSI report) V /0.2nm H

THE PEGASUS QUANTUM MICROLIGHT PILOT reports flying an instructional flight from Strathaven unlicensed airfield in a flexwing microlight, listening out on Safety Common. They were heading 090° at 50kt and 1000ft agl in the mid downwind position for RW27 (RH cct) and carrying out downwind checks, when a maroon helicopter appeared in his 3 o'clock about 200ft lower so he kept helicopter visual and continued to extend the downwind leg. The helicopter passed ahead through his 12 o'clock from R to L, about 200ft below. He assessed the risk as being medium and reported the incident to Glasgow ATC after landing and also to the helicopter airfield.

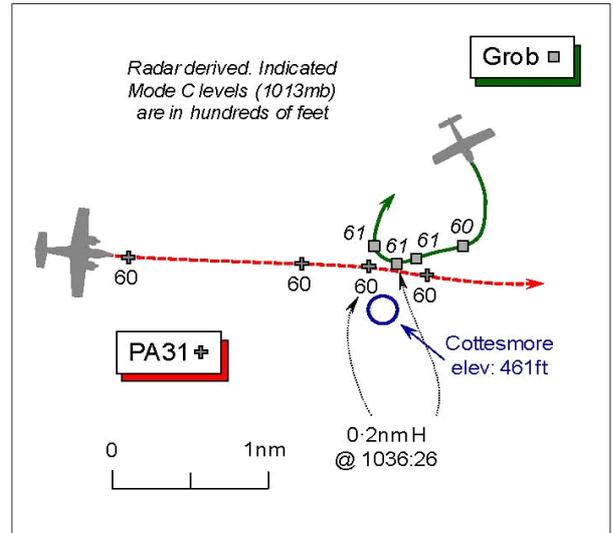
AIRPROX REPORT NO 2011012

Date/Time: 14 Feb 2011 1035Z
Position: 5244N 00039W (Overhead Cottesmore A/D - elev 461ft)
Airspace: London FIR (Class: G)
Type: Grob TutorTMk1 PA31
Operator: HQ Air (Trg) Civ Comm
Alt/FL: 5500ft 5500ft
RPS (991mb) (NK)
Weather: VMC CLOC VMC CLOC
Visibility: 30km >10km
Reported Separation:
300ft V/100m H 800-1000ftV/¼-½nm H
Recorded Separation:
100ft V

THE GROB TUTOR T Mk1 PILOT, a QFI, reports he was conducting a QFI Training sortie from Cranwell with the trainee QFI as the PF. Operating VFR, they were not under an ATS but listening out on the quiet frequency - #19 – squawking the Cranwell conspicuity code of A2641 with Mode C; elementary Mode S is fitted but TCAS is not.

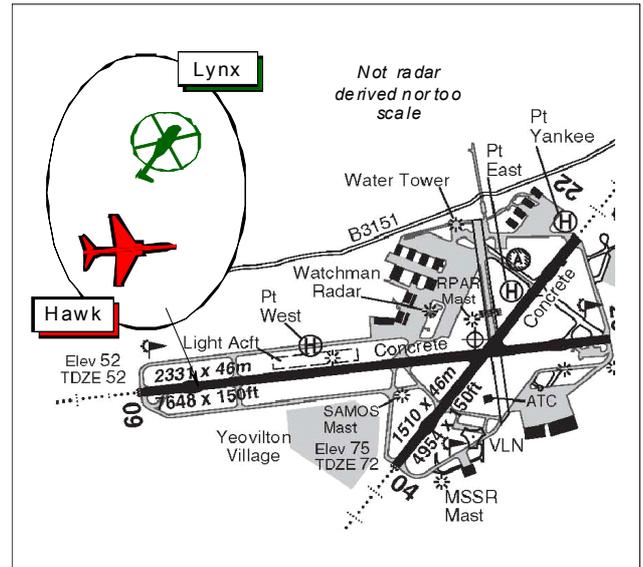
AIRPROX REPORT NO 2011013

Date/Time: 9 Feb 2011 1113Z
Position: 5101N 00238W
 (Yeovilton RW09 - elev 75ft)
Airspace: MATZ/ATZ (Class: G)
Reporting Ac Reported Ac
Type: Lynx Mk8 Hawk T Mk1
Operator: HQ Navy HQ Navy
Alt/FL: 10ft 100ft↓
 QFE (1003mb) QFE (1003mb)
Weather: VMC NR VMC CLOC
Visibility: 10km 15km
Reported Separation:
 >50m Nil V/30m H
Recorded Separation:
 Not recorded

THE AGUSTA WESTLAND LYNX Mk8 HELICOPTER PILOT reports he was returning to Yeovilton from Cudrose and had completed a PAR to RW09 at Yeovilton in VMC. At DH he was transferred from TALKDOWN to the TOWER frequency, the clearance to land was reiterated with the instruction to continue along RW09 to exit at RW04 for Yankee dispersal. After reading back these instructions, TOWER then requested him to vacate RW09, to the L across the grass, because of a Hawk turning Final to Land. He repeated back TOWER's instructions and turned L at 15kt hoverspeed towards the northern parallel taxiway at a height of 10ft QFE (1003mb), about 200m beyond the threshold of RW09. During the L turn his observer, occupying the LH Seat, informed him the Hawk was directly over the RW09 threshold. He expeditiously vacated the runway as the Hawk landed and passed >50m astern from L – R with a 'medium' Risk of a collision. He reported the Airprox to the Duty Air Traffic Control Officer (DATCO) by telephone after landing.

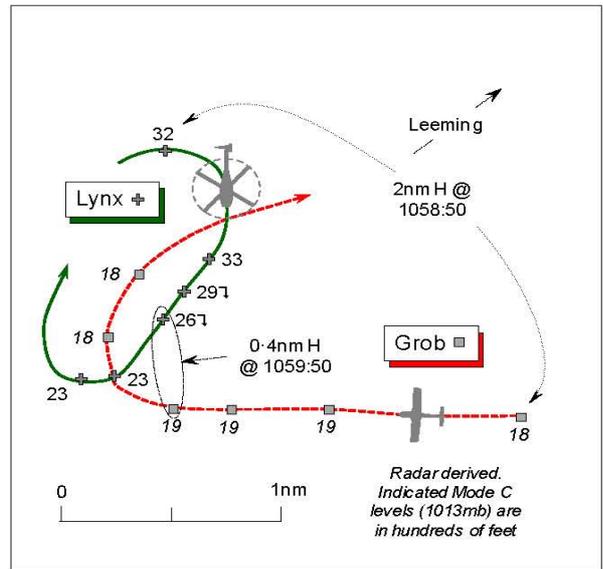
AIRPROX REPORT NO 2011014

Date/Time: 24 Feb 2011 1100Z
Position: 5413N 00143W (8nm SW by W of Leeming - elev 132ft)
Airspace: Vale of York AIAA (Class: G)
Reporting Ac **Reported Ac**
Type: Lynx AH Mk7 Grob Tutor TMk1
Operator: HQ JHC HQ Air (Trg)
Alt/FL: 2200ft 2000ft
 RPS (1014mb) RPS (1013mb)
Weather: VMC Sleet VMC CLBL
Visibility: 20km 10km
Reported Separation:
 500ft V/Nil H 400-500ft V/100m
Recorded Separation:
 ~500ft V

THE WESTLAND LYNX AH Mk 7 PILOT, a maintenance test pilot, reports he was the ac commander and PNF occupying the LH seat whilst conducting a dual airtest; the ac’s crew consisted of just the 2 pilots. The workload in the cockpit was fairly high during the airtest as the PNF monitors instruments/limitations, whilst the PF concentrates on accurate speeds, NR control and rates of application of power. The airtest, involving a series of autorotations, was carried out in VMC whilst in receipt of a BS from Leeming ZONE on 127.750MHz about 2nm SW of Masham, which is situated 1nm SW of the Leeming MATZ boundary. A squawk of A0401 was selected with Mode C; enhanced Mode S is fitted but TCAS is not.

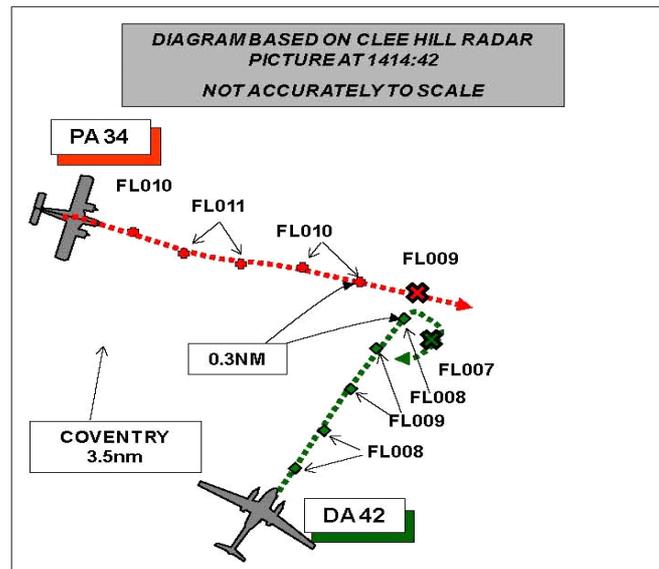
AIRPROX REPORT NO 2011016

Date/Time: 7 Mar 2011 1415Z
Position: 5219N 00128W
(3.5nm S Coventry - elev 267ft)
Airspace: LFIR (Class: G)
Reporting Ac: DA42
Reported Ac: PA34
Type: DA42
Operator: Civ Trg
Alt/FL: 1320ft (QNH 1028mb)
Weather: VMC CLOC
Visibility: >10km
Reported Separation: NR
Recorded Separation: 200ft V/0.3nm H

THE DA42 PILOT reports conducting a CPL skills test from Coventry and in communication with Coventry APP using an 'Exam' callsign, squawking with Modes S and C. The visibility was good and the ac was coloured white with nav, landing, taxi and strobe lights all switched on. The candidate was the handling pilot and they were joining the cct from the Wellesbourne direction having been given a downwind join for RW23. Other traffic [the subject PA34] on frequency was conducting a standard missed approach and was informed of their position and reported that they had his ac in sight.

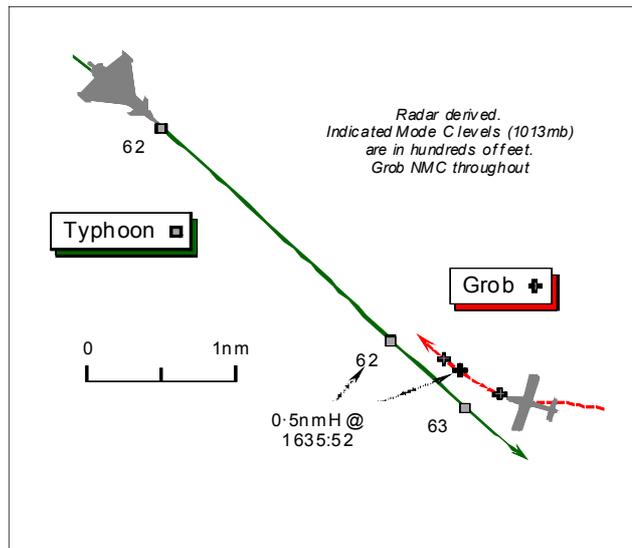
AIRPROX REPORT NO 2011017

Date/Time: 8 Mar 2011 1636Z
Position: 5246N 00013E (15nm NW of Marham)
Airspace: London FIR (Class: G)
Reporting Ac **Reported Ac**
Type: Typhoon Grob Tutor TMk1
Operator: HQ Air (Ops) HQ Air (Trg)
Alt/FL: 6000ft 5000ft
RPS (1007mb) RPS (1007mb)
Weather: VMC CLAH VMC CLAH
Visibility: 5km 20km
Reported Separation:
500-1000ftV/200m 500ft V/1000yd H
Recorded Separation:
0.2nm H [~370m]

THE EUROFIGHTER TYPHOON PILOT reports that he had departed on a VFR training flight from Coningsby to Marham for a Practice Diversion (PD) and was receiving a TS from Coningsby APP. The assigned squawk of A1771 was selected with Mode C; neither TCAS nor Mode S is fitted.

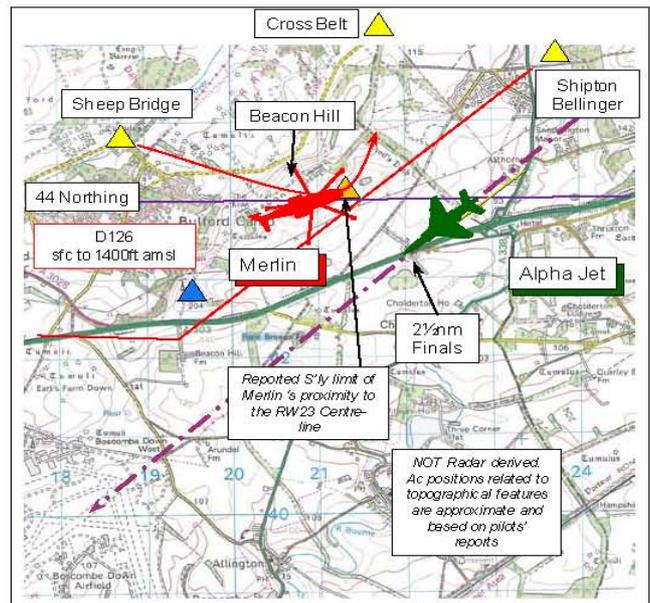
AIRPROX REPORT NO 2011018

Date/Time: 9 Mar 2011 1256Z
Position: 5111N 00141W (2½nm NE of Boscombe Down A/D- elev 407ft)
Airspace: Boscombe MATZ (Class: G)
Reporting Ac Reported Ac
Type: Alpha Jet Merlin
Operator: MoD FTR HQ JHC
Alt/FL: 800ft 300ft
 QFE (1002mb) agl
Weather: VMC NR VMC CLBC
Visibility: 10km 8km
Reported Separation:
 200ft V/800ft H 400ft V/700m H
Recorded Separation:
 Not recorded

THE DASSAULT-DORNIER ALPHA JET PILOT reports he was the ac commander occupying the rear seat of the ac whilst conducting an instrument flying training sortie with a student test pilot in the front seat. During the period of the Airprox, the student was the PF on a simulated single-engine SRA to RW23 at Boscombe Down using standby instruments and he was monitoring his student's instrument flying during the approach with occasional visual lookout searches.

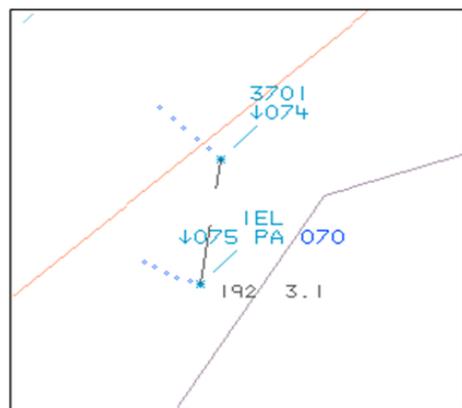
(PC MRT 1237:30)

At 1237:10 the Mode A code of the Tornado changed to 3701 (Lossiemouth) and by 1237:30 both ac were on parallel SE'y tracks, 3.1nm apart, the SF 340 descending through FL075 and the Tornado descending through FL074 (see photo below).

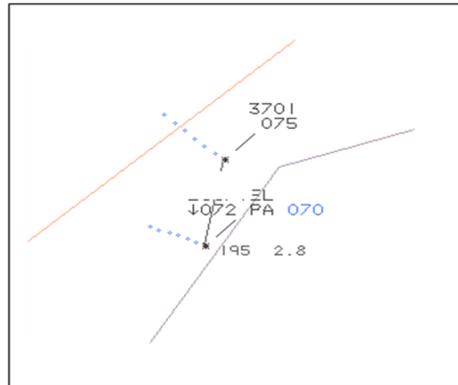
(PC MRT 1237:40)

At 1237:20 the MOR controller asked the SF 340 pilot if they were still visual with the traffic. The pilot replied, "Negative, we're in cloud now". The controller then gave a right turn onto a heading of 180°. The minimum distance between the two ac was 2.8nm laterally, 300 feet vertically, at 1237:40.

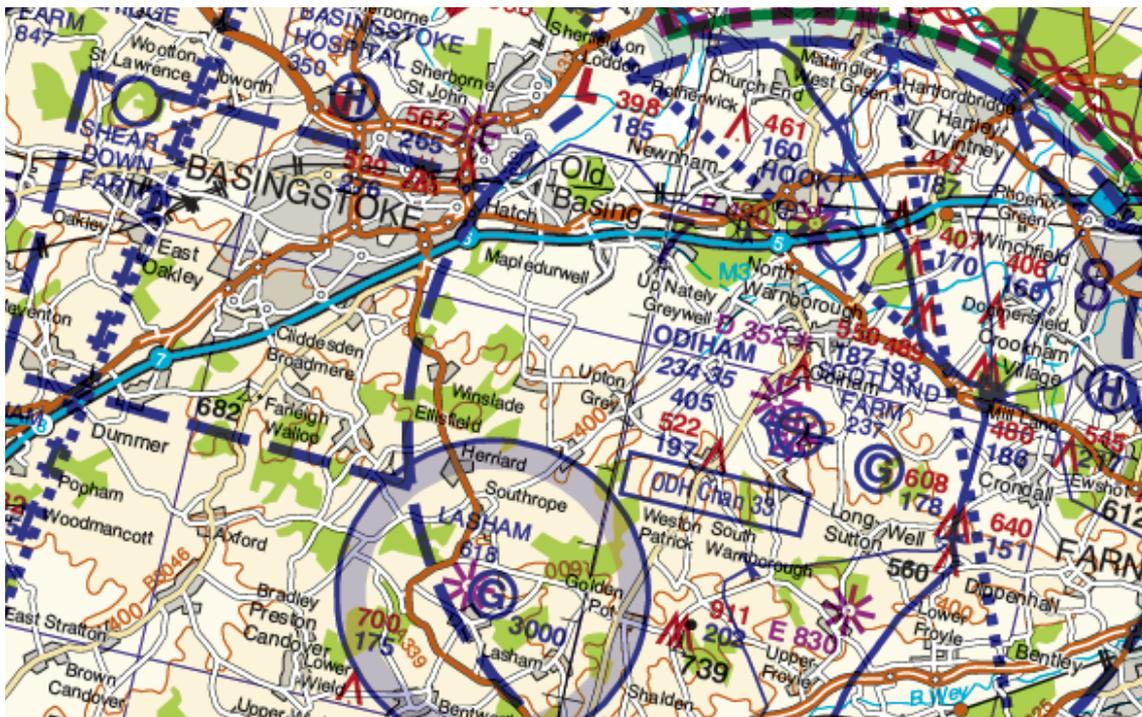
Lasham airfield is a notified glider site approximately 4.5nm SW of Odiham, which has a mandatory military avoidance of 2nm radius up to 3000ft agl. The UK Mil LFHB contains a further warning that "*intensive gliding activity takes place within 5nm of Lasham.*" The diagram below shows the local area.

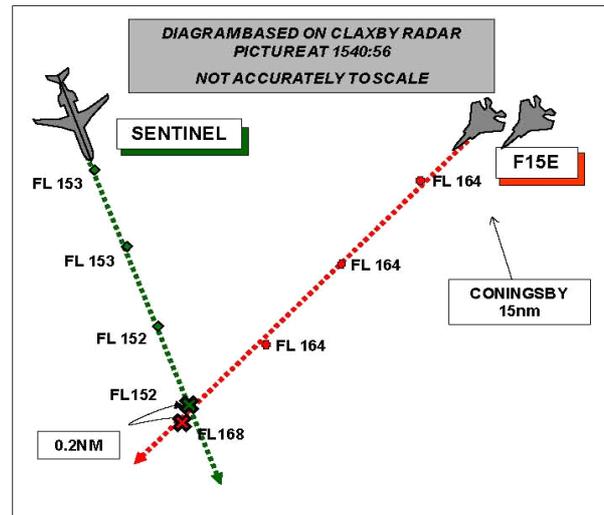
Reported Separation:
500ft V/0m H NR

Recorded Separation:
1600ft V/0.2nm H

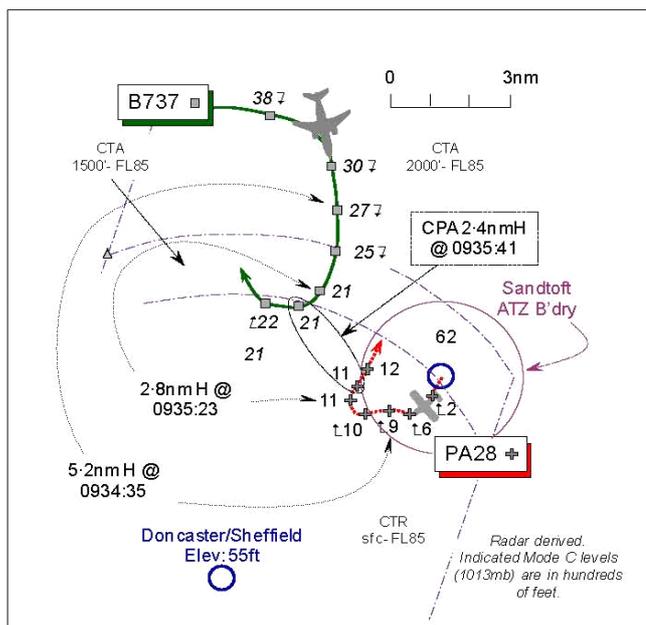
Recorded Separation:

1000ft V/2.4nm H

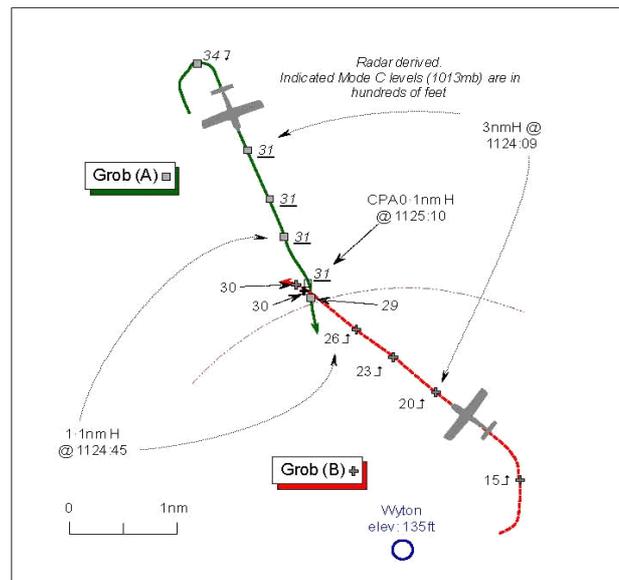
Recorded Separation:

100ft V/0.1nm H

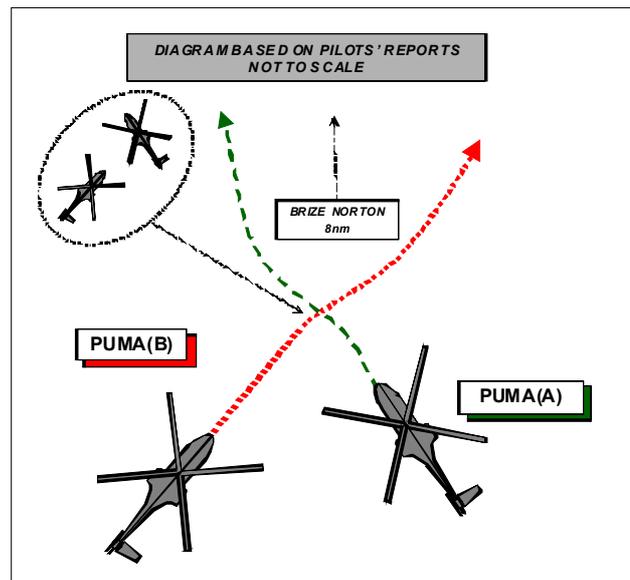
AIRPROX REPORT NO 2011040

Date/Time: 11 May 2011 2128Z
Position: 5137N 00133W
(2nm SE Faringdon)
Airspace: UKNLFS (Class: G)
Reporting Ac Reported Ac
Type: Puma Puma
Operator: HQ JHC HQ JHC
Alt/FL: 250ft agl 300ft
(RPS 1017mb) (RPS 1017mb)
Weather: VMC CLBC VMC CLBC
Visibility: 10km 20km
Reported Separation:
0 V/200m H 50ft V/300m H
Recorded Separation:
NR

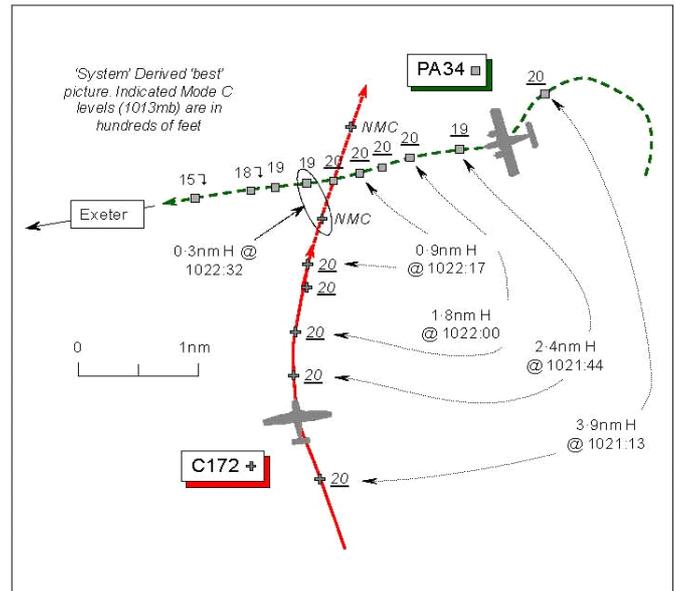
Recorded Separation:

0.3nm H

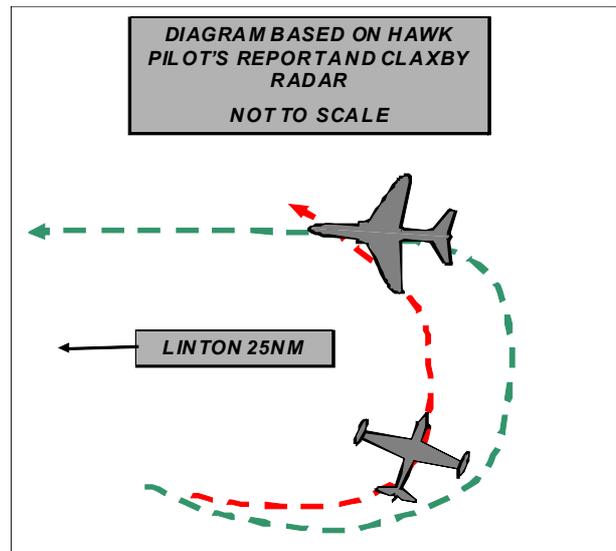
AIRPROX REPORT NO 2011043

Date/Time: 17 May 2011 1410Z
Position: 5408N 00031W (25nm E Linton)
Airspace: London FIR (Class: G)
Reporting Ac Reported Ac
Type: Hawk T Mk1 Untraced Light ac
Operator: HQ AIR (Ops) NK
Alt/FL: 2000ft NK
(RPS 1011mb)
Weather: VMC CLBC NK
Visibility: 20km NK
Reported Separation:
0ft V /1000ft H NK
Recorded Separation:
NK

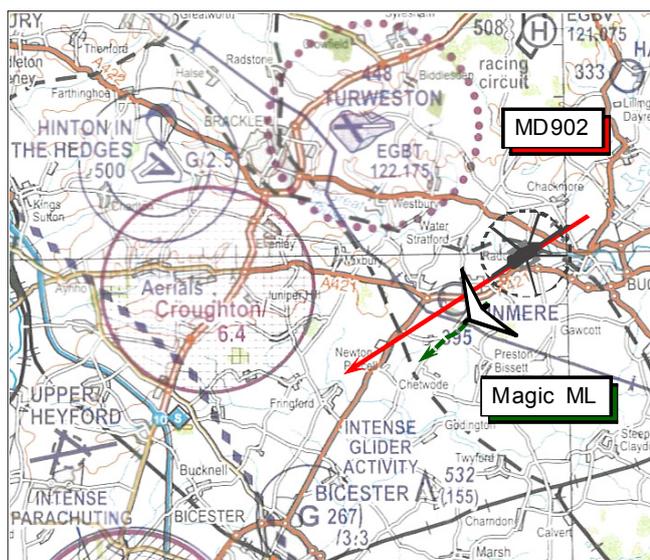
AIRPROX REPORT NO 2011044

Date/Time: 20 May 2011 0952Z
Position: 5159N 00103W (5nm E of Croughton)
Airspace: London FIR (Class: G)
Reporting Ac Reported Ac
Type: Magic Laser MD902 Explorer
Flexwing ML
Operator: Civ Pte Civ Comm
Alt/FL: 2000ft <1000ft
amsl amsl
Weather: VMC CLBC VMC CLBC
Visibility: 50nm >10km
Reported Separation:
300ft V/nil H 500ft V/100ft H
Recorded Separation:
Not recorded

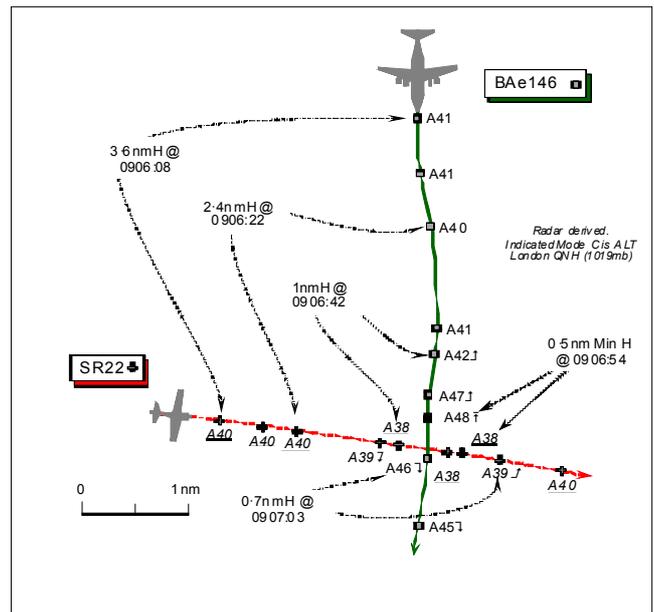
AIRPROX REPORT NO 2011045

Date/Time: 19 May 2011 0906Z
Position: 5208N 00003E
 (5½nm SW of Cambridge)
Airspace: London FIR (Class: G)
Reporting Ac **Reported Ac**
Type: BAe146 Cirrus SR22
Operator: HQ Air (Ops) Civ Pte
Alt/FL: 4000ft 4000ft
 QNH (1018mb) QNH (1018mb)
Weather: IMC CLBL VMC NK
Visibility: 30km >10km
Reported Separation:
 400ft V/<1nm NK
Recorded Separation:
 Nil V @ 2.4nm H
 0.5nm Min H @ 1000ft V

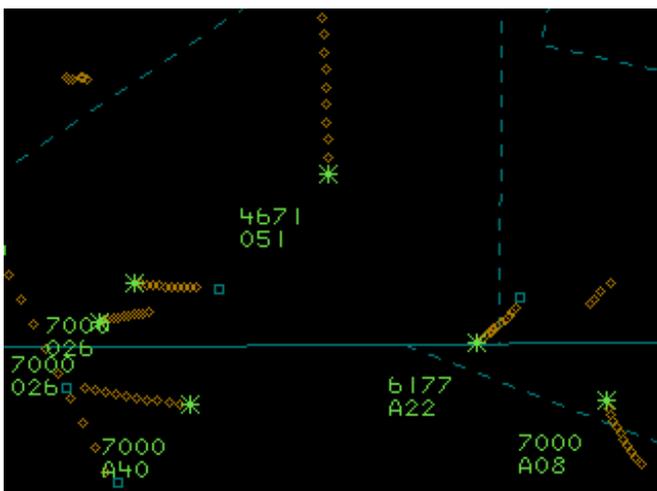
The traffic visible to Luton RADAR at this time is shown on the radar snapshot below:

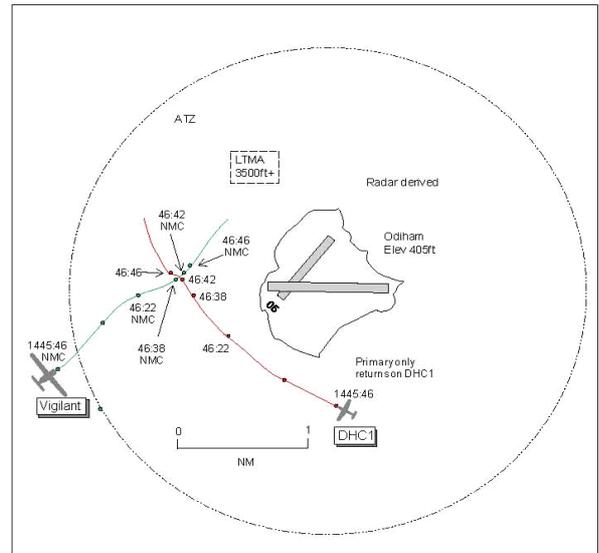
AIRPROX REPORT NO 2011046

Date/Time: 21 May 2011 1447Z (Saturday)
Position: 5114N 00058W
 (1nm W Odiham - elev 405ft)
Airspace: ATZ (Class: G)
Reporting Ac **Reported Ac**
Type: Vigilant DHC1
Operator: HQ Air (Trg) Civ Club
Alt/FL: 750ft 1000ft
 (QFE 1003mb) (QFE 1004mb)
Weather: VMC CLBC VMC CLBC
Visibility: 30km 10km
Reported Separation:
 20ft V/100m H NR
Recorded Separation:
 <0.1nm

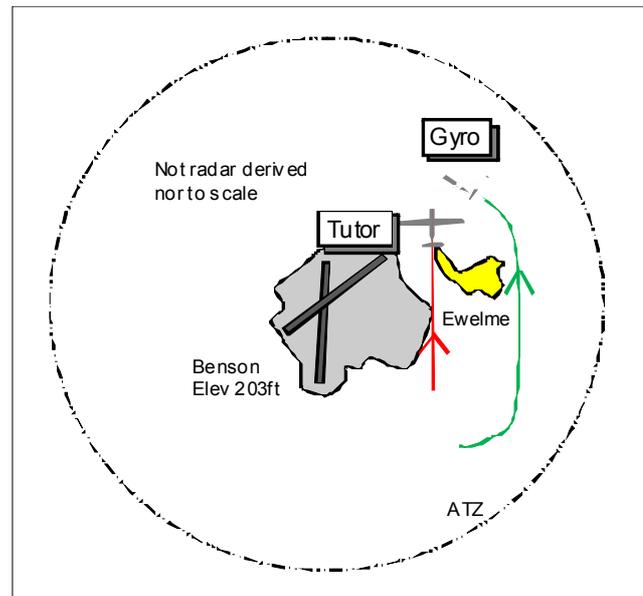
AIRPROX REPORT NO 2011047

Date/Time: 8 May 2011 1431Z (Sunday)
Position: 5138N 00105W (
1nm NNE Benson - elev 203ft)
Airspace: ATZ (Class: G)
Reporting Ac **Reported Ac**
Type: MT03 Gyroplane Grob Tutor T Mk 1
Operator: Civ Trg HQ Air (Trg)
Alt/FL: 500ft 800ft
(QFE) (QFE)
Weather: VMC CLOC VMC NR
Visibility: >10km 30km
Reported Separation:
20-30m 30ft V/100yd H
Recorded Separation:
NR

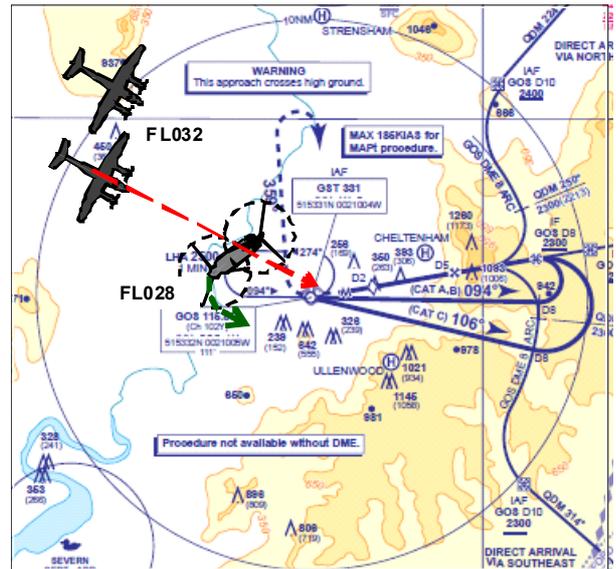
AIRPROX REPORT NO 2011049

Date/Time: 31 May 2011 1237Z
Position: 5155N 00215W
 (Gloucestershire Airport- elev 101ft)
Airspace: Lon FIR (Class: G)
Reporting Ac Reported Ac
Type: Chinook King Air
Operator: HQ JHC HQ AIR (Trg)
Alt/FL: 3000ft 3000ft
 (QNH 1021mb) (QFE 1003mb)
Weather: VMC CLBC VMC CLBC
Visibility: 40km 20km
Reported Separation:
 150ft V/500m H 400ft V/0m H
Recorded Separation:
 400ft V/ 0.1nm H

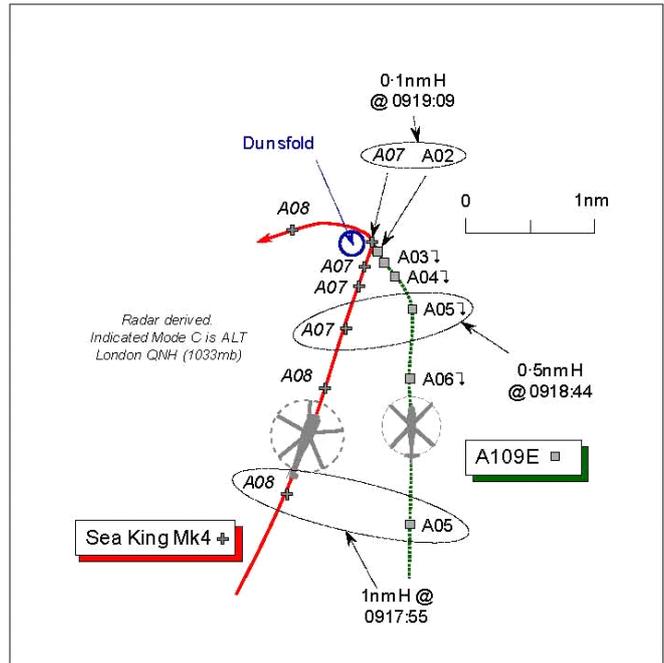
AIRPROX REPORT NO 2011050

Date/Time: 2 Jun 2011 0919Z
Position: 5107N 00032W
 (Dunsfold A/D - elev 172ft)
Airspace: London FIR (Class: G)
Reporter: Dunsfold A/G
1st Ac 2nd Ac
Type: Agusta 109 Sea King Mk4
Operator: NK MFTR/Civ Test
Alt/FL: NK 700ft
 QNH (NKmb)
Weather: NK NK VMC CLBC
Visibility: NK >10km
Reported Separation:
Dunsfold A/G: slightly higher
 NK 700ft V/1nm H
Recorded Separation:
 200ft Min V @ 0.5nm H
 0.1nm Min H @ 500ft V

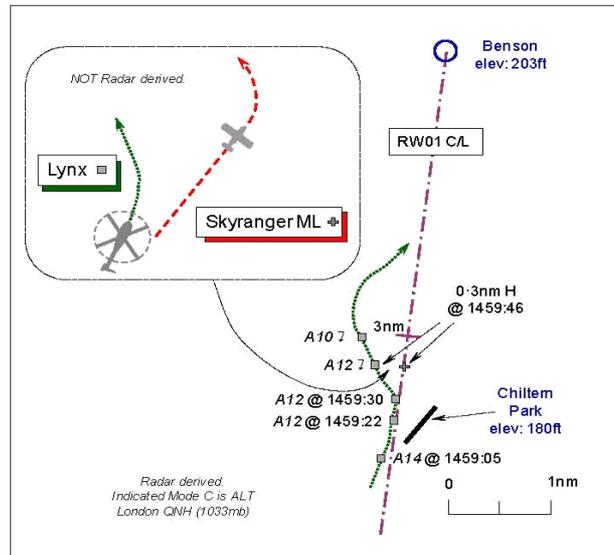
AIRPROX REPORT NO 2011051

Date/Time: 2 June 2011 1459Z
Position: 5133N 00106W
(3½nm S of Benson - elev 203ft)
Airspace: Benson MATZ (Class: G)
Reporting Ac **Reported Ac**
Type: Lynx AH Mk7 Skyranger ML
Operator: HQ JHC Civ Pte
Alt/FL: 900ft ↓ 400ft
QFE (1027mb) QFE
Weather: VMC CLBC VMC CAVOK
Visibility: 25km 10km
Reported Separation:
NR NR
Recorded Separation:
Not recorded

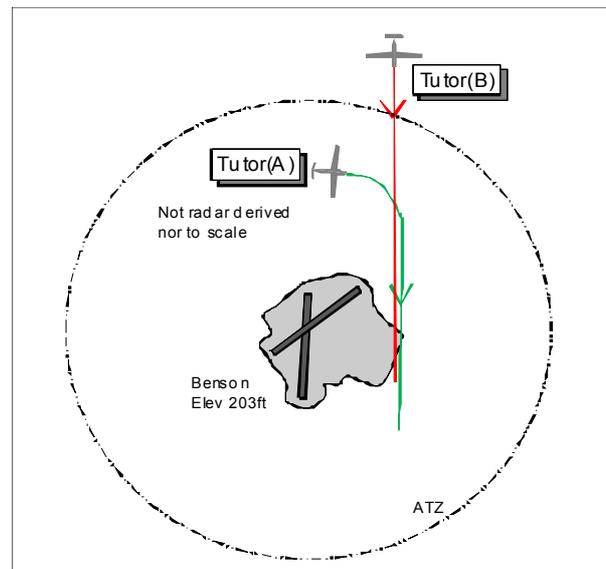
AIRPROX REPORT NO 2011052

Date/Time: 2 Jun 2011 1322Z (Saturday)
Position: 5137N 00105W
(0.5nm ESE Benson - elev 203ft)
Airspace: ATZ (Class: G)
Reporting Ac **Reported Ac**
Type: Tutor(A) Tutor(B)
Operator: HQ Air (Trg) HQ Air (Trg)
Alt/FL: 800ft 850ft↓
(QFE) (QFE)
Weather: VMC CLBC VMC CLBC
Visibility: 10km 10km
Reported Separation:
100ft V/150ft H 50ft V/75m H
Recorded Separation:
NR
