UK AIRPROX BOARD

Analysis of Airprox in UK Airspace

**Report Number 26
January 2011 – June 2011**

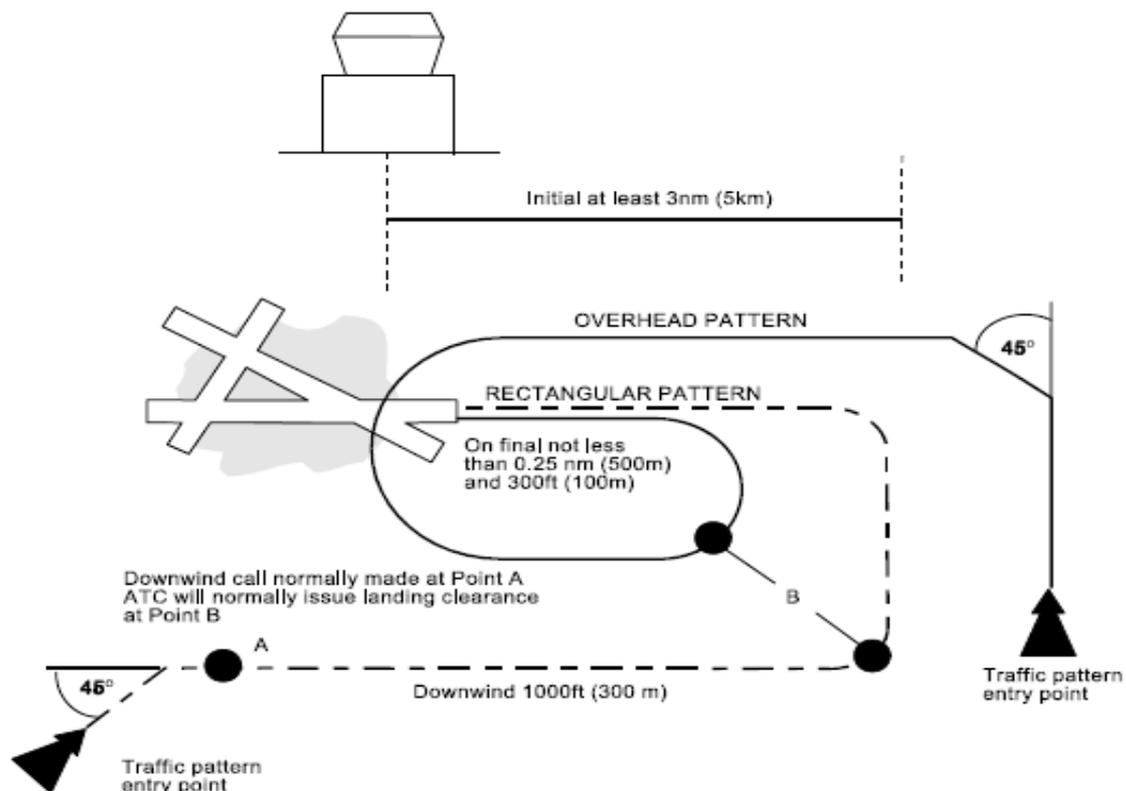
At the time of the Airprox, regulation and guidance for the conduct of visual joins was contained in JSP 552.320.105.4, which has since been carried forward into MAA RA 3020 and associated MAA MATM Chapter 20 Para 11. These documents state that the 'NATO standard visual aerodrome cct and landing patterns '...are to be implemented, except for the authorised single-Service procedures' and that 'clearance from ATC for the aircraft to enter the pattern **should** include items of essential information regarding the circuit direction, runway in use and number and position of all aircraft ahead which have not touched down.' That said, there are no single-Service variations contained within either JSP 552.320.105 or MAA RA 3020 and associated MAA MATM Chapter 20 Para 11. Moreover, the only UK variation to the NATO procedure that is germane to the current investigation is that the 'downwind call is required to be made when abeam the upwind threshold of the RW in use.' No variation is listed for the operation of an oval cct. Whilst the NATO cct pattern at Figure 1 is predicated on a rectangular cct, rather than the oval cct in common use by the UK military, the information relating to downwind join ground tracks and the ATM aspects appear to be able to be carried across to UK mil ATM procedure. However, based upon a quick

Figure 1: NATO Standard VFR Traffic Landing Pattern – Fixed Wing

At the time of the Airprox, regulation and guidance for the conduct of visual joins was contained in JSP 552.320.105.4, which has since been carried forward into MAA RA 3020 and associated MAA MATM Chapter 20 Para 11. These documents state that the ‘NATO standard visual aerodrome cct and landing patterns ‘...are to be implemented, except for the authorised single-Service procedures’ and that ‘clearance from ATC for the aircraft to enter the pattern **should** include items of essential information regarding the circuit direction, runway in use and number and position of all aircraft ahead which have not touched down.’ That said, there are no single-Service variations contained within either JSP 552.320.105 or MAA RA 3020 and associated MAA MATM Chapter 20 Para 11. Moreover, the only UK variation to the NATO procedure that is germane to the current investigation is that the ‘downwind call is required to be made when abeam the upwind threshold of the RW in use.’ No variation is listed for the operation of an oval cct. Whilst the NATO cct pattern at Figure 1 is predicated on a rectangular cct, rather than the oval cct in common use by the UK military, the information relating to downwind join ground tracks and the ATM aspects appear to be able to be carried across to UK mil ATM procedure. However, based upon a quick straw-poll, current mil ATM practice sees controllers pass position information to ac joining through Initial, rather than all ac conducting a visual join.

Figure 1: NATO Standard VFR Traffic Landing Pattern – Fixed Wing

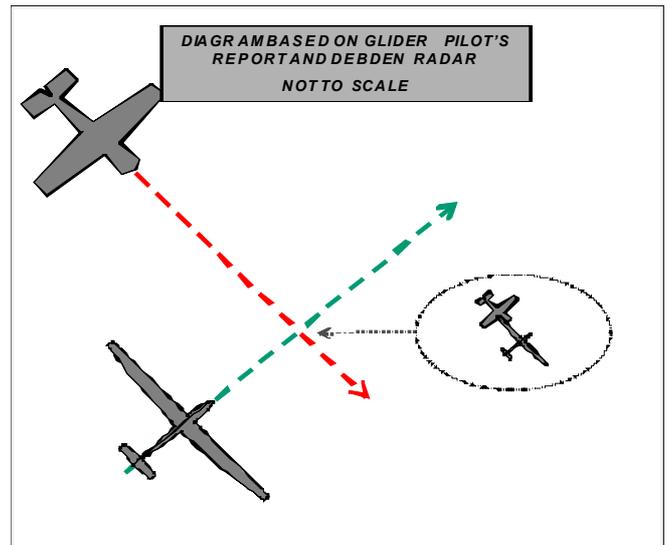
AIRPROX REPORT NO 2011056

Date/Time: 11 June 2011 1258Z (Saturday)
Position: 5215N 00057W (7nm SW Sywell)
Airspace: London FIR (Class: G)
Reporting Ac Reported Ac
Type: Discus Glider T6 Harvard
Operator: Civ Club Civ Trg
Alt/FL: 4300ft NK
(QNH 1007mb) (QNH)
Weather: VMC CLBC VMC CLBC
Visibility: 20km >10km
Reported Separation:
20ft V/0m H Not Seen
Recorded Separation:
NR

THE DISCUS 15M GLIDER PILOT reports soaring at 70kt in a white single-seat glider with orange hi-visibility flashes on the wings and fin. He was 7nm SW of Sywell and listening out on a gliding common frequency when he had a close encounter at 4300ft (QNH) with a single-engine GA ac, believed to be low wing or mid-wing configuration, mostly white with some blue and possibly a yellow flash [actually silver with a yellow band]; the registration was not seen. He was not equipped with SSR or TCAS; FLARM was fitted and serviceable but did not indicate any contacts.

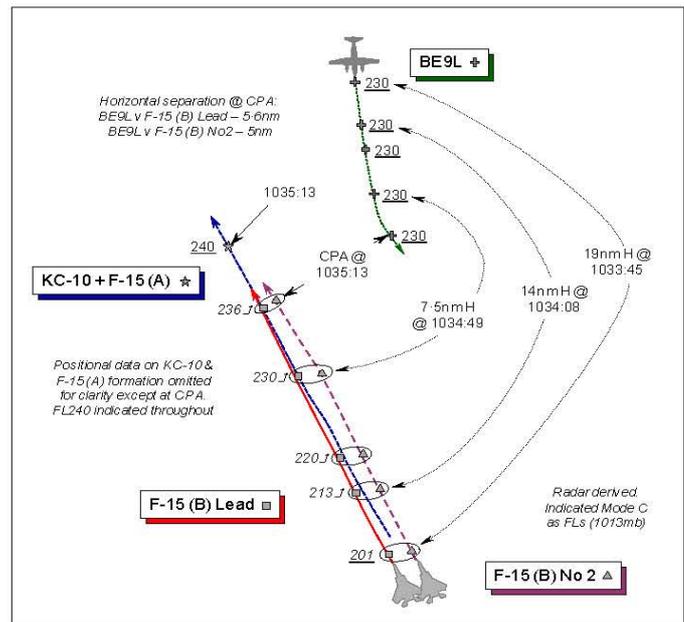
AIRPROX REPORT NO 2011057**Date/Time:** 4 Jun 2011 1035Z (Saturday)**Position:** 5545N 00213W
(10nm S of ST ABBS VOR)**Airspace:** Scottish FIR (Class: C)**Reporting Ac** **Reported Ac****Type:** BE9L F-15E x2**Operator:** Civ Exec Foreign Mil**Alt/FL:** FL230 FL210↑**Weather:** VMC CLAC NR**Visibility:** 50km NR**Reported Separation:**
1000ft V/5nm H NR**Recorded Separation:**
BE9L v F-15 (B) Lead: 600ft V/5-6nm H
BE9L v F-15 (B) No2: N/K V/5nm H

THE BEECH BE90L (BE9L) PILOT reports he was in transit from Wick to Oxford/Kidlington IFR and in receipt of a RCS from Scottish CONTROL. The assigned squawk was selected; Mode S and TCAS are fitted. The ac is coloured silver and blue; the HISLs were on.

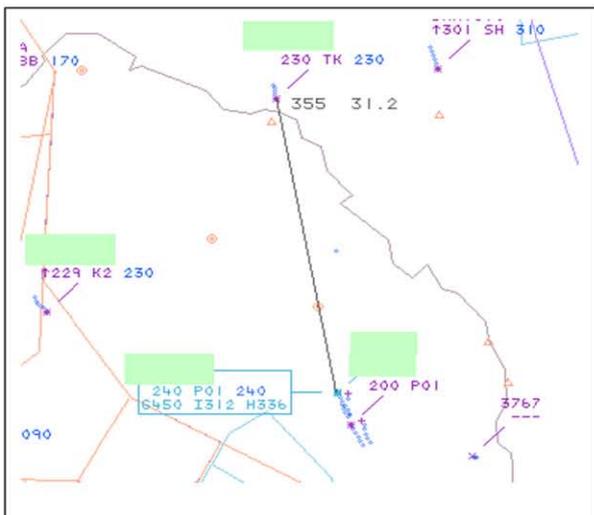
(PC MRT 1032:27)

The TAY SC requested, "Co-ordination against the [BE9L C/S] then, not above 2 3 and you're not below 2 4 is that correct?" The Scottish Military controller read back the co-ordination request and the conversation ended with the TAY SC stating, "that's co-ordinated". At 1028:40, TAY SC passed TI to the BE9L pilots, "traffic information about 4 or 5 minutes you may see ... an American fighter and a D C 10 they'll be a thousand feet above you." The KC-10 and F-15 (A) formation was now overhead Newcastle and 75nm ahead of the BE9L. The formation was now maintaining FL240. The BE9L crew asked if the traffic would be on the aircraft's left-hand side, to which the controller replied, "no ... they're in your 12 o'clock at the moment...its reciprocal". Scottish (Mil) telephoned the TAY Sector at 1032:29 and requested the TAY SC identify another two F-15s, "[F-15 (B) flight C/S] southeast of the [KC-10 and F-15 (A) formation C/S]". F-15 (B) flight had now decreased its distance behind the KC-10 and F-15 (A) formation to 3.4nm. The BE9L was 31nm N of the KC-10 and F-15 (A) formation.

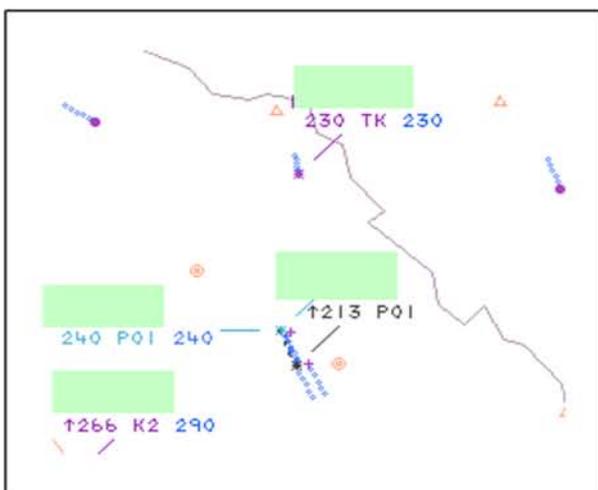
(PC MTRT 1034:10)

At 1033:52 the Mode C of F-15 (B) flight leader indicated that the transponding ac had commenced a climb from FL200 and was now passing FL203; at 1034:08 it was indicating Mode C of FL213, climbing, STCA then activated between F-15 (B) flight and the KC-10 and F-15 (A) formation ahead

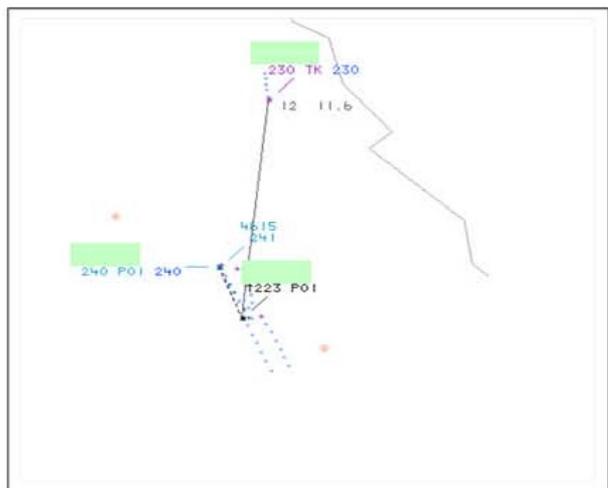
(PC MRT 1034:25)

At 1034:49, F-15 (B) flight leader's Mode C indicated the ac were at the same level as the BE9L, still in the BE9L's 1 o'clock, range 7.7nm. The aircraft were about 45nm N of Newcastle at FL230 in Class C controlled airspace.

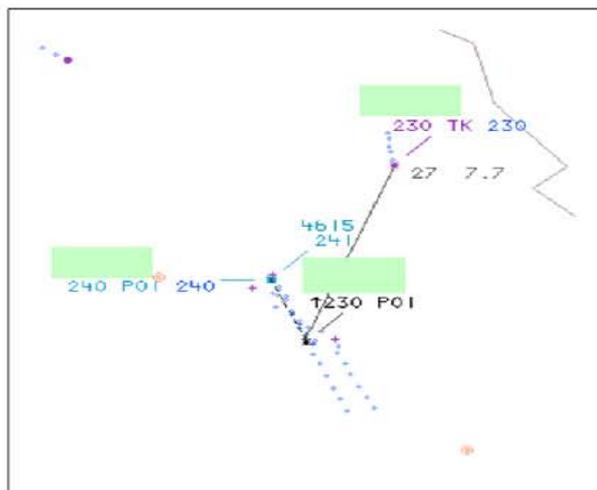
(PC MRT 1034:49)

Minimum separation between F-15 (B) flight and the BE9L occurred at 1035:13 with 5nm between the nearest aircraft and 600ft indicated against the leader's Mode C. Subsequently, F-15 (B) flight levelled at FL239 behind the leading formation. At 1035:39, TAY SC informed the BE9L pilot that his ac was now clear of the traffic and instructed the flight to resume its own navigation.

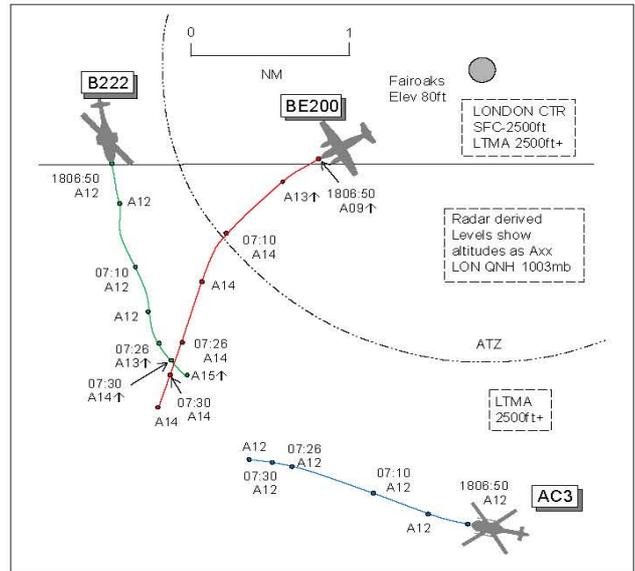
AIRPROX REPORT NO 2011059

Date/Time: 18 Jun 2011 1807Z (Saturday)
Position: 5119N 00037W
 (3nm SW Fairoaks)
Airspace: LFIR (Class: G)
Reporting Ac **Reported Ac**
Type: B222 BE200
Operator: Civ Comm Civ Pte
Alt/FL: ↑2400ft 1400ft
 (QNH 1001mb) (QNH)
Weather: VMC CLBC VMC CLBC
Visibility: >40km >10km
Reported Separation:
 Nil V/60m H Nil V/600m H
Recorded Separation:
 <100ft V/<0.1nm H

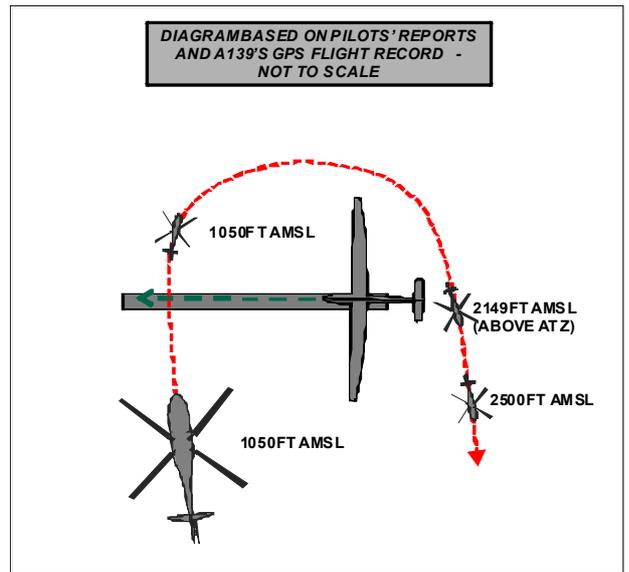
AIRPROX REPORT NO 2011061

Date/Time: 19 Jun 2011 1355Z (Sunday)
Position: 5101N 00238W
 (RNAS Yeovilton - elev 75ft)
Airspace: ATZ (Class: G)
Reporting Ac Reported Ac
Type: SZD-50 Glider AW139
Operator: Civ Club NK
Alt/FL: 500ft NK
 (QFE NK) NK
Weather: VMC CLBC VMC CLBC
Visibility: >5nm 10km
Reported Separation:
 500ft V/0.5nm H NK
Recorded Separation:
 Est 800ft V/NR H

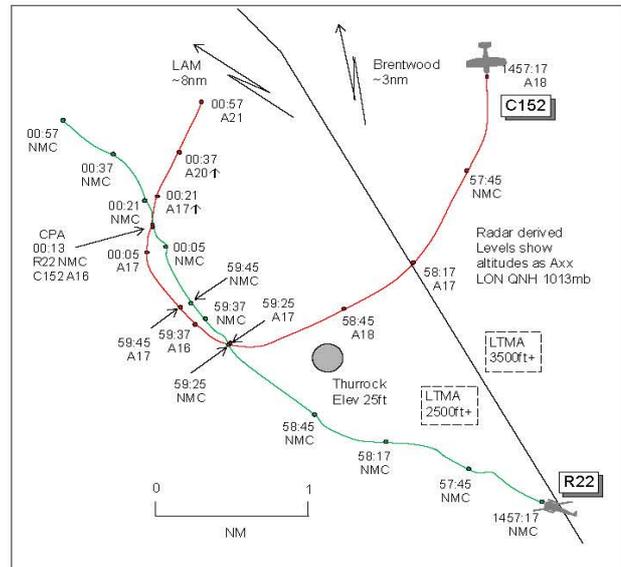
Date/Time: 19 Jun 2011 1500Z (Sunday)
Position: 5133N 00020E
(1.5nm NW Thurrock)

Airspace: LFIR (Class: G)
Reporting Ac **Reported Ac**
Type: R22 C152
Operator: Civ Pte Civ Trg
Alt/FL: 1200ft 2000ft
QNH (1013mb) QNH
Weather: VMC CLOC VMC CLOC
Visibility: >10km >10km
Reported Separation:
350ft Not seen
Recorded Separation:
Radar returns merge

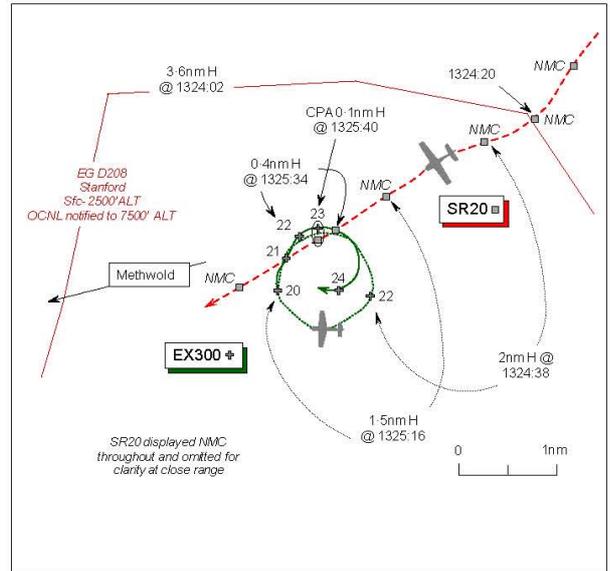
AIRPROX REPORT NO 2011065

Date/Time: 30 Jun 2011 1325Z
Position: 5232N 00044E
 (4½nm SW of Watton)
Airspace: EGD 208 (Class: -)
Reporting Ac Reported Ac
Type: Extra 300 LPS SR20
Operator: Civ Comm Civ Pte
Alt/FL: 2500ft 2200ft
 QNH (1025mb) QNH
Weather: VMC CLBC VMC In Rain
Visibility: 10km 6km
Reported Separation:
 200ft V/nil H NR
Recorded Separation:
 0.1nm H

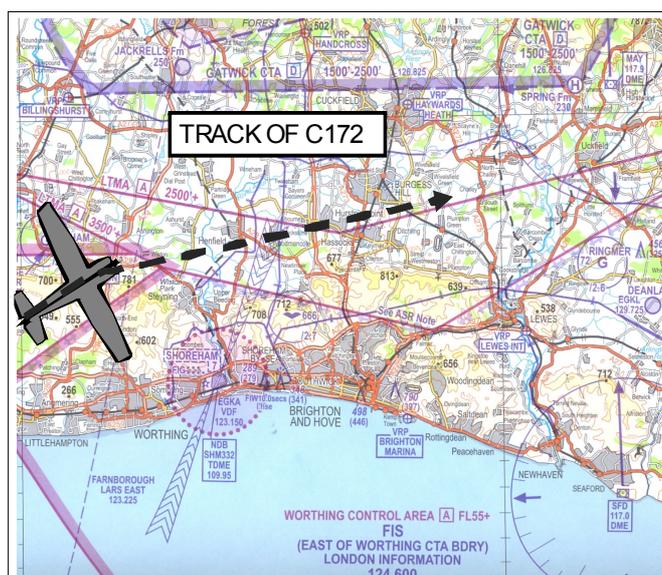
AIRPROX REPORT NO 2011070

Date/Time: 26 Jun 2011 1403Z (Sunday)
Position: 5056N 00018W
 (8nm N Shoreham)
Airspace: Lon FIR (Class: G)
Reporting Ac **Reported Ac**
Type: C172 Untraced Ac
Operator: Civ Pte NK
Alt/FL: 2200ft NK
 (NK)
Weather: VMC NR NK
Visibility: 30nm NK
Reported Separation:
 20ft V/0ft H NK
Recorded Separation:
 NK

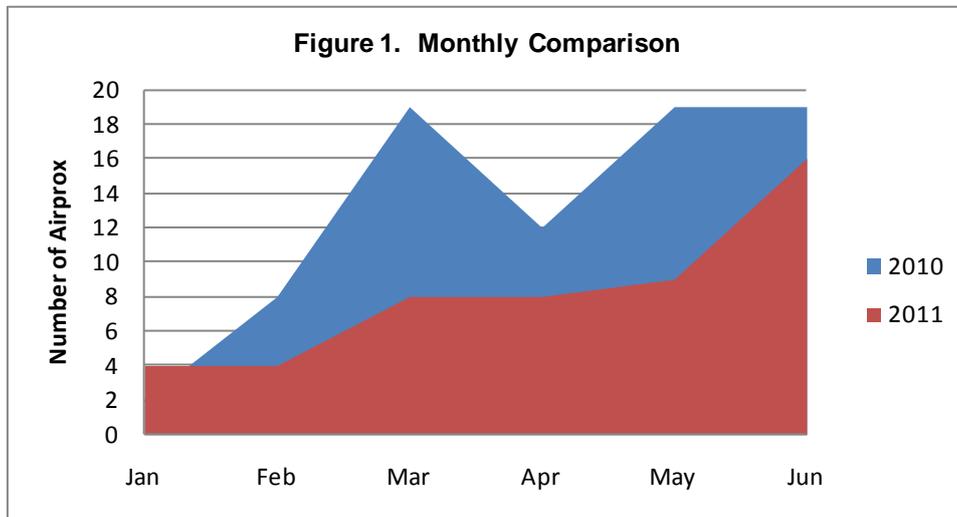
The profile of Airprox occurrences month by month is shown in Figure 1. Both 2010 and 2011 started slowly due to bad winter weather and the sharp decline in Apr 2010 reflects the reduced flying due to volcanic ash.

The profile of Airprox occurrences month by month is shown in Figure 1. Both 2010 and 2011 started slowly due to bad winter weather and the sharp decline in Apr 2010 reflects the reduced flying due to volcanic ash.

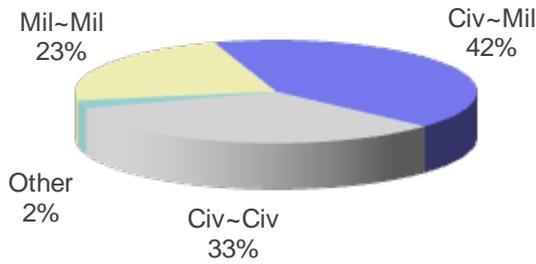
Figure 2.
User Group Mix Jan - Jun 2010

The breakdown is shown graphically in Figures 2 and 3 below. The category 'Other' is used when one of the aircraft is untraced and it cannot be determined whether it was civil or military. For obvious reasons, this is most common with gliders and light aircraft.

The breakdown is shown graphically in Figures 2 and 3 below. The category 'Other' is used when one of the aircraft is untraced and it cannot be determined whether it was civil or military. For obvious reasons, this is most common with gliders and light aircraft.

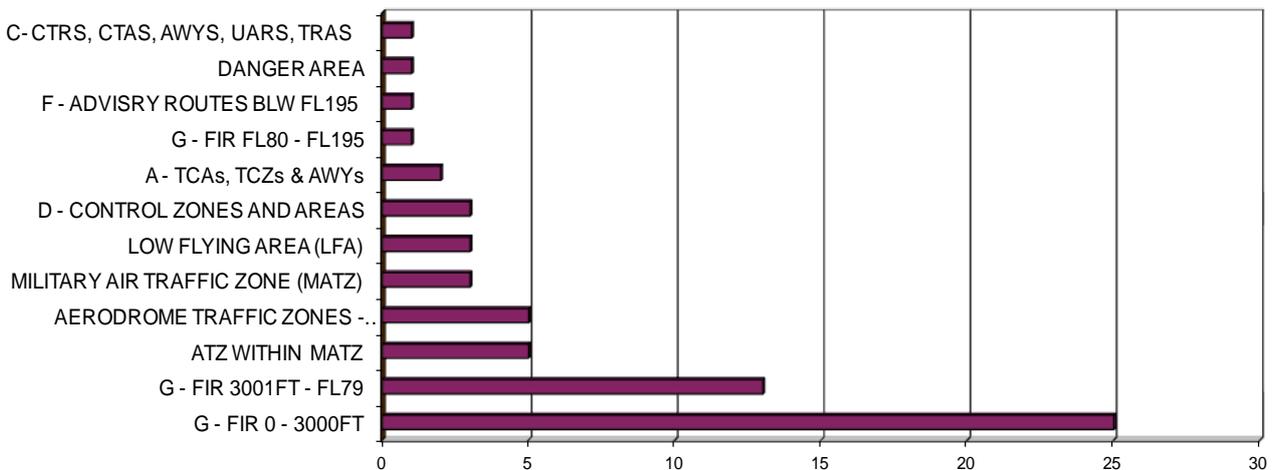
Figure 4. Airprox by Airspace Jan - Jun 2011

Figure 4 shows the breakdown of Airprox by airspace. The distribution profile is almost identical to that of the previous year.

Figure 4 shows the breakdown of Airprox by airspace. The distribution profile is almost identical to that of the previous year.

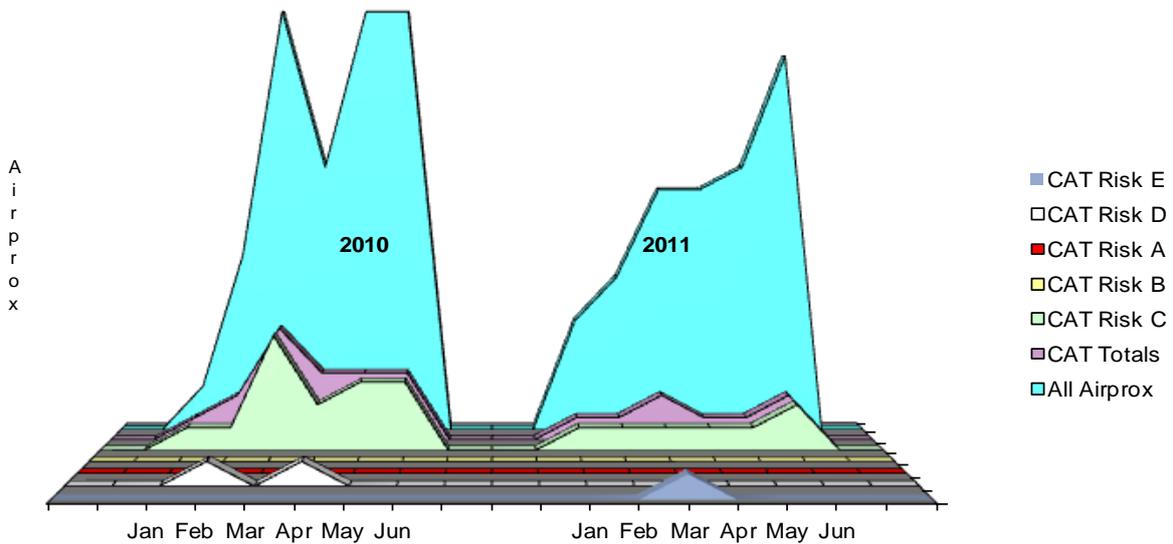
CAT Involvement in Airprox: Jan - Jun in 2010 and 2011

There was a reduction in the number of Airprox involving CAT between 2010 and 2011 and none of them in either year was assessed to be risk-bearing. Tables 5 and 6 and Figures 5 and 6 show the distribution was even throughout the period. For coherence between the years, Risk Categories C and E in 2011 should be added together and compared with Risk Category C in 2010.

There was a reduction in the number of Airprox involving CAT between 2010 and 2011 and none of them in either year was assessed to be risk-bearing. Tables 5 and 6 and Figures 5 and 6 show the distribution was even throughout the period. For coherence between the years, Risk Categories C and E in 2011 should be added together and compared with Risk Category C in 2010.

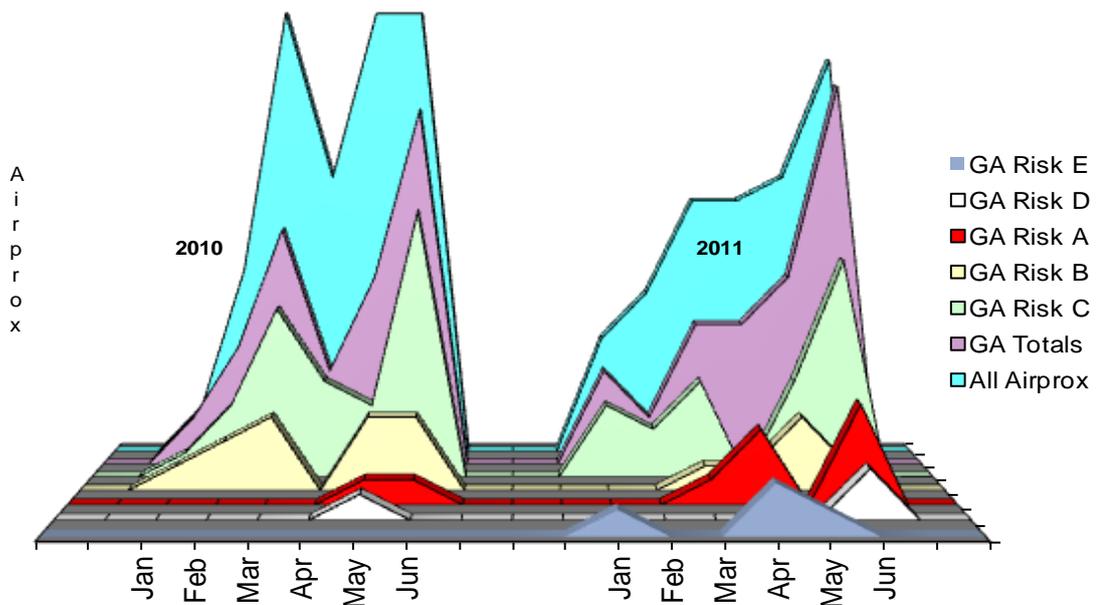
GA Involvement in Airprox: January - June in 2010 and 2011

The number and distribution of GA Airprox during Jan-Jun 2011 was very similar to 2010. Furthermore the number of risk-bearing events was exactly the same in both years, albeit that there was a greater number of Risk Category A events in 2011. The details are in Tables 8 and 9 and Figures 7 and 8.

The number and distribution of GA Airprox during Jan-Jun 2011 was very similar to 2010. Furthermore the number of risk-bearing events was exactly the same in both years, albeit that there was a greater number of Risk Category A events in 2011. The details are in Tables 8 and 9 and Figures 7 and 8.

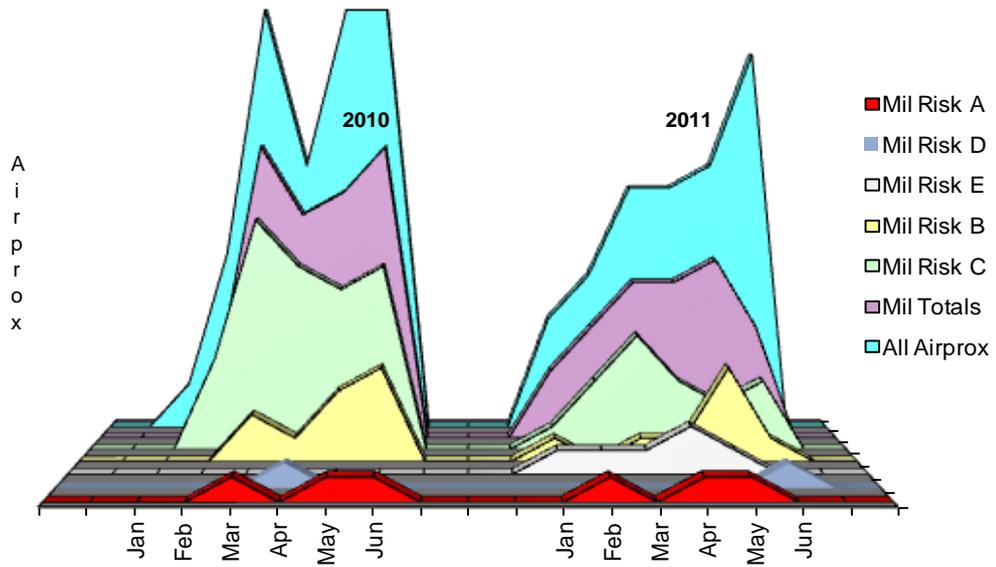
Military Involvement in Airprox: January - June in 2010 and 2011

Tables 11 and 12 and Figures 9 and 10 show there was a welcome reduction in the number of Airprox involving military aircraft from 51 to 35 comparing periods Jan-Jun 2010 with Jan-Jun 2011. Most of this reduction was in Risk Category C events with the number of Risk category A events remaining constant (3) and the number of Risk Category B events falling slightly from 10 to 8. The introduction of Risk Category E enables us to separate genuine Airprox from those which that are determined to be entirely benign or which it would be misleading to consider as Airprox events. The comparatively high number of Risk Category E events involving military aircraft is partially explained by the routine reporting of TCAS RA events in Class G airspace as Airprox.

Tables 11 and 12 and Figures 9 and 10 show there was a welcome reduction in the number of Airprox involving military aircraft from 51 to 35 comparing periods Jan-Jun 2010 with Jan-Jun 2011. Most of this reduction was in Risk Category C events with the number of Risk category A events remaining constant (3) and the number of Risk Category B events falling slightly from 10 to 8. The introduction of Risk Category E enables us to separate genuine Airprox from those which that are determined to be entirely benign or which it would be misleading to consider as Airprox events. The comparatively high number of Risk Category E events involving the military is partially explained by the routine reporting of TCAS RA events in Class G airspace as Airprox.

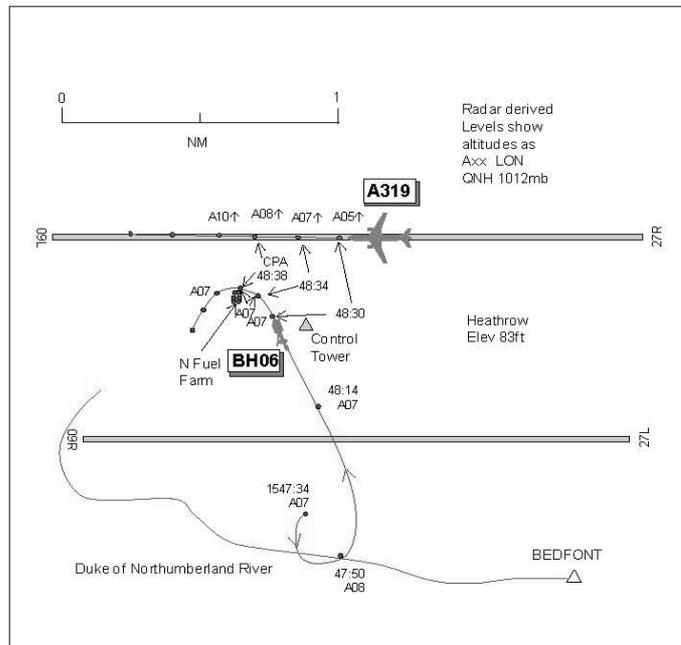
Recorded Separation:

100ft V/0.2nm H

THE A319 PILOT reports outbound from Heathrow RW27R, IFR and in communication with Heathrow Tower, squawking with Modes S and C. Just after rotation, heading 271° at 140kt, Tower advised of a helicopter operating to the S of the aerodrome. As they climbed through 300ft the Capt visually acquired a black helicopter approx 300m to the forward/L of their ac at about 600ft moving towards the extended C/L of RW27R. Both pilots were ready to take avoiding action if required. The helicopter made a very sharp L turn by which time they were approximately 300ft higher than it. Neither a TCAS TA nor RA warning was received at any time and he assessed the risk as medium.

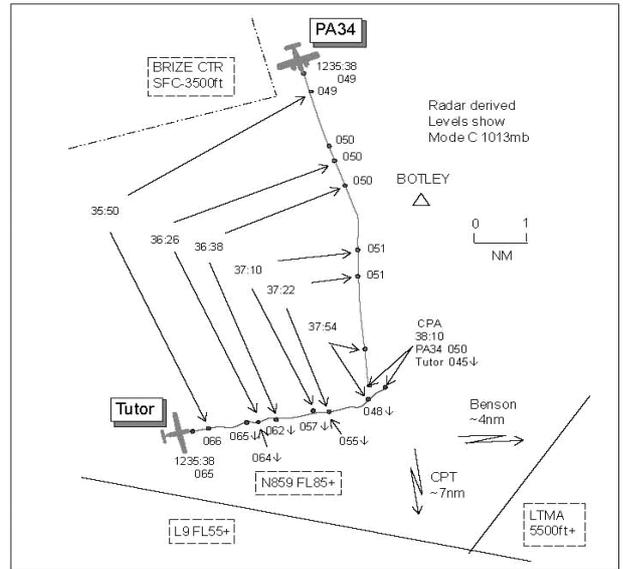
Date/Time: 20 Jan 2011 1238Z
Position: 5138N 00115W (8.5nm N CPT)
Airspace: Oxford AIAA (Class: G)
Reporter: LTC SW

<u>1st Ac</u>	<u>2nd Ac</u>
<u>Type:</u> PA34	Grob TutorTMk1
<u>Operator:</u> Civ Trg	HQ AIR (TRG)
<u>Alt/FL:</u> FL50	4500ft↓ (NR)
<u>Weather:</u> IMC IICL	VMC CLAC
<u>Visibility:</u> 10km	>10km
<u>Reported Separation:</u> Not seen	NR
<u>Recorded Separation:</u> 500ft V/0.3nm H

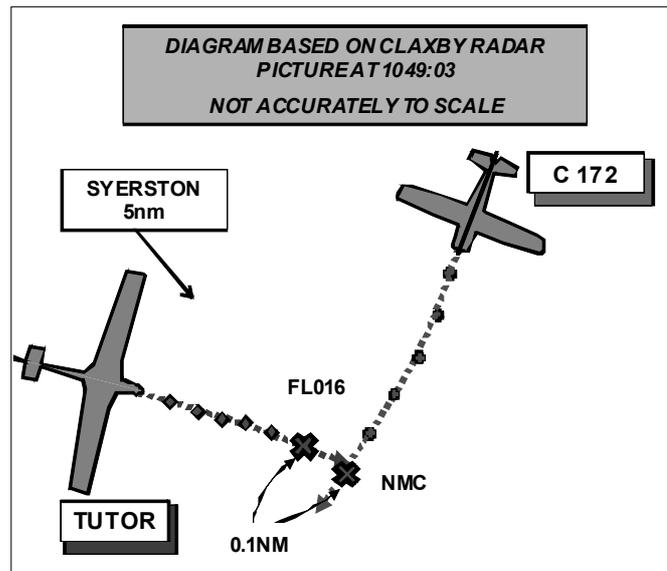
AIRPROX REPORT NO 2011005

Date/Time: 28 Jan 2011 1049Z
Position: 5310N 00100W
(5nm NW Syerston)
Airspace: Lon FIR (Class: G)
Reporting Ac Reported Ac
Type: Grob Tutor T Mk1 C172
Operator: HQ AIR (Trg) Civ Pte
Alt/FL: 1500ft 2000ft
(RPS 1022mb) (QNH)
Weather: VMC CLBC VMC CAVOK
Visibility: 10km >10km
Reported Separation:
150ft V/250ft H 200ft V/20m H
Recorded Separation:
NR V (est 350ft) /0.1nm H

THE TUTOR PILOT reports flying an instructional sortie in a white ac with all lights switched on, initially in receipt of a BS from Waddington ZONE, with the student as handling pilot. They were 5nm NW of Syerston, heading 100° in the climb out from a PFL and passing 1300ft when he (the instructor) cancelled the BS and changed freq to Cranwell APP. Passing 1700ft and before gaining contact with Cranwell, the student pilot pushed forward abruptly and reported an ac above, he gained visual contact with the ac, 400ft away, by moving his head forward and right to clear the area obscured by the canopy arch then took control, noting the height as being 1650ft. The conflicting ac was a white high-wing Cessna with a blue registration mark and was in straight and level flight heading about 195° and he assessed the vertical separation to be 150ft.

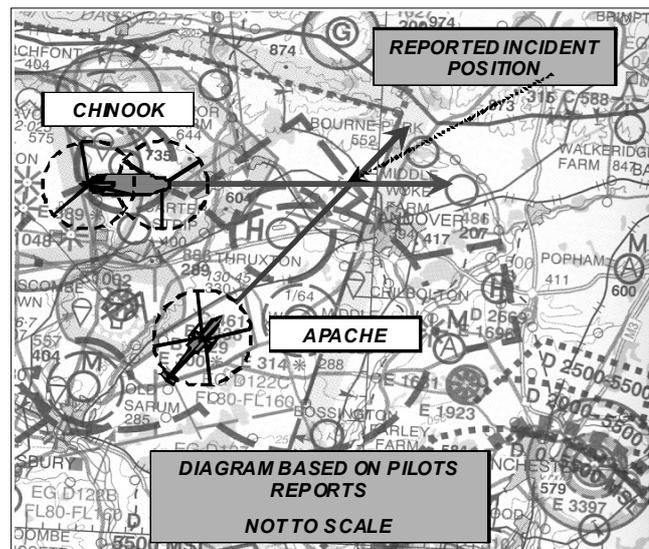
AIRPROX REPORT NO 2011006

Date/Time: 24 Jan 2011 2047Z
Position: 5115N 00132W (2nm NW Andover)
Airspace: UKNLFS (Class: G)
Reporting Ac Reported Ac
Type: Chinook Apache
Operator: HQ JHC HQ JHC
Alt/FL: 800ft NR
(RPS 1024mb) (NK)
Weather: VMC NR NK NR
Visibility: 10km NR
Reported Separation:
100ft V/0ft H NR
Recorded Separation:
NR

THE CHINOOK PILOT reports that they were Reversionary Night Flying (RNF) [not on NVGs], transiting in the Night Rotary Region 1 from Lugershall to Odiham at 800ft on the Cotswold RPS [1024mb], routing to the A34 before climbing for a radar pickup for an approach at Odiham. They had all lights switched on and were heading 090° at 130kt approaching Andover and had reselected the radios and IFF [squawking 3646] from SPTA in preparation for the climb and approach to Odiham. The NHP called "break" and at the same time he saw an Apache helicopter crossing from right to left in level flight about 50ft below and 100ft in front of them. He cyclically climbed the ac to avoid the Apache which disappeared under their nose. The No1 crewman picked up the Apache as it cleared to their 9 o'clock and saw it continue away without manoeuvring. RT calls were made to try and establish comms with the Apache on Middle Wallop Approach, low level common and Guard UHF but there was no response.

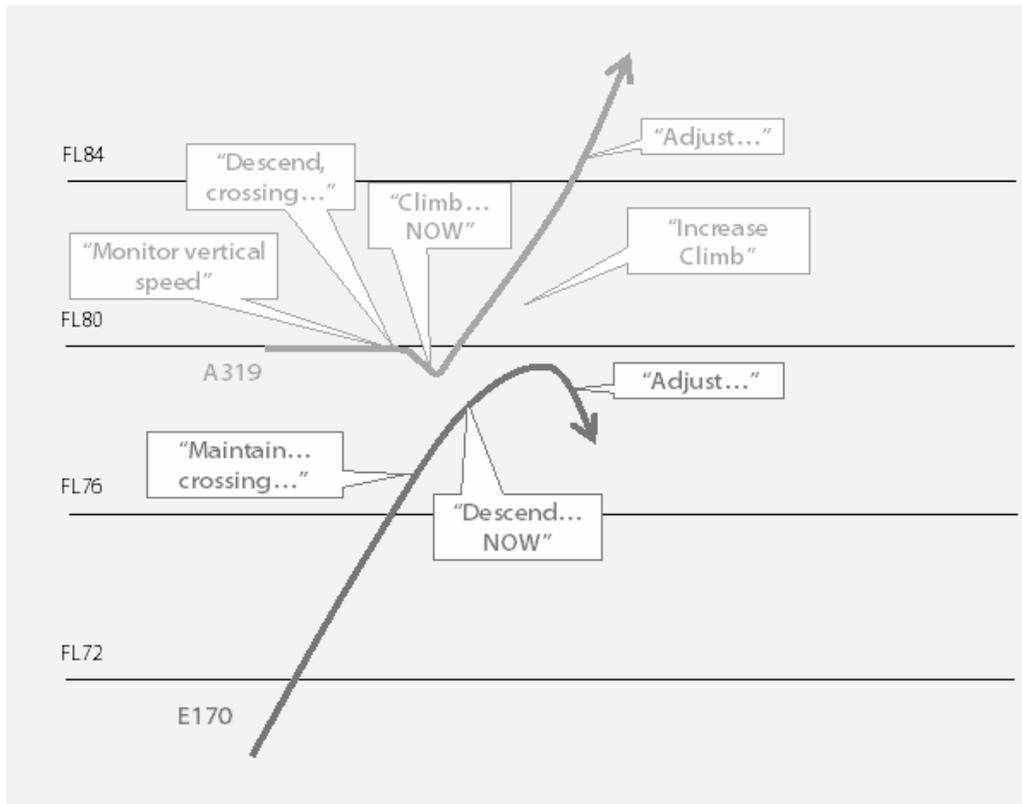
Graphic above courtesy of Eurocontrol from an ACAS II Bulletin.

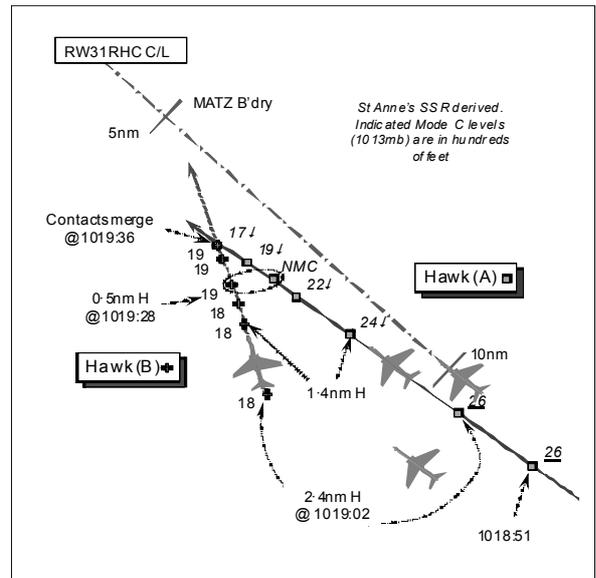
AIRPROX REPORT NO 2011009

Date/Time: 1 Feb 2011 1019Z
Position: 5310N 00424W
 (6½nm SE of Valley - elev 36ft)
Airspace: London FIR (Class: G)
Reporting Ac **Reporting Ac**
Type: Hawk T Mk1 x3 Hawk T Mk1
Operator: HQ Air (Trg) HQ Air (Trg)
Alt/FL: 2000ft ↓ 2000ft
 QFE (1021mb) QFE (1020mb)
Weather: VMC CLBC VMC CLBC
Visibility: 20km >10km
Reported Separation:
 Nil V/<100ftH 200ft V/nil H
Recorded Separation:
 200ft V/SSR contacts merged

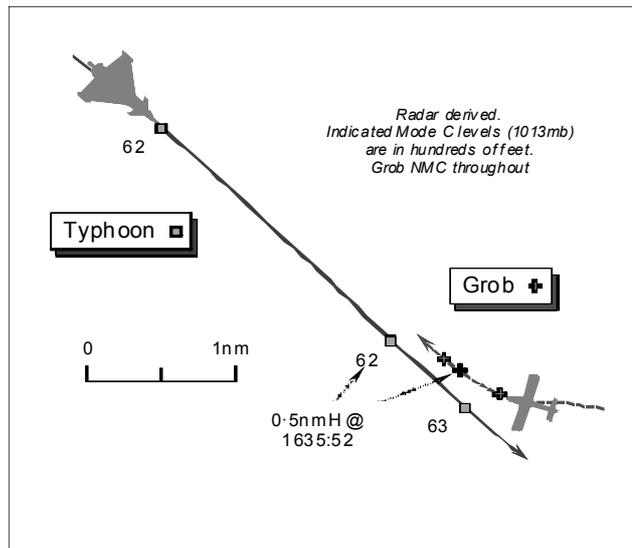
AIRPROX REPORT NO 2011017

Date/Time: 8 Mar 2011 1636Z
Position: 5246N 00013E (15nm NW of Marham)
Airspace: London FIR (Class: G)
Reporting Ac **Reported Ac**
Type: Typhoon Grob Tutor TMk1
Operator: HQ Air (Ops) HQ Air (Trg)
Alt/FL: 6000ft 5000ft
RPS (1007mb) RPS (1007mb)
Weather: VMC CLAH VMC CLAH
Visibility: 5km 20km
Reported Separation:
500-1000ftV/200m 500ft V/1000yd H
Recorded Separation:
0.2nm H [~370m]

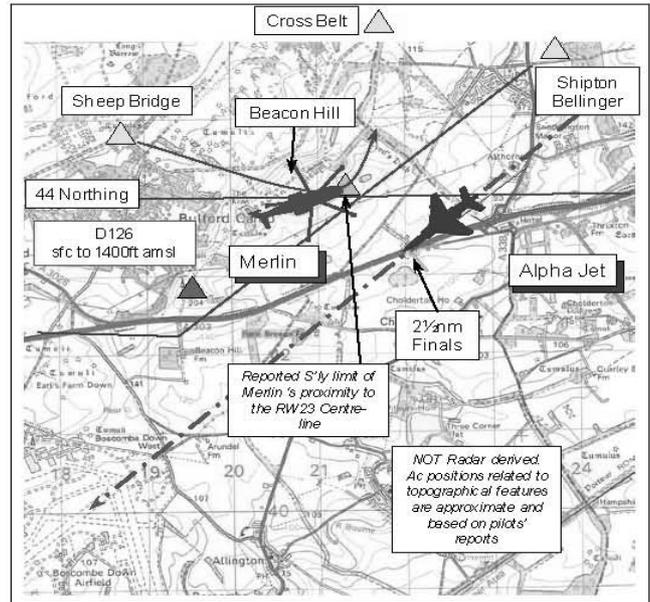
AIRPROX REPORT NO 2011018

Date/Time: 9 Mar 2011 1256Z
Position: 5111N 00141W (2½nm NE of Boscombe Down A/D- elev 407ft)
Airspace: Boscombe MATZ (Class: G)
Reporting Ac Reported Ac
Type: Alpha Jet Merlin
Operator: MoD FTR HQ JHC
Alt/FL: 800ft 300ft
 QFE (1002mb) agl
Weather: VMC NR VMC CLBC
Visibility: 10km 8km
Reported Separation:
 200ft V/800ft H 400ft V/700m H
Recorded Separation:
 Not recorded

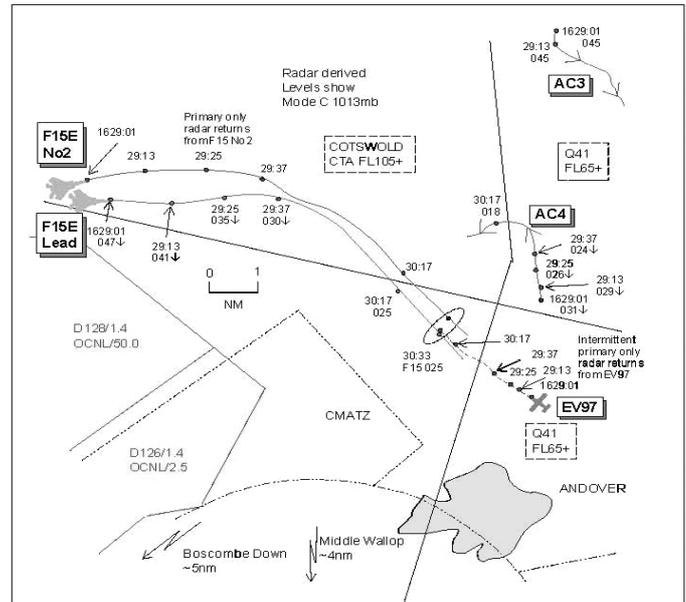
AIRPROX REPORT NO 2011020

Date/Time: 14 Mar 2011 1630Z
Position: 5117N 00130W (4nm N Andover)
Airspace: London FIR (Class: G)
Reporting Ac **Reported Ac**
Type: Evektor EV97 F15Ex2
Eurostar
Operator: Civ Pte Foreign Mil
Alt/FL: 2000ft NR
(QNH 1016mb) (QNH)
Weather: VMC HZBC VMC HAZE
Visibility: 10km 8km
Reported Separation:
50ft V/25m H 50-100ft V
/300m H
Recorded Separation:
0·1nm/0·3nm H

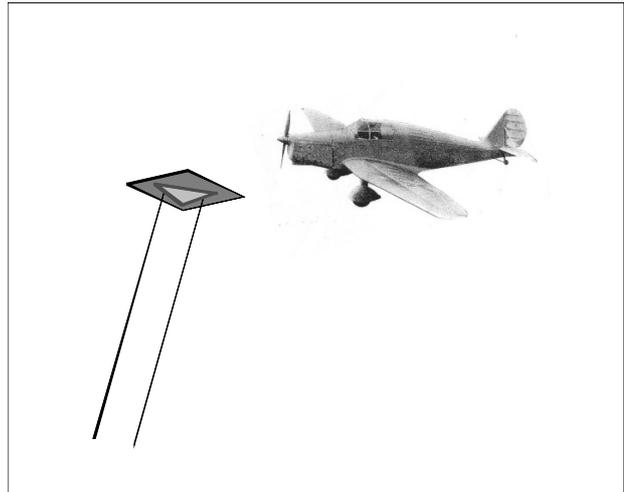
AIRPROX REPORT NO 2011021

Date/Time: 27 Mar 2011 1130Z (Sunday)
Position: 5206N 00050W
(3nm N Milton Keynes)
Airspace: Lon FIR (Class: G)
Reporting Ac Reported Ac
Type: Topsy Belfair Kite
Operator: Civ Pte NK
Alt/FL: 1450ft NK
(QNH 1014mb)
Weather: VMC HAZE NK
Visibility: 6km NK
Reported Separation:
50ft V/10m H NK
Recorded Separation:
NR

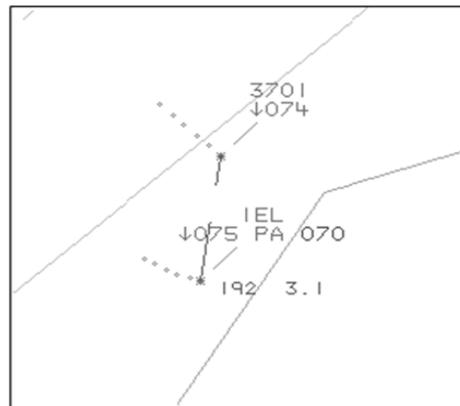
(PC MRT 1237:30)

At 1237:10 the Mode A code of the Tornado changed to 3701 (Lossiemouth) and by 1237:30 both ac were on parallel SE'y tracks, 3.1nm apart, the SF 340 descending through FL075 and the Tornado descending through FL074 (see photo below).

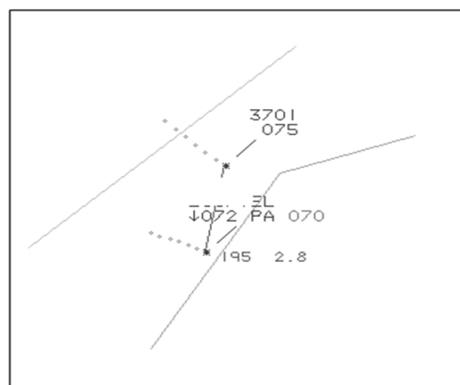
(PC MRT 1237:40)

At 1237:20 the MOR controller asked the SF 340 pilot if they were still visual with the traffic. The pilot replied, "Negative, we're in cloud now". The controller then gave a right turn onto a heading of 180°. The minimum distance between the two ac was 2.8nm laterally, 300 feet vertically, at 1237:40.

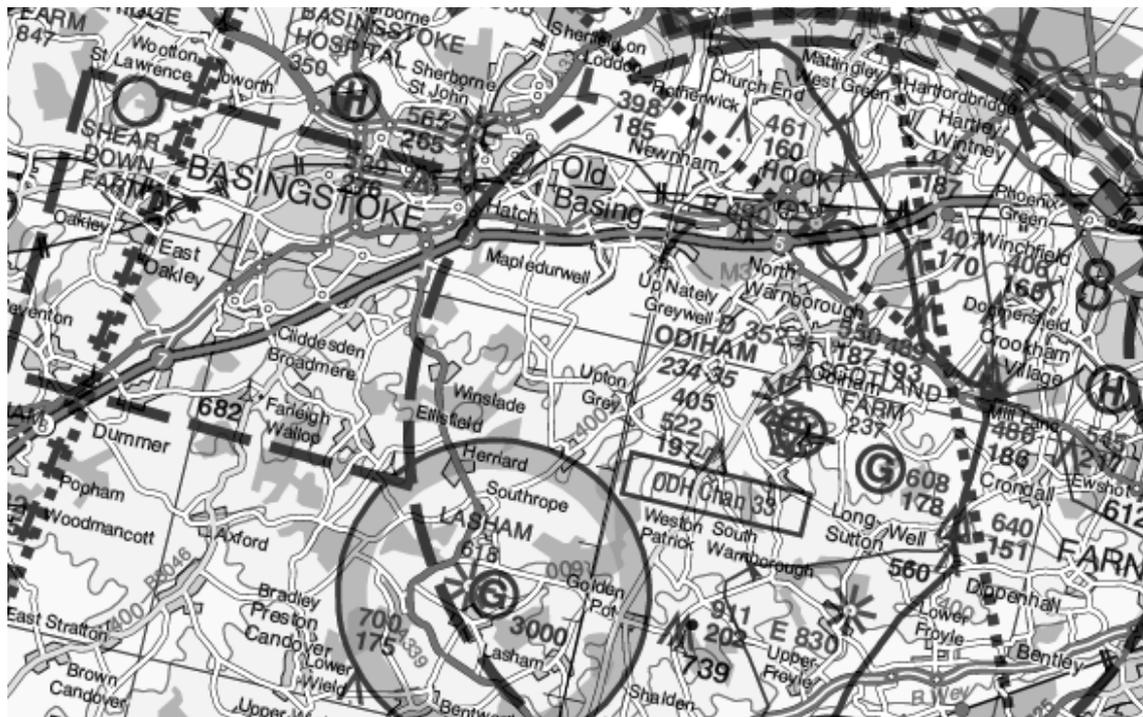
Lasham airfield is a notified glider site approximately 4.5nm SW of Odiham, which has a mandatory military avoidance of 2nm radius up to 3000ft agl. The UK Mil LFHB contains a further warning that "*intensive gliding activity takes place within 5nm of Lasham.*" The diagram below shows the local area.

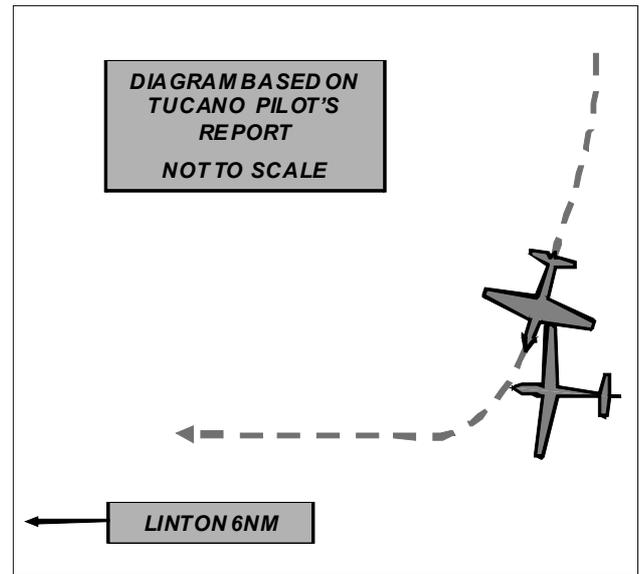
Date/Time: 19 May 2011 1238Z
Position: 5403N 00100W
 (6nm E Linton - elev 53ft)
Airspace: Lon FIR (Class: G)
Reporting Ac Reported Ac
Type: Tucano Untraced Glider
Operator: HQ AIR (TRG) NR
Alt/FL: 2500ft NR
 (QFE 1015mb) NR
Weather: VMC CAVOK NR
Visibility: 40km NR
Reported Separation:
 100ft V/Nil H NR
Recorded Separation:
 NR

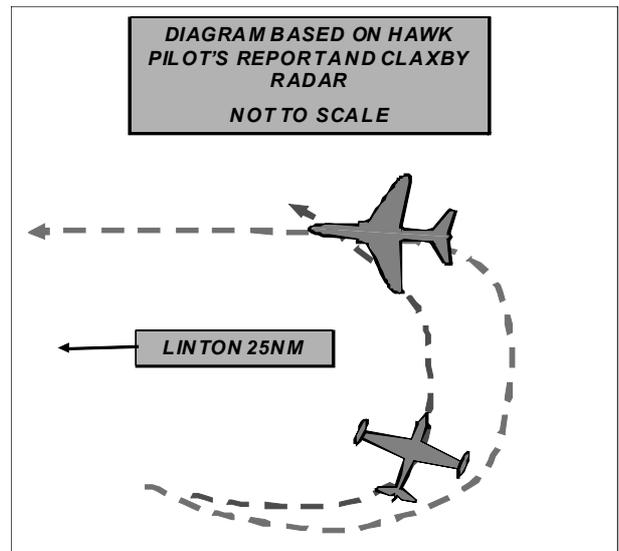
Date/Time: 17 May 2011 1410Z
Position: 5408N 00031W (25nm E Linton)
Airspace: London FIR (Class: G)
Reporting Ac Reported Ac
Type: Hawk T Mk1 Untraced Light ac
Operator: HQ AIR (Ops) NK
Alt/FL: 2000ft NK
(RPS 1011mb)
Weather: VMC CLBC NK
Visibility: 20km NK
Reported Separation:
0ft V /1000ft H NK
Recorded Separation:
NK

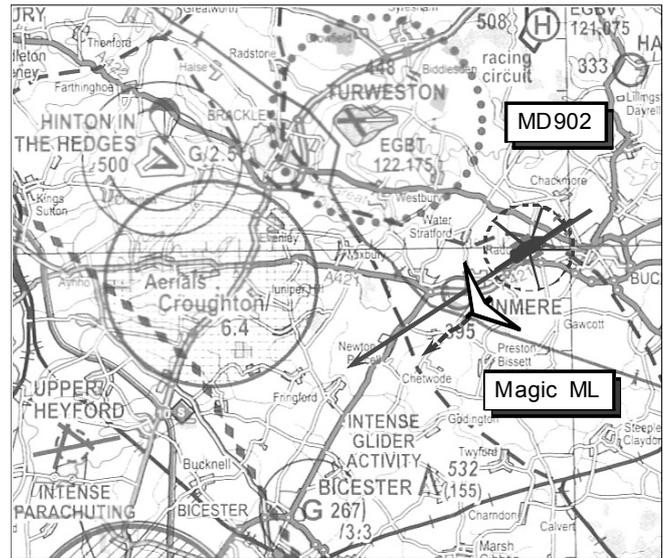
Date/Time: 20 May 2011 0952Z
Position: 5159N 00103W (5nm E of Croughton)
Airspace: London FIR (Class: G)
Reporting Ac Reported Ac
Type: Magic Laser MD902 Explorer
 Flexwing ML
Operator: Civ Pte Civ Comm
Alt/FL: 2000ft <1000ft
 amsl amsl
Weather: VMC CLBC VMC CLBC
Visibility: 50nm >10km
Reported Separation:
 300ft V/nil H 500ft V/100ft H
Recorded Separation:
 Not recorded

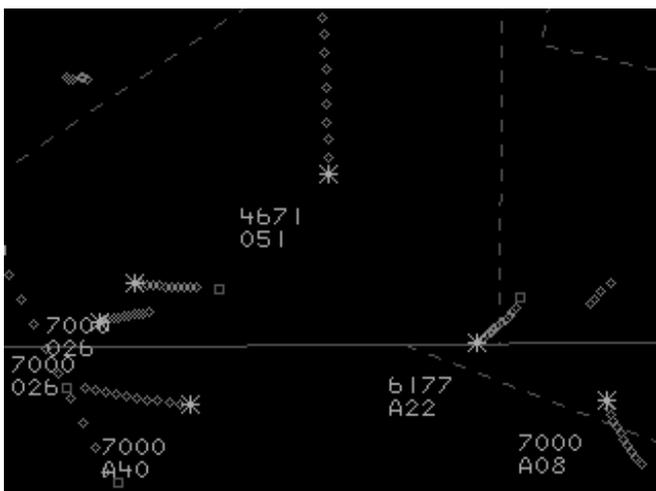
The traffic visible to Luton RADAR at this time is shown on the radar snapshot below:

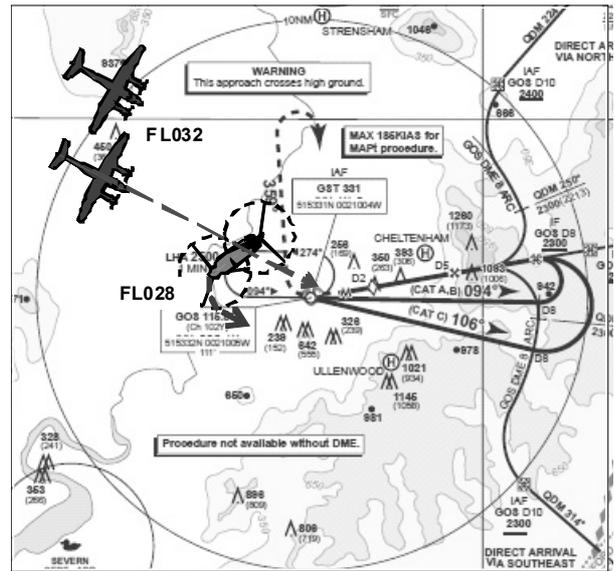
Date/Time: 31 May 2011 1237Z
Position: 5155N 00215W
 (Gloucestershire Airport- elev 101ft)
Airspace: Lon FIR (Class: G)
Reporting Ac Reported Ac
Type: Chinook King Air
Operator: HQ JHC HQ AIR (Trg)
Alt/FL: 3000ft 3000ft
 (QNH 1021mb) (QFE 1003mb)
Weather: VMC CLBC VMC CLBC
Visibility: 40km 20km
Reported Separation:
 150ft V/500m H 400ft V/0m H
Recorded Separation:
 400ft V/ 0.1nm H

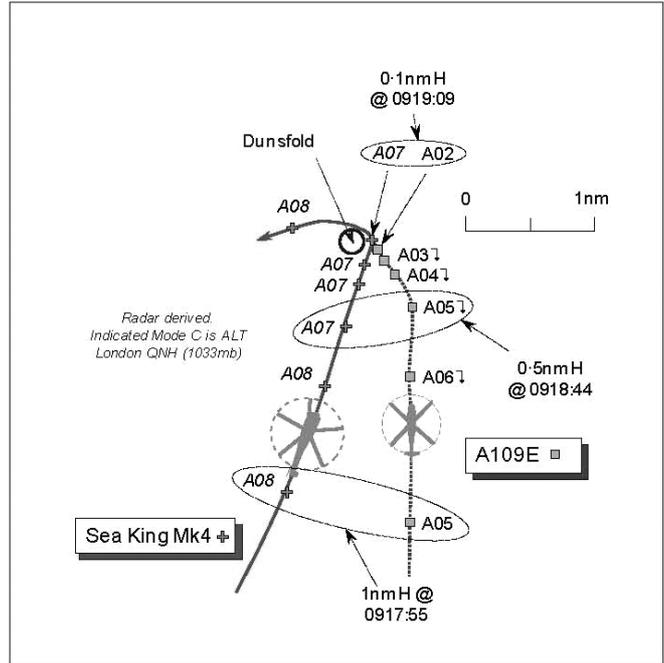
Date/Time: 2 Jun 2011 0919Z
Position: 5107N 00032W
 (Dunsfold A/D - elev 172ft)
Airspace: London FIR (Class: G)
Reporter: Dunsfold A/G
1st Ac 2nd Ac
Type: Agusta 109 Sea King Mk4
Operator: NK MFTR/Civ Test
Alt/FL: NK 700ft
 QNH (NKmb)
Weather: NK NK VMC CLBC
Visibility: NK >10km
Reported Separation:
Dunsfold A/G: slightly higher
 NK 700ft V/1nm H
Recorded Separation:
 200ft Min V @ 0.5nm H
 0.1nm Min H @ 500ft V

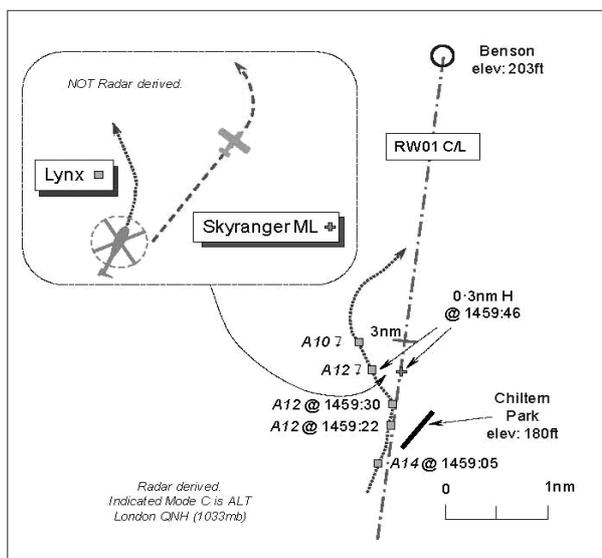
Date/Time: 2 June 2011 1459Z
Position: 5133N 00106W
(3½nm S of Benson - elev 203ft)
Airspace: Benson MATZ (Class: G)
Reporting Ac **Reported Ac**
Type: Lynx AH Mk7 Skyranger ML
Operator: HQ JHC Civ Pte
Alt/FL: 900ft ↓ 400ft
QFE (1027mb) QFE
Weather: VMC CLBC VMC CAVOK
Visibility: 25km 10km
Reported Separation:
NR NR
Recorded Separation:
Not recorded

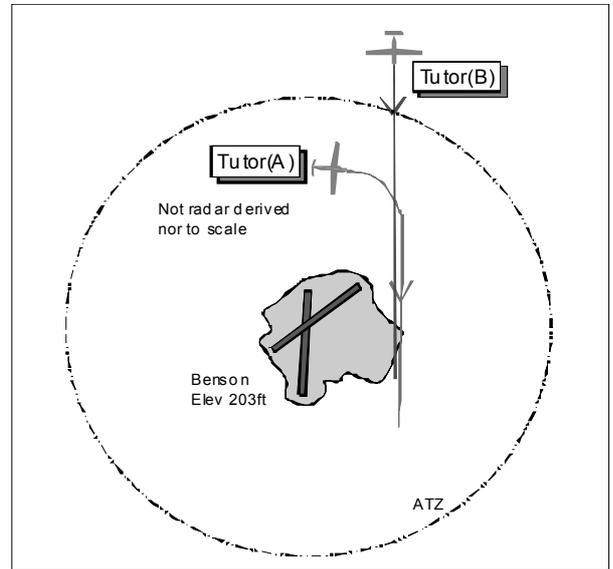
Date/Time: 2 Jun 2011 1322Z (Saturday)
Position: 5137N 00105W
 (0.5nm ESE Benson - elev 203ft)
Airspace: ATZ (Class: G)
Reporting Ac Reported Ac
Type: Tutor(A) Tutor(B)
Operator: HQ Air (Trg) HQ Air (Trg)
Alt/FL: 800ft 850ft↓
 (QFE) (QFE)
Weather: VMC CLBC VMC CLBC
Visibility: 10km 10km
Reported Separation:
 100ft V/150ft H 50ft V/75m H
Recorded Separation:
 NR
