UK AIRPROX BOARD

Analysis of Airprox in UK Airspace

**Report Number 26
January 2011 – June 2011**

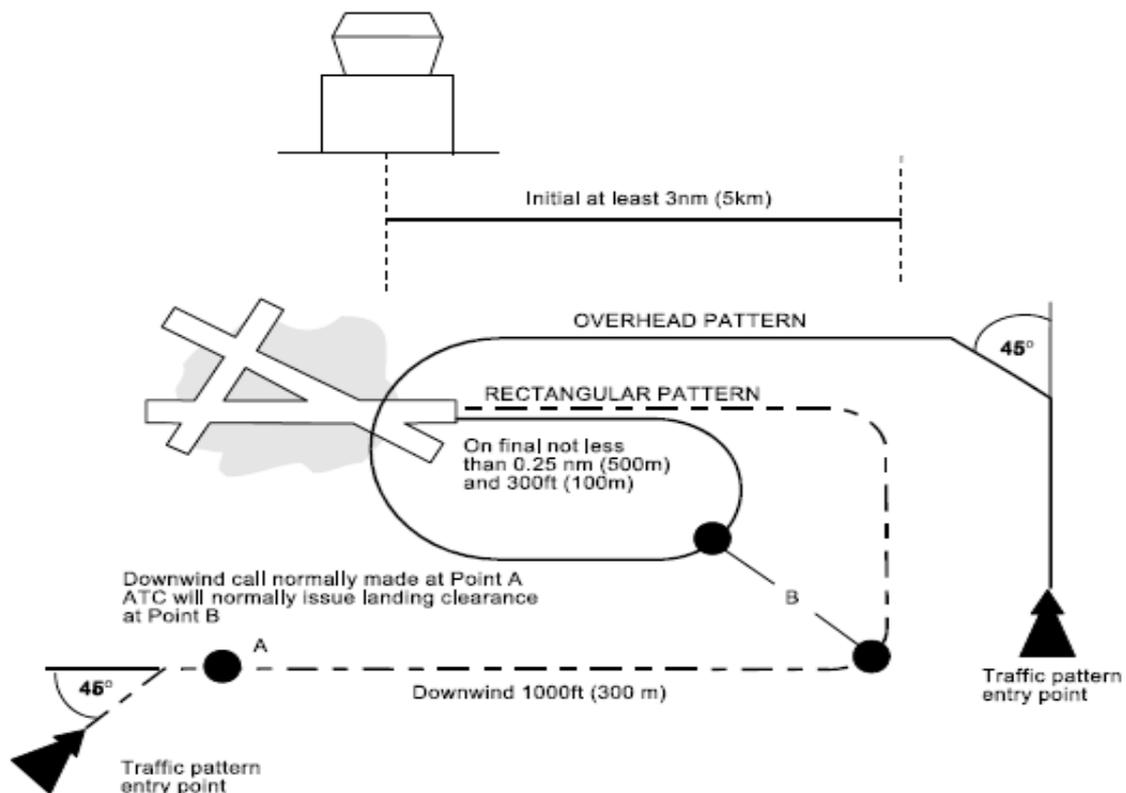
At the time of the Airprox, regulation and guidance for the conduct of visual joins was contained in JSP 552.320.105.4, which has since been carried forward into MAA RA 3020 and associated MAA MATM Chapter 20 Para 11. These documents state that the ‘NATO standard visual aerodrome cct and landing patterns ‘...are to be implemented, except for the authorised single-Service procedures’ and that ‘clearance from ATC for the aircraft to enter the pattern **should** include items of essential information regarding the circuit direction, runway in use and number and position of all aircraft ahead which have not touched down.’ That said, there are no single-Service variations contained within either JSP 552.320.105 or MAA RA 3020 and associated MAA MATM Chapter 20 Para 11. Moreover, the only UK variation to the NATO procedure that is germane to the current investigation is that the ‘downwind call is required to be made when abeam the upwind threshold of the RW in use.’ No variation is listed for the operation of an oval cct. Whilst the NATO cct pattern at Figure 1 is predicated on a rectangular cct, rather than the oval cct in common use by the UK military, the information relating to downwind join ground tracks and the ATM aspects appear to be able to be carried across to UK mil ATM procedure. However, based upon a quick straw-poll, current mil ATM practice sees controllers pass position information to ac joining through Initial, rather than all ac conducting a visual join.

At the time of the Airprox, regulation and guidance for the conduct of visual joins was contained in JSP 552.320.105.4, which has since been carried forward into MAA RA 3020 and associated MAA MATM Chapter 20 Para 11. These documents state that the 'NATO standard visual aerodrome cct and landing patterns '...are to be implemented, except for the authorised single-Service procedures' and that 'clearance from ATC for the aircraft to enter the pattern **should** include items of essential information regarding the circuit direction, runway in use and number and position of all aircraft ahead which have not touched down.' That said, there are no single-Service variations contained within either JSP 552.320.105 or MAA RA 3020 and associated MAA MATM Chapter 20 Para 11. Moreover, the only UK variation to the NATO procedure that is germane to the current investigation is that the 'downwind call is required to be made when abeam the upwind threshold of the RW in use.' No variation is listed for the operation of an oval cct. Whilst the NATO cct pattern at Figure 1 is predicated on a rectangular cct, rather than the oval cct in common use by the UK military, the information relating to downwind join ground tracks and the ATM aspects appear to be able to be carried across to UK mil ATM procedure. However, based upon a quick

Figure 1: NATO Standard VFR Traffic Landing Pattern – Fixed Wing

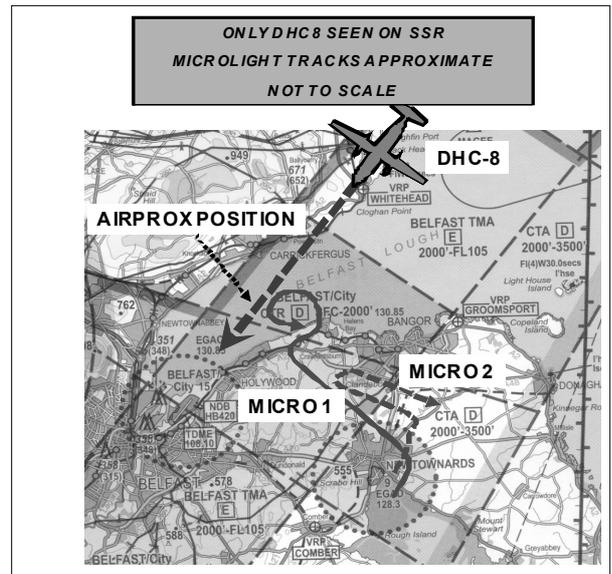
Date/Time: 6 June 2011 1046Z
Position: 5441N 00549W (Belfast City
 5nm final RW22 - elev 15ft)
Airspace: Belfast City CTR (Class: G)
Reporting Ac **Reported Ac**
Type: DHC-8 A22 Microlight
Operator: CAT Civ Pte
Alt/FL: 1500ft 800ft
 (QNH 1006mb) (QFE NK)
Weather: NK CLBC VMC CLBC
Visibility: 30km 20km
Reported Separation:
 0ft V/0.5nm H 0ft V/1.5nm
Recorded Separation:
 NR V/0.5nm H

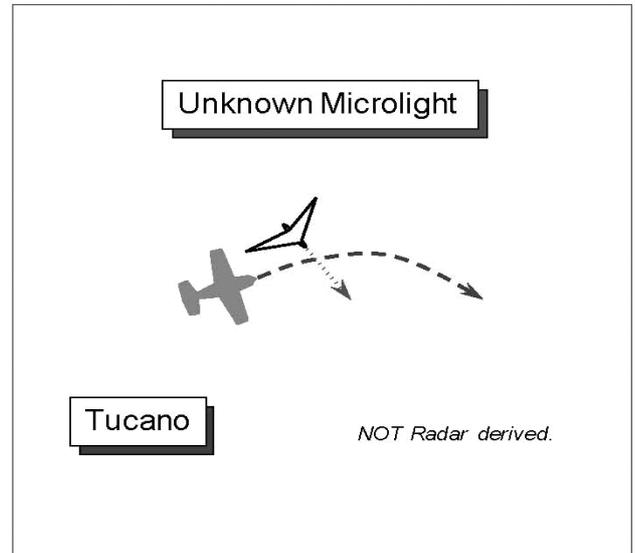
Date/Time: 6 Jun 2011 1207Z
Position: 5406N 00105W
 (7.5nm E of Linton-on-Ouse)
Airspace: Vale of York AIAA (Class: G)
Reporting Ac Reported Ac
Type: Tucano T Mk1 Microlight
Operator: HQ Air (Trg) Civ Club
Alt/FL: 2500ft NR
 RPS (1002mb) NR
Weather: VMC CLBC VMC CLOC
Visibility: 40km 15nm
Reported Separation:
 200ft V/nil H Not seen
Recorded Separation:
 Not recorded

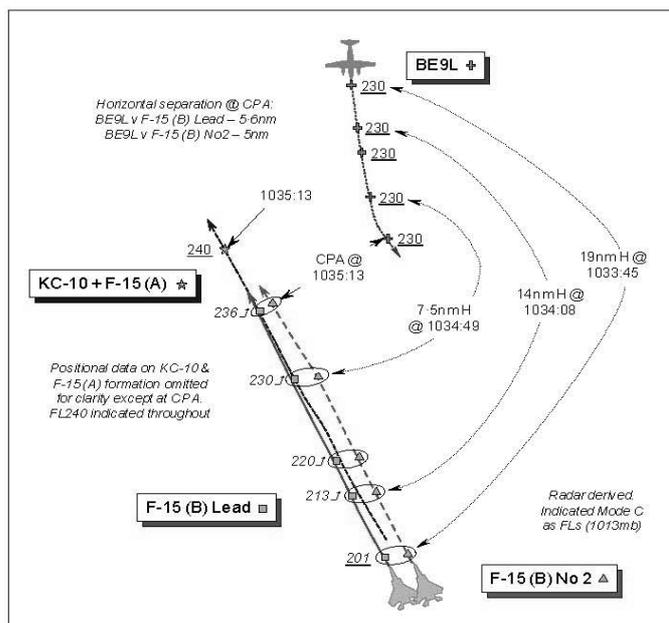
Date/Time: 4 Jun 2011 1035Z (Saturday)
Position: 5545N 00213W
(10nm S of ST ABBS VOR)
Airspace: Scottish FIR (Class: C)
Reporting Ac Reported Ac
Type: BE9L F-15E x2
Operator: Civ Exec Foreign Mil
Alt/FL: FL230 FL210↑
Weather: VMC CLAC NR
Visibility: 50km NR
Reported Separation:
1000ft V/5nm H NR
Recorded Separation:
BE9L v F-15 (B) Lead: 600ft V/5.6nm H
BE9L v F-15 (B) No2: N/K V/5nm H

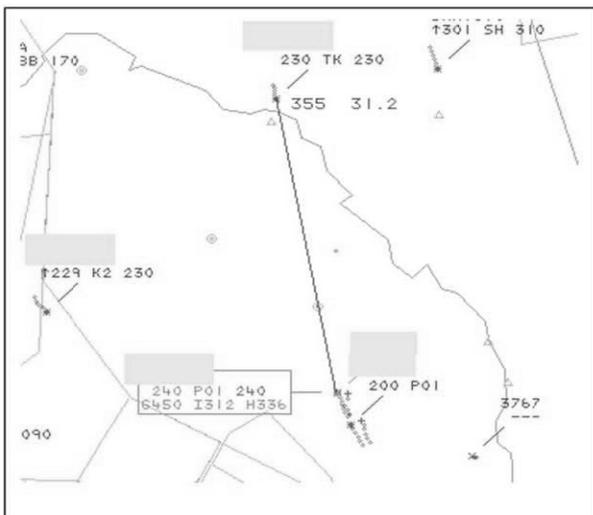
(PC MRT 1032:27)

The TAY SC requested, "Co-ordination against the [BE9L C/S] then, not above 2 3 and you're not below 2 4 is that correct?" The Scottish Military controller read back the co-ordination request and the conversation ended with the TAY SC stating, "that's co-ordinated". At 1028:40, TAY SC passed TI to the BE9L pilots, "traffic information about 4 or 5 minutes you may see ... an American fighter and a D C 10 they'll be a thousand feet above you." The KC-10 and F-15 (A) formation was now overhead Newcastle and 75nm ahead of the BE9L. The formation was now maintaining FL240. The BE9L crew asked if the traffic would be on the aircraft's left-hand side, to which the controller replied, "no ... they're in your 12 o'clock at the moment...its reciprocal". Scottish (Mil) telephoned the TAY Sector at 1032:29 and requested the TAY SC identify another two F-15s, "[F-15 (B) flight C/S] southeast of the [KC-10 and F-15 (A) formation C/S]". F-15 (B) flight had now decreased its distance behind the KC-10 and F-15 (A) formation to 3.4nm. The BE9L was 31nm N of the KC-10 and F-15 (A) formation.

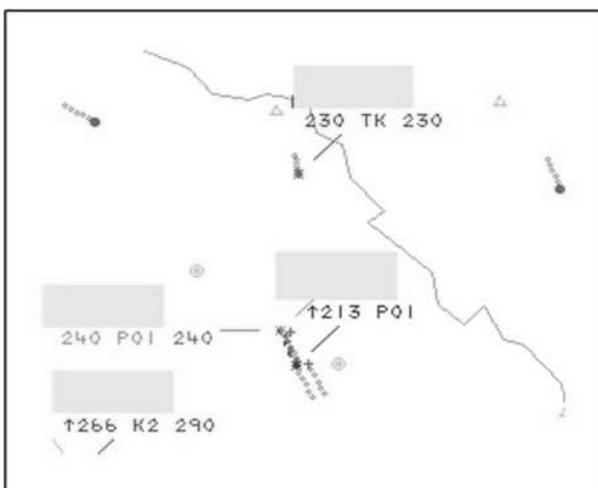
(PC MTRT 1034:10)

At 1033:52 the Mode C of F-15 (B) flight leader indicated that the transponding ac had commenced a climb from FL200 and was now passing FL203; at 1034:08 it was indicating Mode C of FL213, climbing, STCA then activated between F-15 (B) flight and the KC-10 and F-15 (A) formation ahead

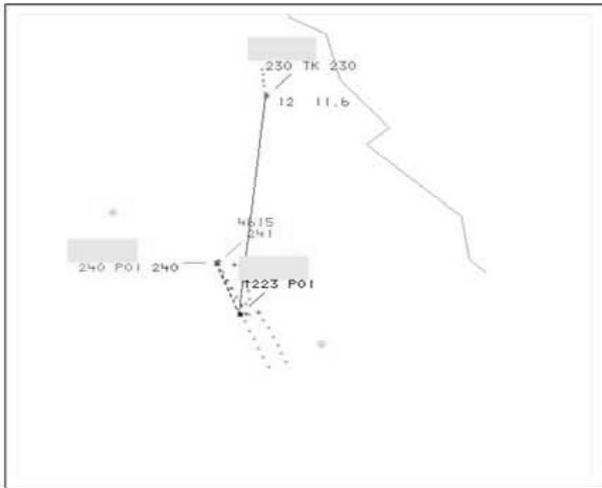
(PC MRT 1034:25)

At 1034:49, F-15 (B) flight leader's Mode C indicated the ac were at the same level as the BE9L, still in the BE9L's 1 o'clock, range 7.7nm. The aircraft were about 45nm N of Newcastle at FL230 in Class C controlled airspace.

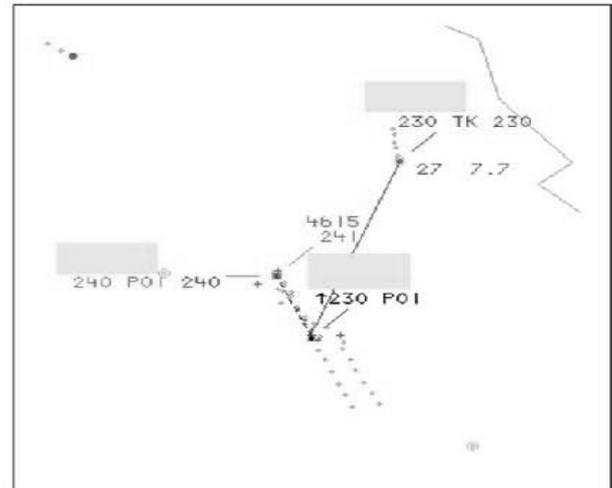
(PC MRT 1034:49)

Minimum separation between F-15 (B) flight and the BE9L occurred at 1035:13 with 5nm between the nearest aircraft and 600ft indicated against the leader's Mode C. Subsequently, F-15 (B) flight levelled at FL239 behind the leading formation. At 1035:39, TAY SC informed the BE9L pilot that his ac was now clear of the traffic and instructed the flight to resume its own navigation.

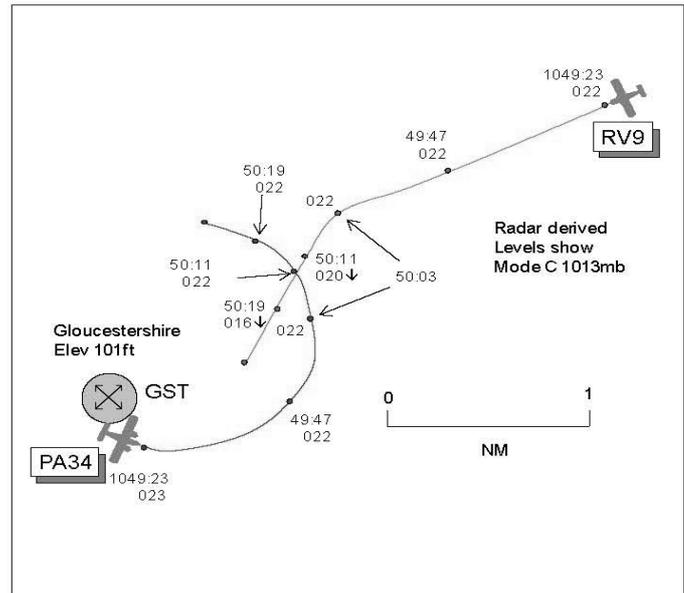
Date/Time: 2 Jun 2011 1050Z
Position: 5154N 00209W (1.25nm NE Gloucestershire - elev 101ft)
Airspace: LFIR (Class: G)
Reporting Ac **Reported Ac**
Type: Vans RV9 PA34
Operator: Civ Pte Civ Trg
Alt/FL: 2700ft ↓2800ft
 (QNH 1034mb) (QNH 1034mb)
Weather: VMC CLBC IMC IICL
Visibility: 15nm 10km
Reported Separation:
 Nil V/NR H Not seen
Recorded Separation:
 >200ft V/<0.1nm H

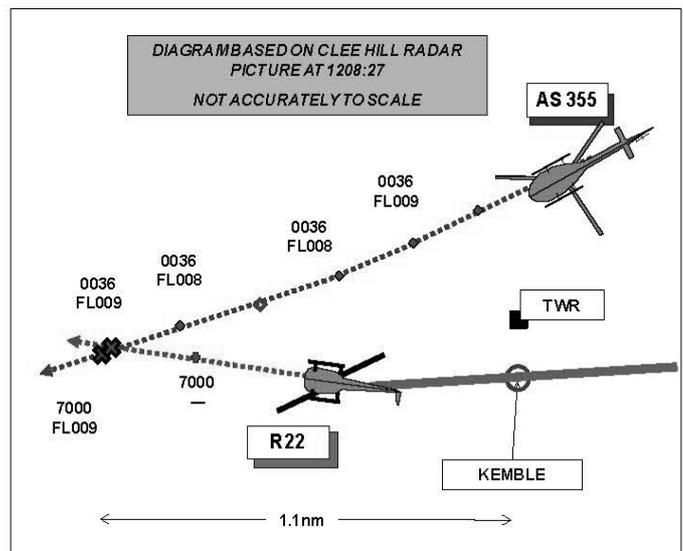
Date/Time: 23 Jun 2011 1208Z
Position: 5140N 00206W
 (1nm W of Kemble - elev 433ft)
Airspace: Kemble ATZ (Class: G)
Reporting Ac **Reported Ac**
Type: AS355 R22
Operator: Civ Comm Civ Pte
Alt/FL: 700ft 800ft
 (N/K) QNH (1014mb)
Weather: VMC CLBC VMC CLBC
Visibility: >10km 999
Reported Separation:
 30ft V/0ft H 80ft V/100ft H
Recorded Separation:
 0 V/ <0.1nm H

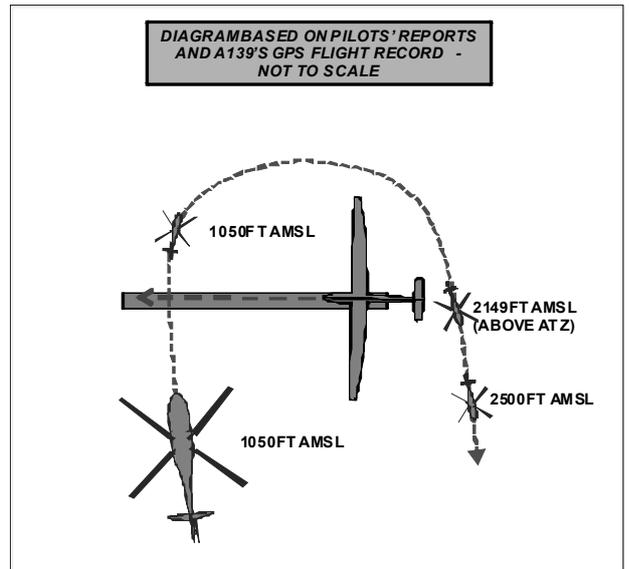
Date/Time: 19 Jun 2011 1355Z (Sunday)
Position: 5101N 00238W
 (RNAS Yeovilton - elev 75ft)
Airspace: ATZ (Class: G)
Reporting Ac Reported Ac
Type: SZD-50 Glider AW139
Operator: Civ Club NK
Alt/FL: 500ft NK
 (QFE NK) NK
Weather: VMC CLBC VMC CLBC
Visibility: >5nm 10km
Reported Separation:
 500ft V/0.5nm H NK
Recorded Separation:
 Est 800ft V/NR H

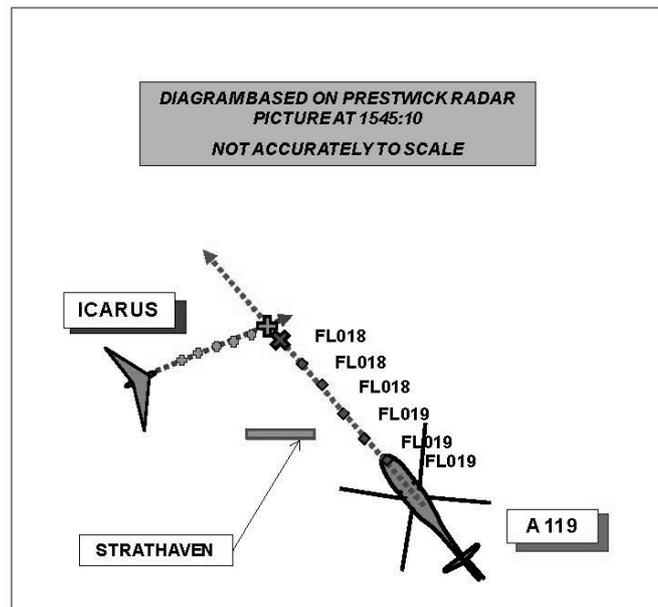
Date/Time: 20 Jun 2011 1545Z
Position: 5541N 00406W
 (Strathaven RW27 RH cct - elev 847ft)
Airspace: Scot FIR (Class: G)
Reporting Ac Reported Ac
Type: Ikarus C42 Agusta 119
Operator: Civ Club Civ Pte
Alt/FL: 800ft 1968ft
 QFE (NK) QNH (NK)
Weather: VMC CAVOK VMC CAVOK
Visibility: NR >10km
Reported Separation:
 200ft V/0ft H 350ft V/ 2000-3000m H
Recorded Separation:
 NR V/<0.1nm H
