UK AIRPROX BOARD

Analysis of Airprox in UK Airspace

Report Number 6

January 2001 to June 2001

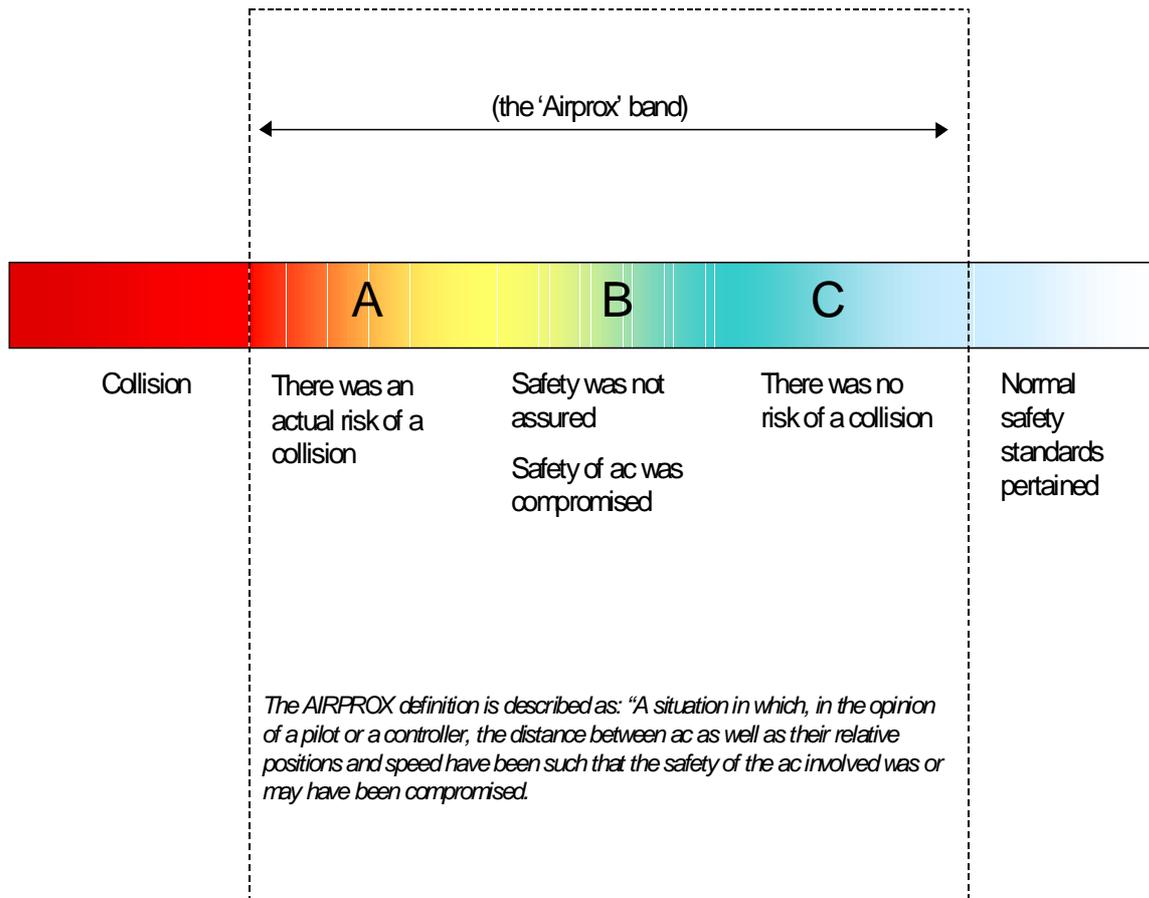
A pictorial representation of the Airprox risk band is shown below:

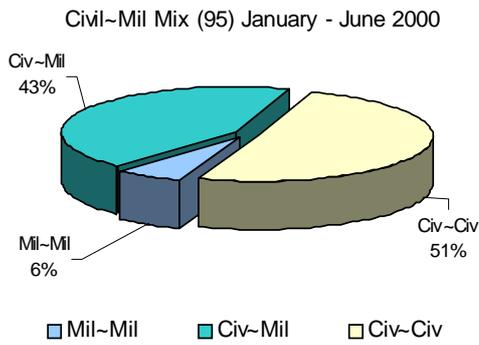
Figure 1

There were 101 Airprox between January and June 2001, compared with 95 in the same period last year. Broad percentage changes in the 'mix' can be seen from the pie charts at *Fig 1 and Fig 2* below, while *Tables 1 and 2* provide the detail. Note that up to the end of March, totals were the same in both years. Slight reductions in Civil~Military and Civil~Civil encounters were absorbed by a larger 'slice' depicting Military~Military incidents

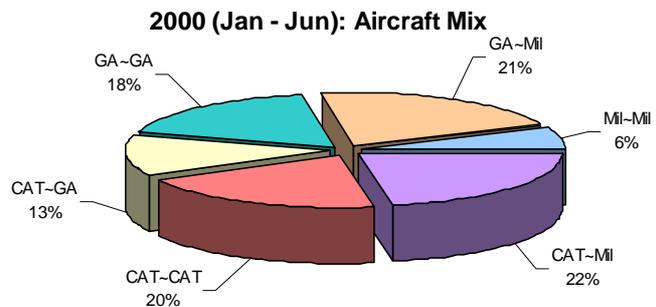
Figure 3

A further breakdown of results is shown in the pie charts at *Fig 3 and Fig 4*. These allow a comparison in percentage terms of how the three groups interacted with each other.

Most change can be seen in CAT aircraft involvement, which reduced by 14 points from 55% to 41%. Smaller 'slices' in the pie, against both GA and Military elements, depict this shrinkage in pictorial terms.

In contrast, there was little change to the overall results for GA involvement. This went up 1 point only after taking into account some plus and minus adjustments against the other 2 groups.

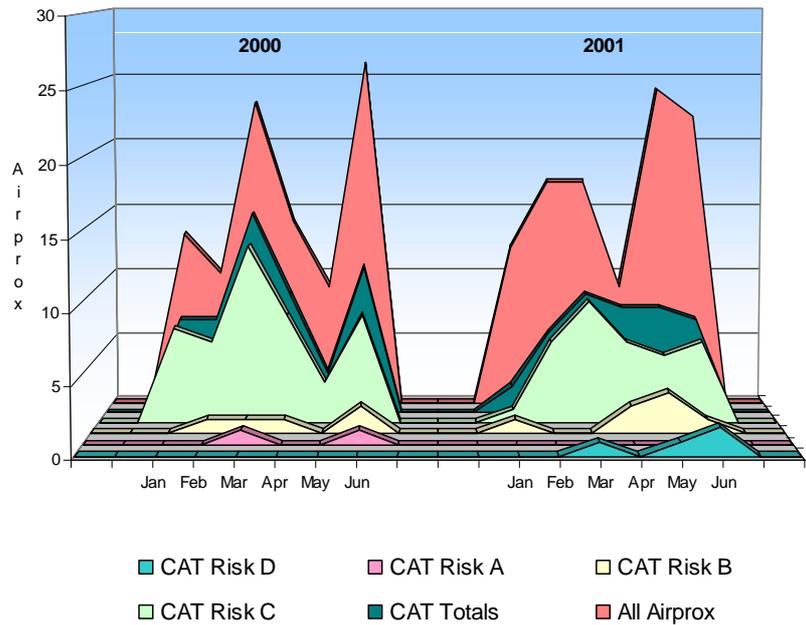
Figure 5

Fig 5 shows CAT results for both years, which allows 'snapshot' comparisons to be made. Tables 3 and 4 (below) give added detail.

CAT incidents fell by 15%, but the monthly CAT profile did not mimic the 'All Airprox' total as it did in 2000. Of note, there were no Risk A cases, while Risk B findings rose by 2. Most encounters ended without any collision risk although, unusually, there were 4 where risk could not be determined owing to insufficient information.

CAT Involvement in Airprox: January - June in 2000 and 2001

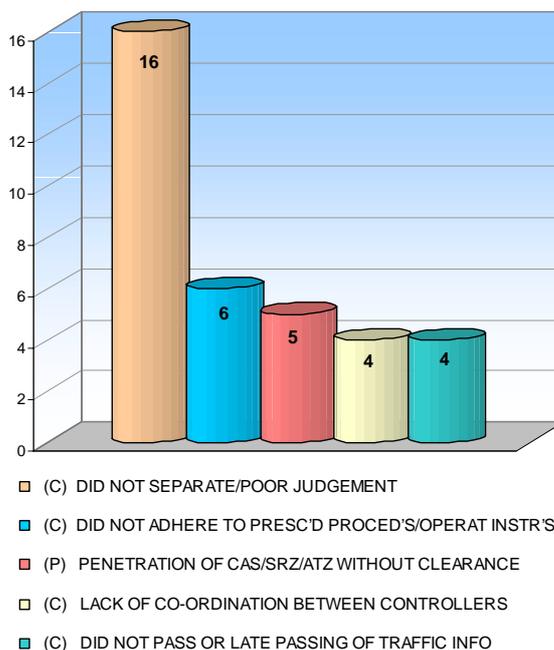
Figure 6

CAT Cause Results: January - June 2001

86 causal factors emerged from the 44 CAT encounters during the period. Various failures in airborne and ground systems each accounted for 2 factors and 7 other miscellaneous reasons also featured. However the majority was attributed either to controllers or pilots where the split was 49 to the former and 26 to the latter.

Fig 6 depicts the leading 5 causes and only those factors with 4 or more examples are shown. The most common reason remains unchanged from last year, but 'level busts' have dropped out of the picture, together with factors connected with incidents outside controlled airspace. Their places have been filled instead with more 'controller' involvement.

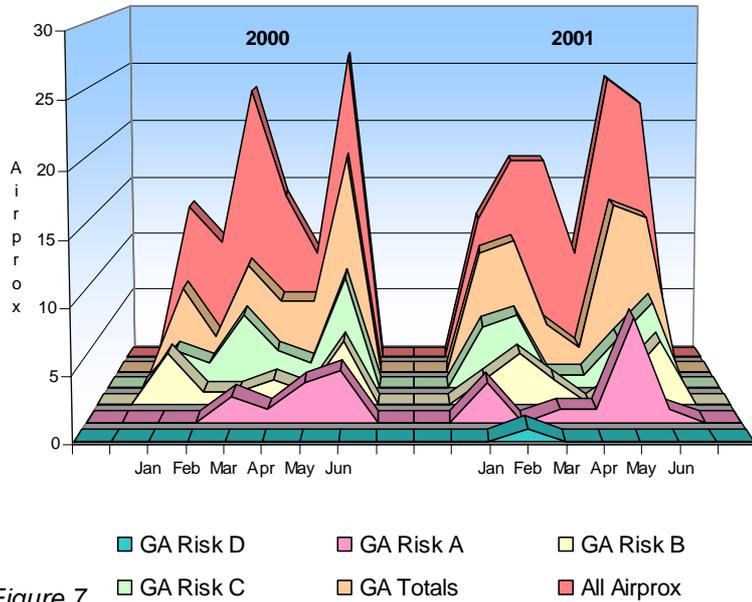
Figure 7

Fewer incidents during March and April 2001 produced the curious bite in the GA total profile shown at Fig 7. Figures then adjusted sharply upwards in May accompanied by a sudden and unwelcome increase in Risk A incidents. These peaked at 8 before falling back again equally abruptly and correlate closely with Military results.

Throughout the period Risk B and Risk C returns were very much in line with those experienced during the first half of 2000; unlike 2000 there was one Risk D case.

GA Involvement in Airprox: January - June in 2000 and 2001

May 2001 was a critical month in which Risk A numbers displaced Risk C returns; both the 'A' spike and the 'C' plateau stand out on the chart. Interestingly, a similar jump in collision risk figures shows up in the GA chart (previous page) and had much to do with improved weather at the time. One encounter attracted a Risk D assessment.

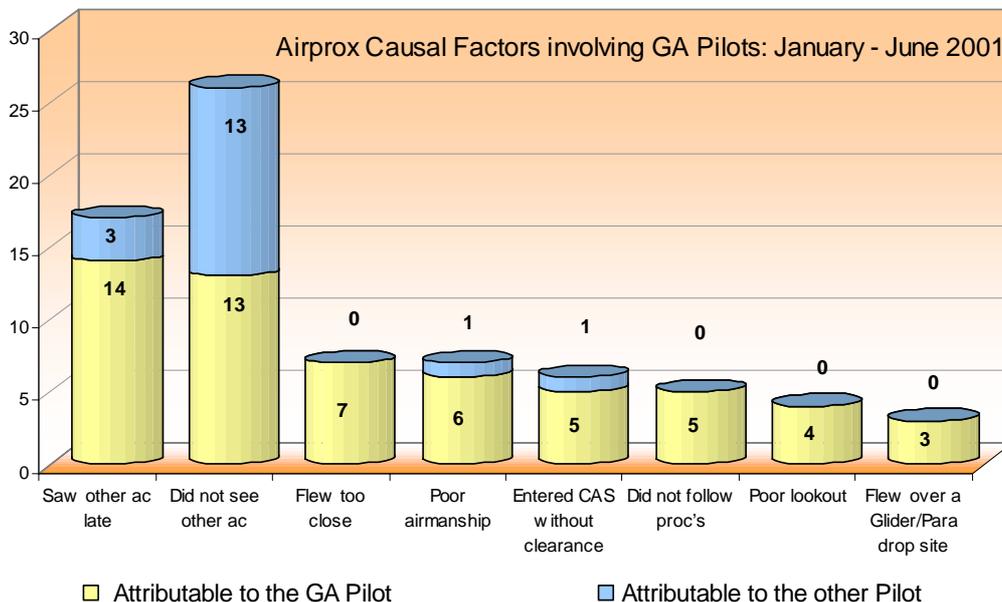
Figure 8

Fig 8 shows the main reasons for encounters involving GA pilots - and who caused them.

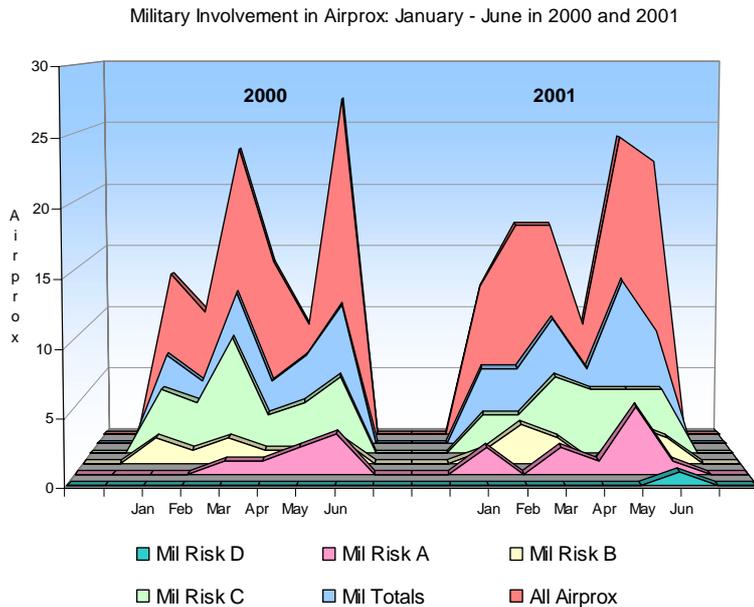
Figure 9

Fig 9 illustrates half-year results, while further detail is set out in Tables 7 & 8. Military totals (up 3) accounted for half the 'All Airprox' tally and Military risk distribution shifted.

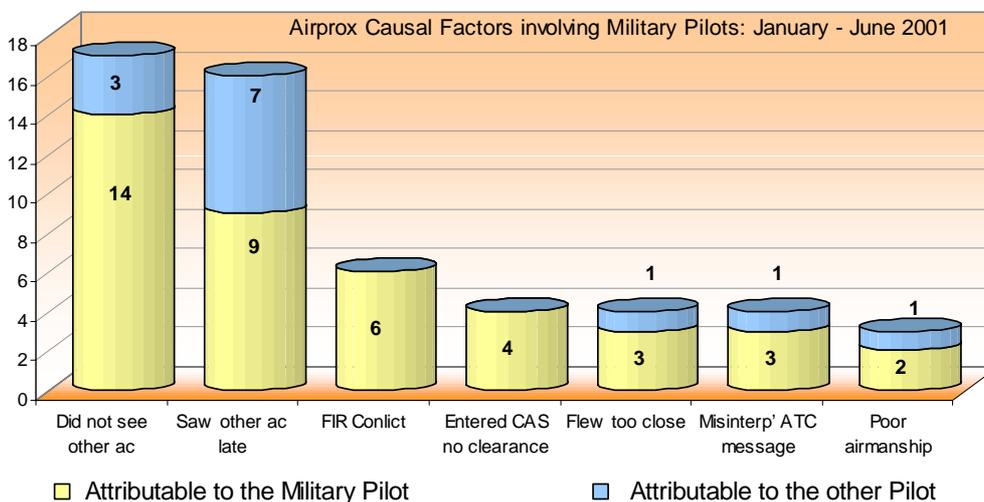
Figure 10

Fig 10 shows the most common reasons for encounters involving Military pilots with a proportional indication on cause.

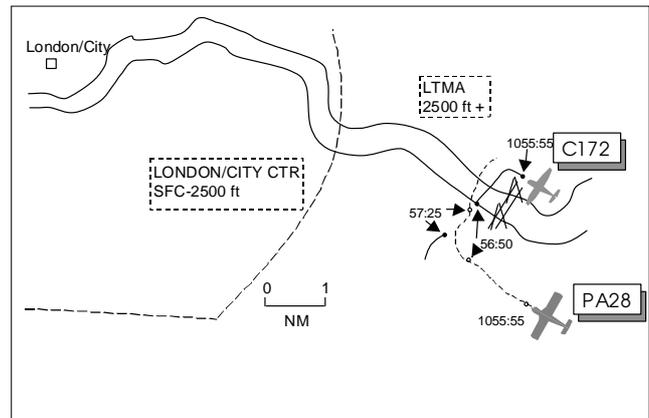
UKAB Note: Replay of the Heathrow radar at 1055:55 shows a primary response, believed to be the PA28, 1.75 NM S of the Dartford Bridge tracking NW with another primary only response, believed to be the C172, 0.5 NM N of the bridge in a L turn passing NW. At 1056:50, the C172 fades from radar W Abm the bridge steady on a SW track as the PA28 commences a R turn 1 NM SW of the bridge. The close encounter is not observed on radar except for the PA28, at 1057:14, executing a tight R turn towards the NE before turning L onto a N track; this is believed to be the Airprox avoiding action manoeuvre as described by the reporting pilot. 10 seconds later, the C172 reappears on radar 0.65 NM SW of the PA28.

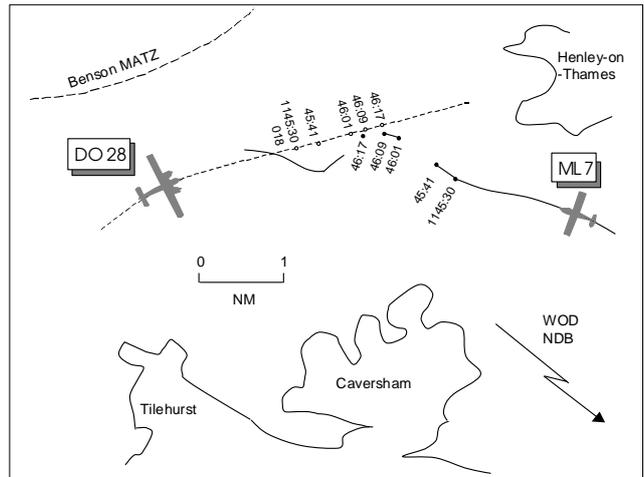
UKAB Note (4): Analysis of the Heathrow radar recording at 1145:30 shows a 7000 squawk, believed to be the DO28, at 1800 ft Mode C (2400 ft QNH 1035) tracking 085° 6.5 NM SE of Benson with a primary only return, believed to be the ML7, 2 NM to its E tracking 315°. The ML7 fades from radar 11 seconds later and pops up again at 1146:01 in the DO28's 1 o'clock range 0.6 NM on a converging track. The ML7 again fades from radar 8 seconds later 0.25 NM SE of the DO28 and intermittently appears at 1146:17, 0.25 NM behind the DO28. The encounter, as described by the DO28 pilot, is not observed on radar.

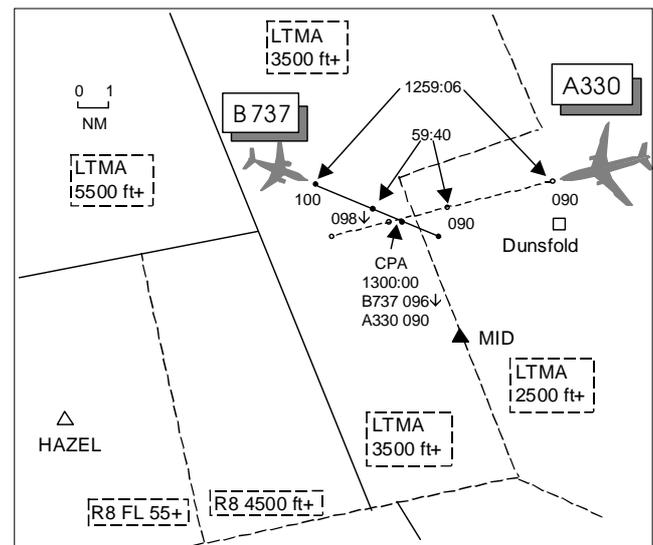
THE LATCC TC WILLO SECTOR CONTROLLER reports he descended the B737 to FL 100 inbound to Gatwick having agreed coordination with the Ockham SC who was climbing the A330 to FL 90. He then descended the B737 to FL 90 prematurely and this, coupled with the speed of the B737, resulted in an erosion of standard separation against the A330.

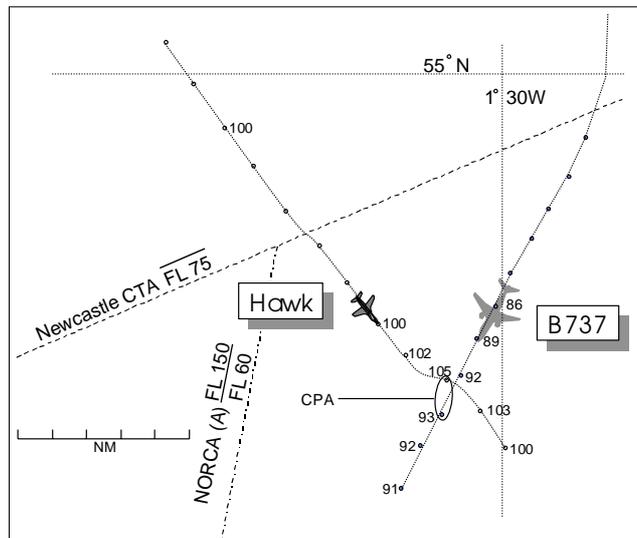
The ScATCC recording of the Great Dun Fell Radar (the radar and display system that ALLOC was using) shows the B737 in the Hawk’s 10 o’clock at 6.5 NM passing FL 54 and also partially obscured by merging traffic; the B737’s radar trail dots do not give a clear indication that the ac is turning. At 1207:28, after the landline conversation had terminated, the Hawk is about 1.5 NM SE of Newcastle descending through FL 110 with one contact 1 NM to the NW and another 1.5 NM to the E. The B737 is exiting the Newcastle Zone between the Hawk’s 10 and 11 o’clock at 6 NM and in a tighter right turn; there are 3 further tracks cluttering the picture 5 NM S of the B737, 2 of which are tracking NW towards the Hawk and B737. At 1207:41, the Hawk is 4 NM SE of Newcastle passing FL 106 with the B737 in its 11 o’clock at 4 NM climbing through FL 75; the B737 is badly obscured by one track to the NW at 1 NM and 2 tracks 2 NM to the SSE tracking NW. At 1208:15, the time of ALLOC’s attempted avoiding action/TI, the Hawk has levelled at FL 100 with the B737 left of its 12 o’clock at 1 NM climbing through FL 89 tracking 225°.

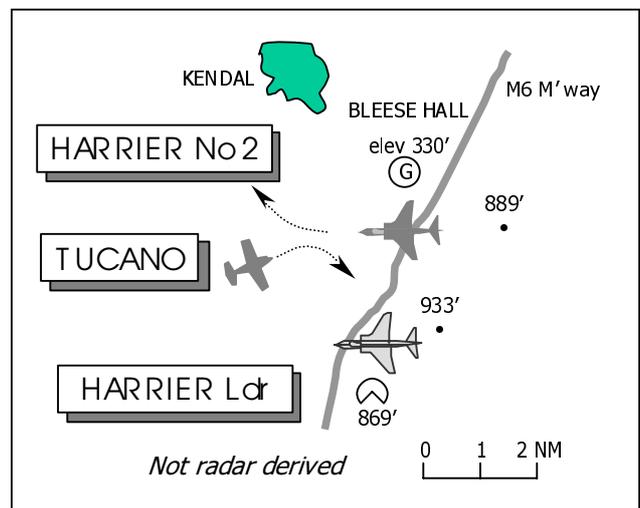
THE TUCANO PILOT, a QFI, was occupying the

rear seat whilst conducting the low-level section of a final navigation test at 250 ft msd. The ac has a high-conspicuity black colour scheme and high-intensity sidelights were on. Whilst approaching

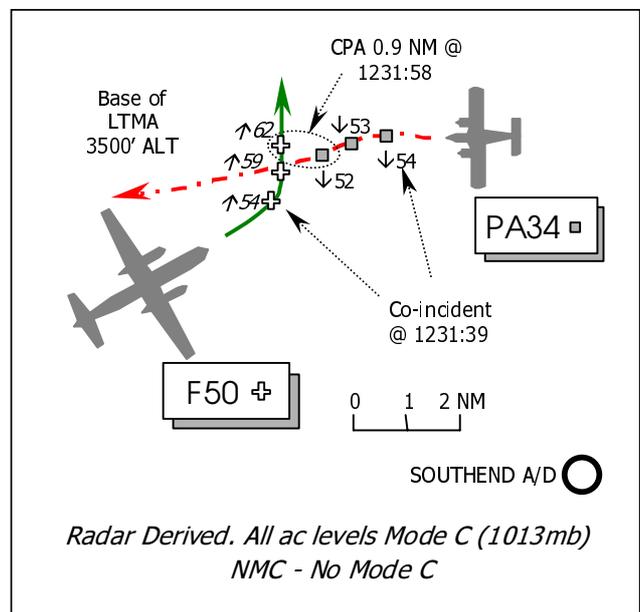
<u>First Aircraft</u>	<u>Second Aircraft</u>
<u>Type:</u> F50	PA34 Seneca II
<u>Operator:</u> CAT	Civ Pte
<u>Alt/FL:</u> ↑ FL110	3000 ft (QNH)
<u>Weather:</u> VMC NR	VMC
<u>Visibility:</u> >10 km	Not reported
<u>Reported Separation:</u>	
	3-500 ft V, 1 NM H Not seen
<u>Recorded Separation:</u>	1000 ft V @ 0.9 NM H

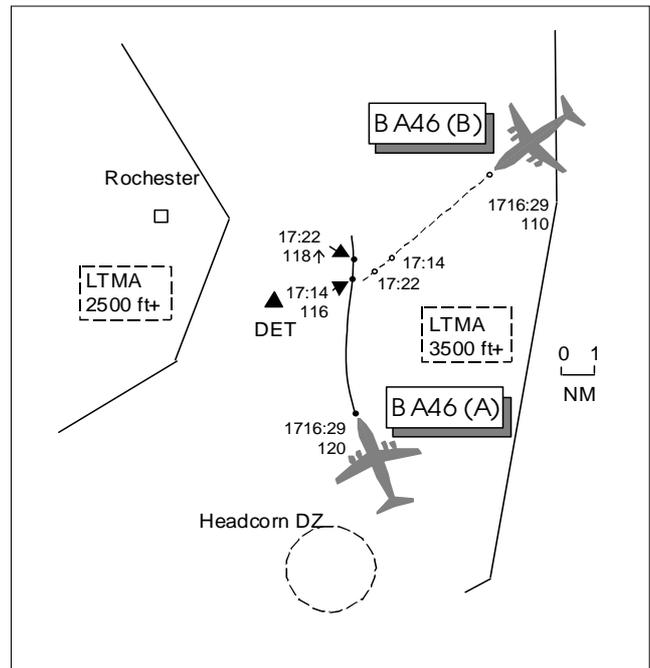
AIRPROX REPORT No 20/01

Date/Time: 18 Feb 1717 (Sunday)
Position: 5119 N 0040 E (3 NM ENE DET VOR)
Airspace: TMA (Class: A)
Reporter: LATCC TC
First Aircraft Second Aircraft
Type: BA46 (A) BA46 (B)
Operator: CAT CAT
Alt/FL: ↓ FL 90 FL 110
Weather VMC CAVOK VMC CAVOK
Visibility: 50 km 50 km
Reported Separation: 700 ft V 0 H/700 ft V 1 NM H
Recorded Separation: 800 ft V 0.8 NM H

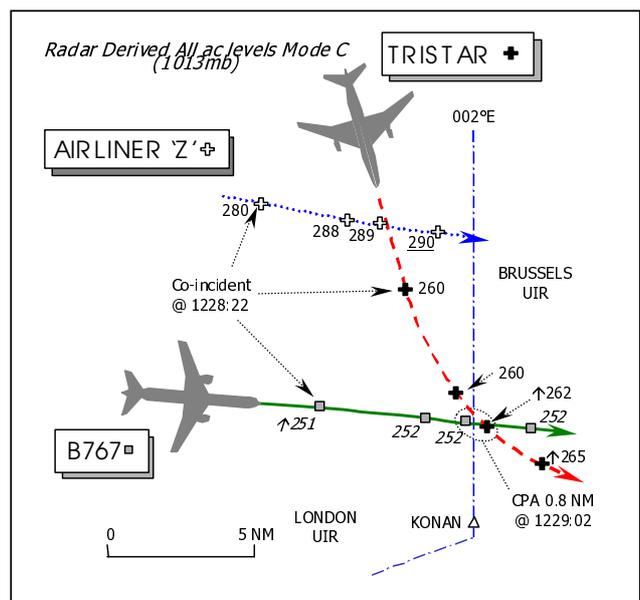
AIRPROX REPORT No 23/01

Date/Time: 17 Feb 1228 (Saturday)
Position: 5111 N 0200 E (3.5 NM N of KONAN)
Airspace: UAR – UG1 (Class: B)
Reporting Aircraft Reported Aircraft
Type: B767 L1011
Operator: CAT Foreign Mil
Alt/FL: FL 252 ↑ ↑ FL 280
Weather: VMC CAVOK Not reported
Visibility: >50 km Not reported
Reported Separation:
 <50 m H, 800 ft V Not reported
Recorded Separation: 0.8 NM H, 1000 ft V

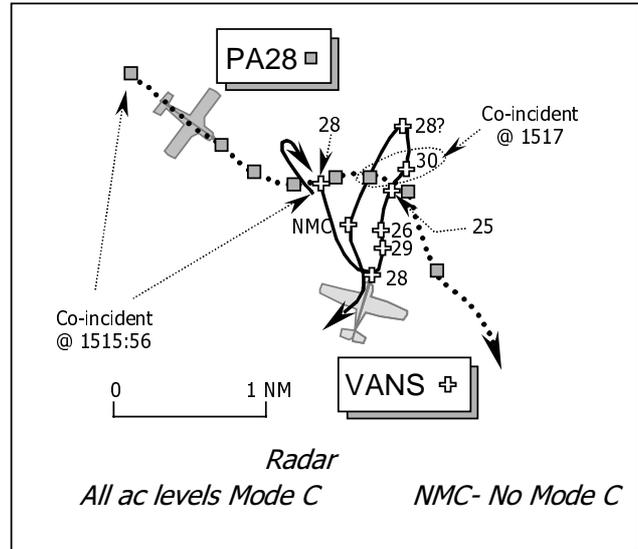
AIRPROX REPORT No 29/01

Date/Time: 24 Feb 1517 (Saturday)
Position: 5322 N 0058 W (6.75 NM NE of GAMSTON VOR)
Airspace: London FIR (Class: G)
Reporting Aircraft Reported Aircraft
Type: PIPER PA28 VANS RV4
Operator: Civ Pte Civ Pte
Alt/FL: 3300 ft 4000ft↓↑
(RPS 1010 mb) (Gamston QNH)
Weather VMC CLBC VMC No Cloud
Visibility: >10 km >10 km
Reported Separation:
100 m H, nil V 100 m+
Recorded Separation: not recorded

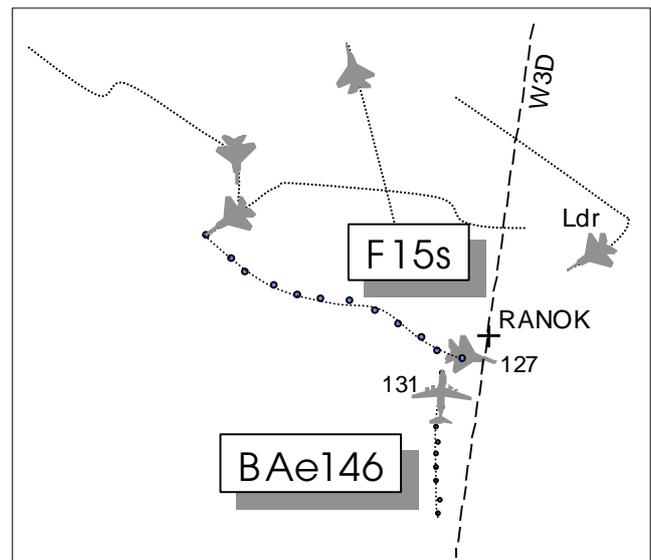
AIRPROX REPORT No 33/01

Date/Time: 2 Mar 1058
Position: 5640 N 0417 W (2 NM SW of RANOK)
Airspace: ADR W3D (Class: F)
Reporting Aircraft Reported Aircraft
Type: BAe146 F15 x 6
Operator: CAT Foreign Mil
Alt/FL: FL 140-110↓ Various (SPS 1013 mb)
Weather VMC CLOC VMC CLOC
Visibility: 10 km NK
Reported NK
Separation: /4000 ft V
Recorded Separation: 1 NM, 400 ft V

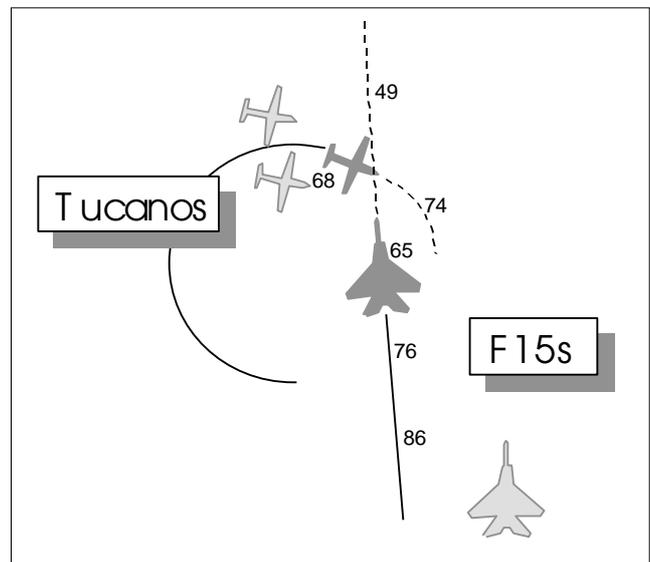
AIRPROX REPORT No 34/01

Date/Time: 8 Mar 1623
Position: 5412 N 0050 W (4 NM NNW of Malton)
Airspace: FIR (Class: G)
Reporting Aircraft Reported Aircraft
Type: Tucano F15
Operator: HQ PTC Foreign Mil
Alt/FL: 6000 ft FL 70 (RPS)
Weather VMC CLAC VMC
Visibility: Unltd
Reported 300 ft V
Separation: 2000 ft H, 500 ft V
Recorded Separation: NK

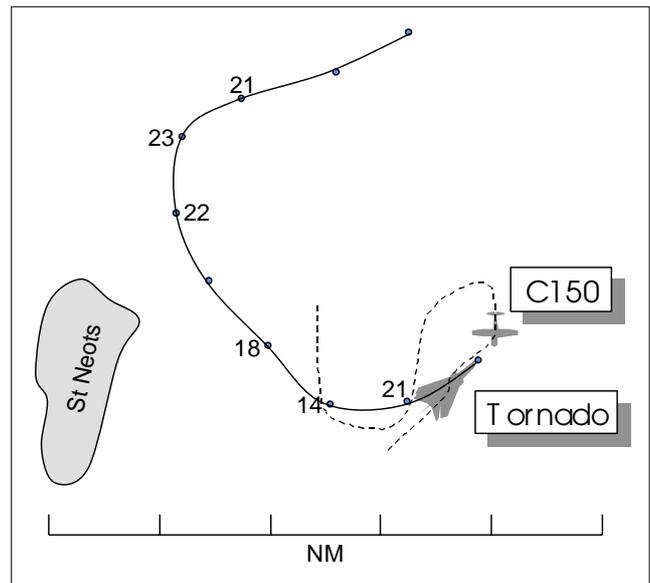
AIRPROX REPORT No 36/01

Date/Time: 15 Mar 1530
Position: 5213 N 0010 W (3 NM E of St Neots)
Airspace: FIR (Class: G)
Reporting Aircraft Reported Aircraft
Type: Tornado GR Cessna 150
Operator: HQ STC Civ Trg
Alt/FL: 2500ft ↑ 2300ft
(Rad Alt) (QNH)
Weather VMC HZBC VMC HZBC
Visibility: 6 km 7 km
Reported 150 ft V, 400 ft H
Separation: /20-50 ft V
Recorded Separation: NK

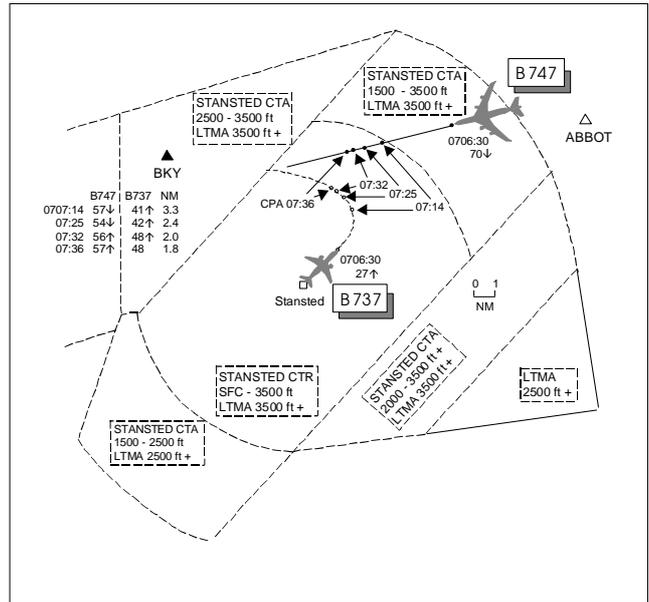
Recorded Separation: 900 ft V 1.8 NM H

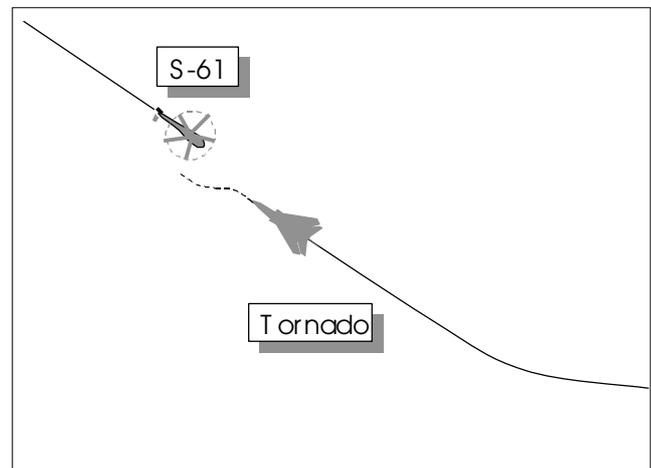
AIRPROX REPORT No 44/01

Date/Time: 26 Mar 1901 TWILIGHT
Position: 5700 N 0607 W (E of Rhum)
Airspace: FIR/LFS (Class: G)
Reporting Aircraft Reported Aircraft
Type: Tornado GR S61N
Operator: HQ STC Civ Comm
Alt/FL: 520 ft 1000 ft
(Rad Alt) (QNH 1011 mb)
Weather VMC CLBC VMC CLBC
Visibility: 20 km 10 km
Reported 0.3 NM, 80 ft V
Separation: /250 yd, 200 ft V
Recorded Separation: NK

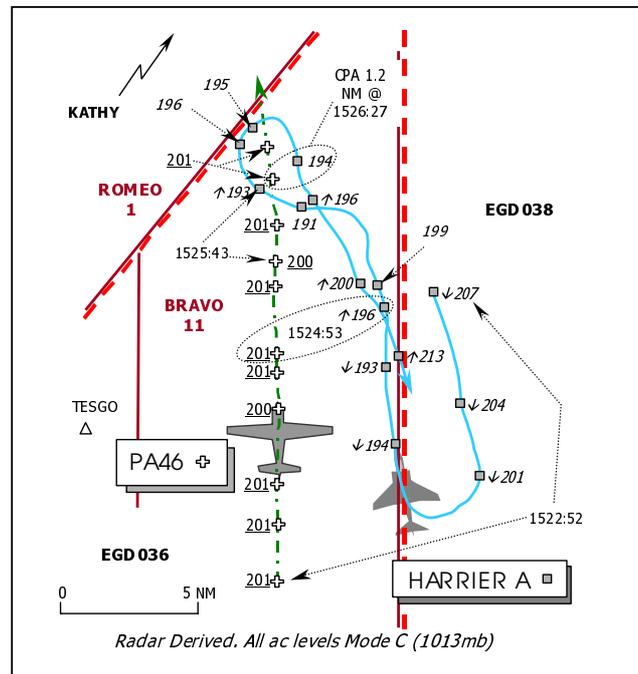
700 ft V, 1.2 NM H

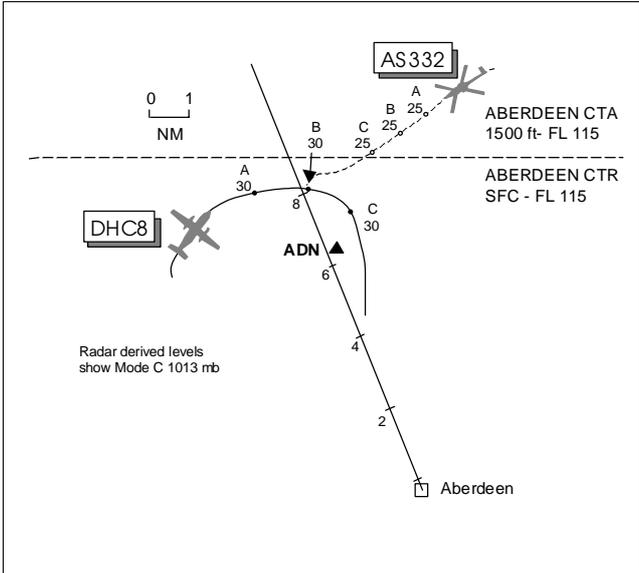
AIRPROX REPORT No 47/01

Date/Time: 28 Mar 0923
Position: 5720 N 0215 W (2 NM NNE ADN VOR)
Airspace: CTR (Class: D)
Reporter: Aberdeen APR
First Aircraft Second Aircraft
Type: DHC8 AS332
Operator: CAT CAT
Alt/FL: 2500 ft 2000 ft
(QNH 995 mb) (QNH 995 mb)
Weather IMC KLWD IMC KLWD
Visibility: NK NK
Reported NK NK
Separation:
Recorded Separation: 500 ft V 1.6 NM H

Lateral separation reduced to a minimum of 1.6 NM (diag. position C) before starting to increase again as the DHC8 turned R. Once again, the DHC8 did not appear to take up its assigned heading of 200° and appeared to settle on a S track. The APR continued its descent, to remain below the ILS GP, and instructed it to turn further R heading 210° but again the flight failed to capture the LLZ. The APR decided that a successful approach could not be achieved and instructed the flight to go-around. A further circuit and approach was carried out, which proved to be uneventful. In the meantime, the AS332 had also completed a successful ILS approach.

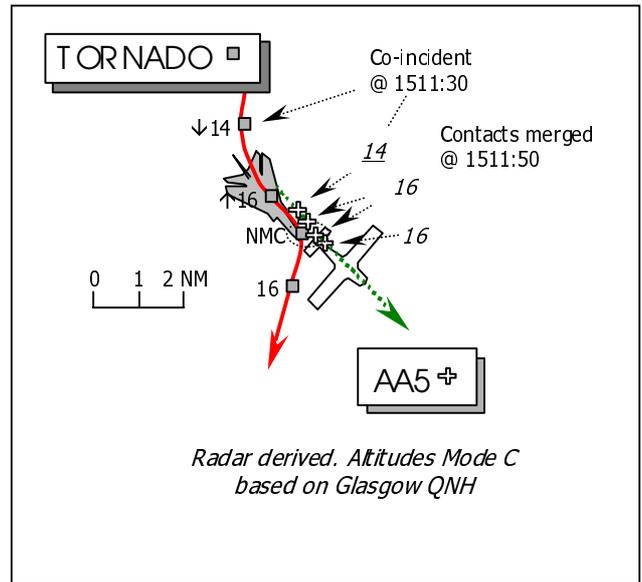
Contacts merged < 0.2 NM H/ nil ft V

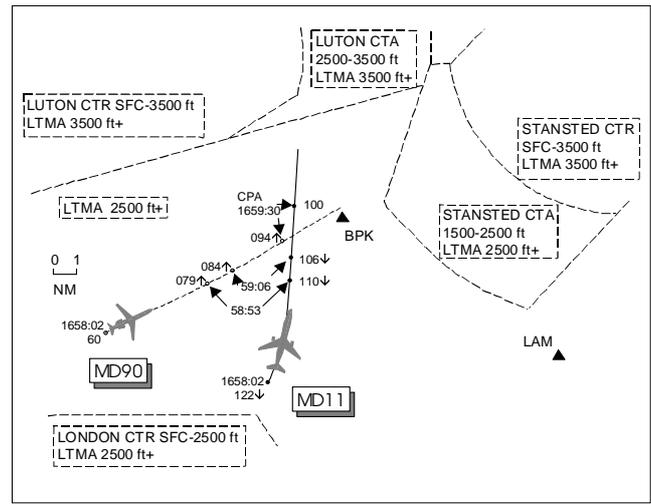
600 ft V 1.5 NM H

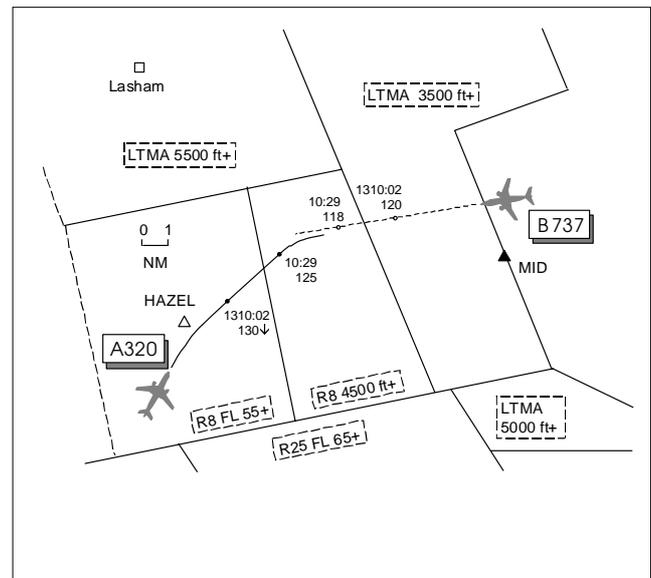
AIRPROX REPORT No 50/01

Date/Time: 31 Mar 1310 (Saturday)
Position: 5104 N 0050 W (8 NM W MID)
Airspace: CTA (Class: A)
Reporting Aircraft Reported Aircraft
Type: B737-400 A320
Operator: CAT CAT
Alt/FL: FL 120 ↓ FL 70
Weather VMC NK VMC NK
Visibility: >10 km >10 km
Reported Separation: 500 ft V 50 m H/700 ft V NK H
Recorded Separation: 700 ft V 2.8 NM H

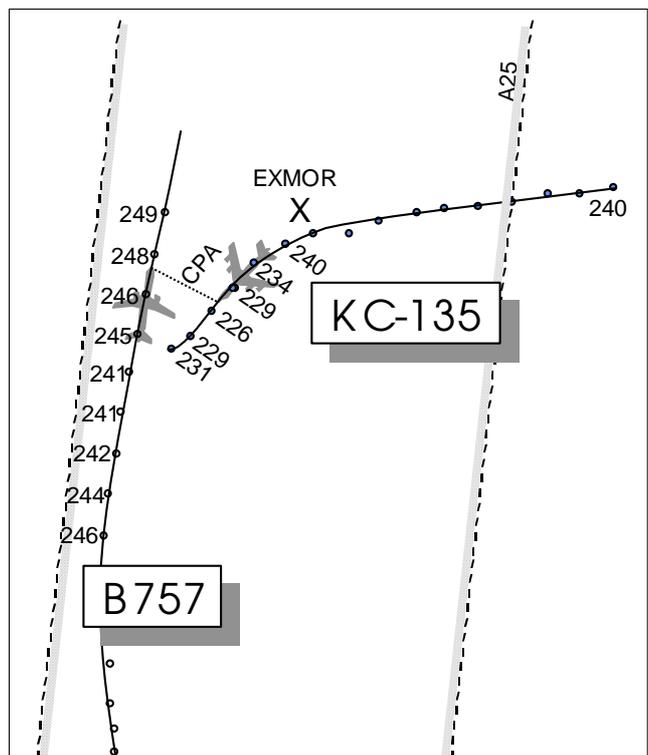
Date/Time: 23 Apr 1314
Position: 5108 N 0326 W (4 NM SW of EXMOR)
Airspace: Airway A25 (Class: A)
Reporting Aircraft Reporting Aircraft
Type: KC-135 B757
Operator: Foreign Mil CAT
Alt/FL: FL 240 FL 245 ↓
Weather VMC CLBC VMC CLOC
Visibility: Unltd 50 km
Reported Separation: 0.5 NM, 1000 ft+
Recorded Separation: 1.75 NM, 2000 ft

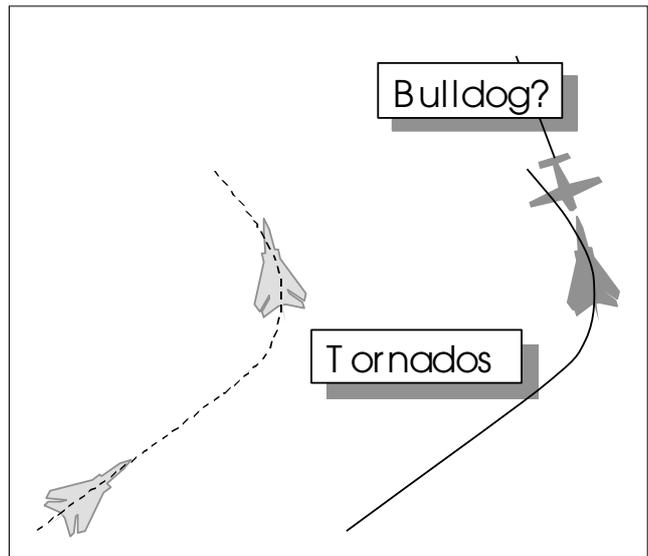
AIRPROX REPORT No 59/01

Date/Time: 1 May 1330
Position: 5650 N 0304 W (22 NM N of Dundee)
Airspace: LFS (Class: G)
Reporting Aircraft Reported Aircraft
Type: Tornado GR Untraced light ac
Operator: HQ STC
Alt/FL: 500 ft (Rad Alt)
Weather VMC CLNC
Visibility: 15 NM
Reported 150 ft V
Separation: /NK
Recorded Separation: NK

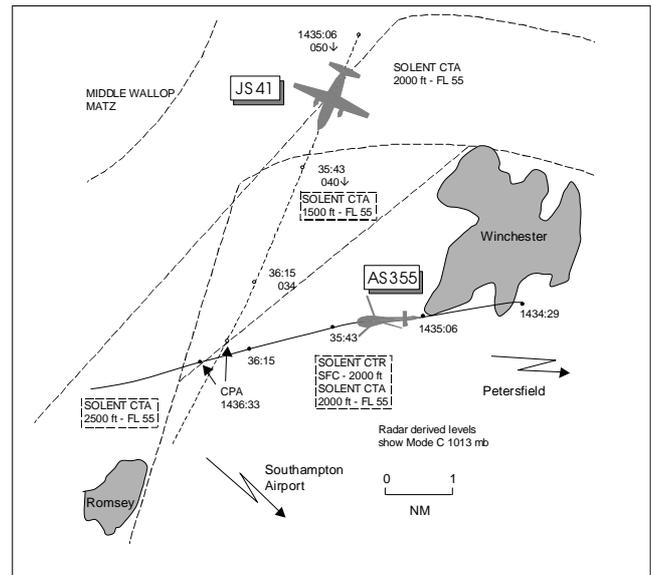
<u>Type:</u>	JS41	AS355
<u>Operator:</u>	CAT	Civ Pte
<u>Alt/FL:</u>	↓ 3500 ft (QNH 1017 mb)	2500 ft (QNH NK mb)
<u>Weather</u>	VMC CLBC	VMC CBLC
<u>Visibility:</u>	>10 km	>10 km
<u>Reported Separation:</u>	0 V 300 m H	not seen
<u>Recorded Separation:</u>	NK V 0.5 NM H

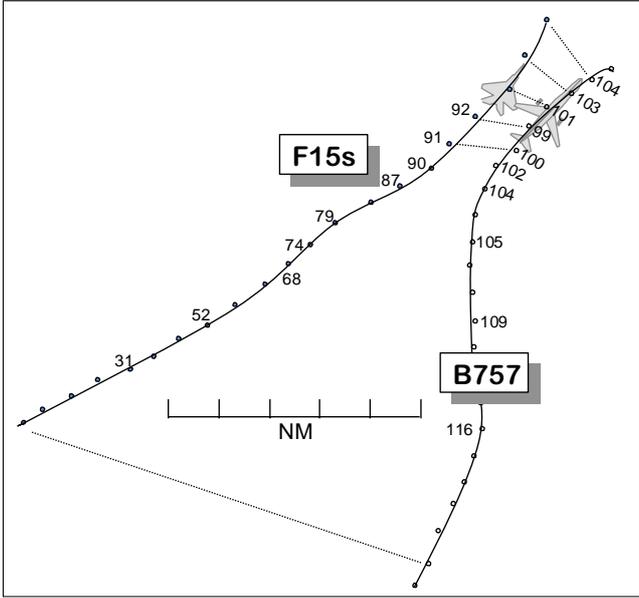
AIRPROX REPORT No 62/01

Date/Time: 3 May 1014
Position: 5232 N 0052 E (7 NM NE of Thetford)
Airspace: FIR (Class: G)
Reporting Aircraft Reported Aircraft
Type: B757 F15 x 2
Operator: CAT Foreign Mil
Alt/FL: FL 100 ↓ FL 100
Weather VMC CLBC VMC CLBL
Visibility: 30 km
Reported 700 ft, < 1 NM
Separation: /NK
Recorded Separation: 0.75 NM, 700 ft

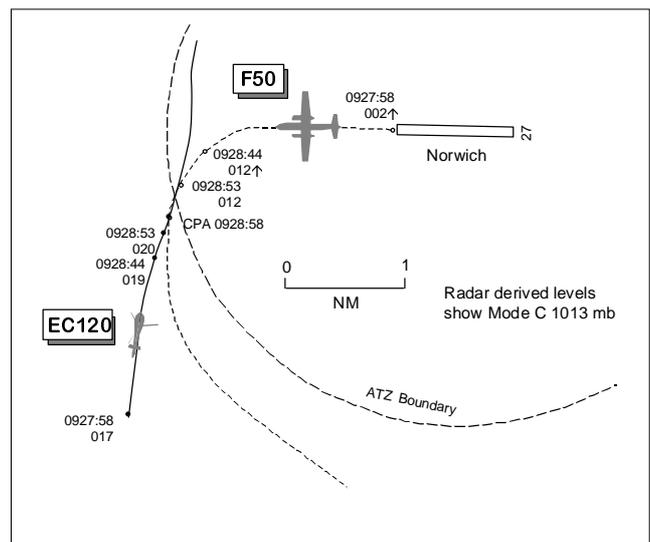
AIRPROX REPORT No 88/01

Date/Time: 4 Jun 0929
Position: 5240 N 0113 E (2.5 NM WSW Norwich Airport - elev. 117 ft)
Airspace: FIR/ATZ (Class: G)
Reporting Aircraft Reported Aircraft
Type: F50 EC120
Operator: CAT Civ Pte
Alt/FL: ↑ 2000 ft 2000 ft (QNH 1023 mb) (RPS 1017 mb)
Weather VMC CBL VMC CBL
Visibility: >10 km >10 km
Reported 0 H 600 ft V 0 H >500 ft V
Separation:
Recorded Separation: 0 H 800 ft V

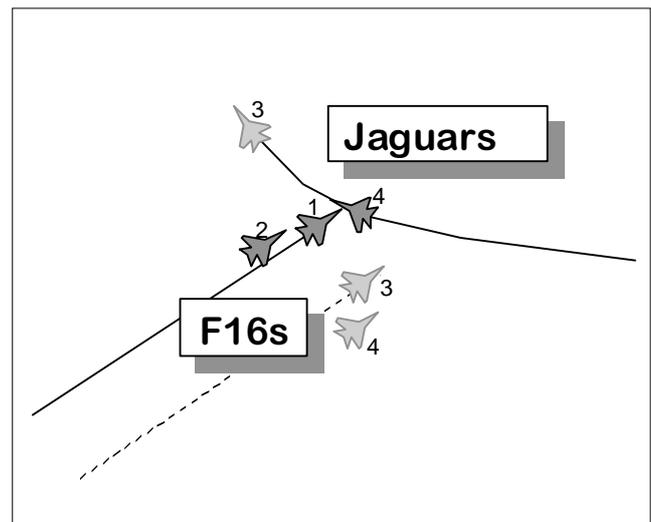
AIRPROX REPORT No 89/01

Date/Time: 7 Jun 0914
Position: 5320 N 0011 E (7 NM SE of Louth)
Airspace: FIR (Class: G)
Reporting Aircraft Reported Aircraft
Type: Jaguar F16 x 2
Operator: HQ STC Foreign Mil
Alt/FL: FL 151 FL 150 ↓
Weather VMC CLAC VMC CLAC
Visibility: Unltd
Reported 100 ft V
Separation:
Recorded Separation: 500 ft V

Members noted that the F16s had levelled at FL 150, a suitable quadrantal level, but that the Jaguars had not chosen a quadrantal, although they would shortly be manoeuvring while holding for the range. It could also be seen from the HUD video that the F16s probably became visually observable objects while the Jaguar pilot was setting Range QFE and that this probably contributed to the pilot's late sighting of the F16s. It could be seen that the F16s were descending to avoid the Jaguar, which they had acknowledged seeing, and the Board concluded that the incident was a confliction of flightpaths in the FIR which was resolved by the F16 pilots with the assistance of London Radar.

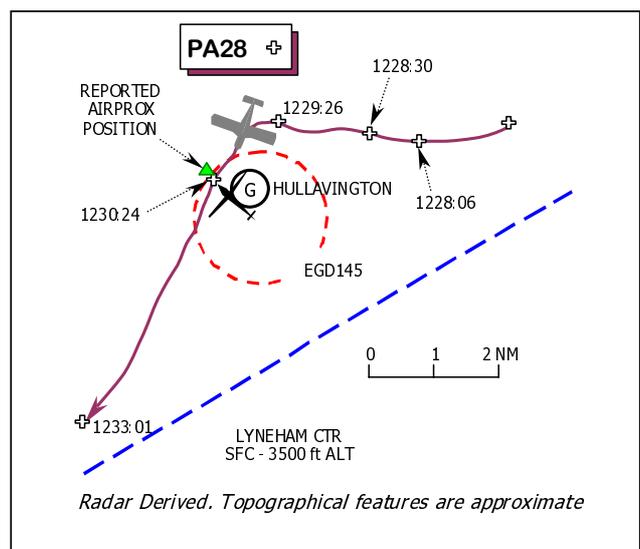
AIRPROX REPORT No 92/01

Date/Time: 9 Jun 1230 (Saturday)
Position: 5132 N 0209 W (1 NM NW of Hullavington GS - elev 343 ft)
Airspace: London FIR (Class: G)
Reporting Aircraft Reported Aircraft
Type: Viking Glider Piper PA28
Operator: HQ PTC Civ Pte
Alt/FL: 950 ft 2200 ft
(QFE 1005 mb) (RPS 1010 mb)
Weather VMC CLBC VMC CLBC
Visibility: >10 km 10 km
Reported Separation:
300 ft V, nil H Not seen
Recorded Separation: Not recorded

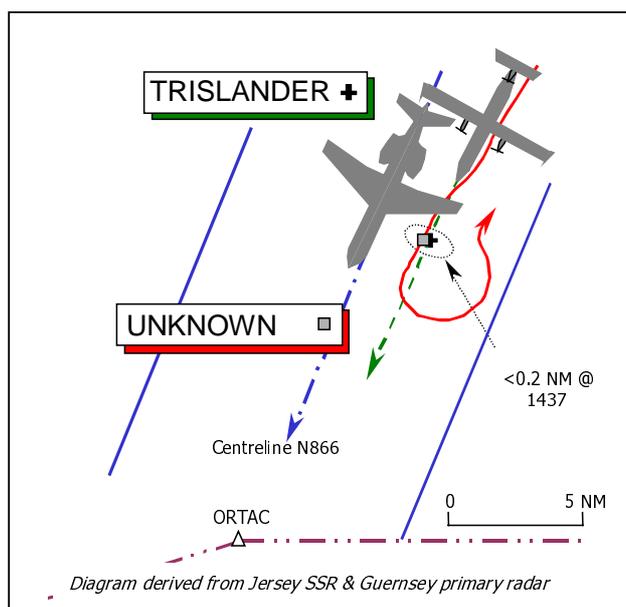
AIRPROX REPORT No 96/01

Date/Time: 9 Jun 1436 (Saturday)
Position: 5011 N 0152 W (12 NM NE of ORTAC)
Airspace: Airway (Class: A)
Reporting Aircraft/Reported Aircraft
Type: BN2III Unknown
Operator: CAT Unk
Alt/FL: FL 40 Unk
Weather VMC SKC Unk
Visibility: >20 km Unk
Reported Separation:
 50 yd, Nil V Unk
Recorded Separation: <0.2 NM H

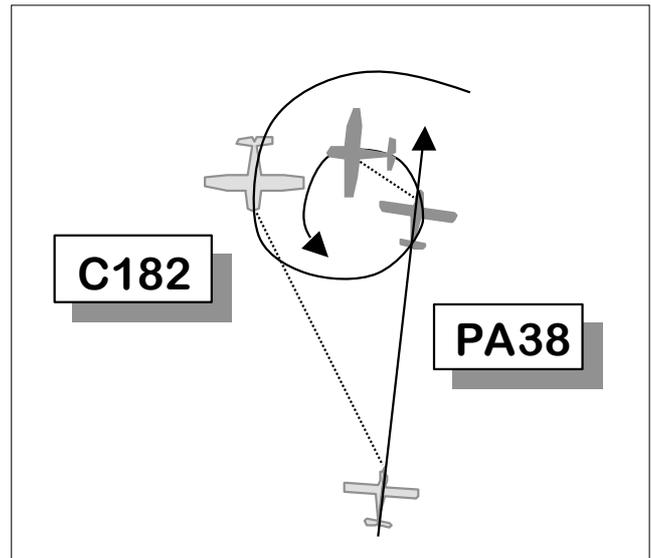
AIRPROX REPORT No 99/01

Date/Time: 21 Jun 1439
Position: 5253 N 0054 W (Langar - elev 109ft)
Airspace: FIR (Class: G)
Reporting Aircraft Reported Aircraft
Type: Parachutists PA38
Operator: Civ Club Civ Club
Alt/FL: 2800 ft ↓ 2800 ft
(QNH) (QNH 1015 mb)
Weather VMC CLBC VMC CLBC
Visibility: 20 NM 10 km
Reported 3-400 ft V
Separation: /NK
Recorded Separation: NK

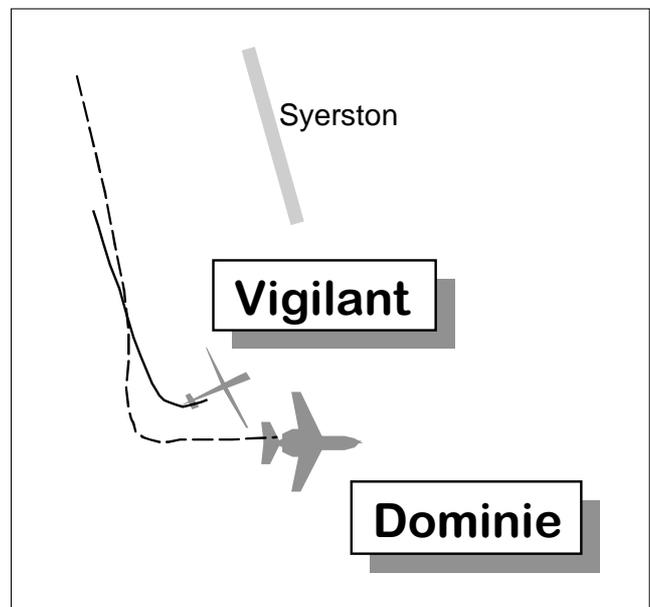
AIRPROX REPORT No 102/01

Date/Time: 26 Jun 1040
Position: 5300 N 0055 W (Syerston - elev 228 ft)
Airspace: ATZ (Class: G)
Reporting Aircraft Reported Aircraft
Type: Vigilant Dominie
Operator: HQ PTC HQ PTC
Alt/FL: 1400 ft ↓ 1500 ft
(QFE 1012 mb) (QFE 1009 mb)
Weather VMC HZNC VMC HZBC
Visibility: 15 km+ 6 km
Reported 500 m H, 100 ft V
Separation: /1 NM, 4-500 ft V
Recorded Separation: NK
