AIRPROX REPORT No 2010106

Date/Time: 28 Jun 2010 1539Z

Position: 5129N 00252W
(3nm N CLEVEDON
VRP)

Airspace: Lon FIR (Class: G)

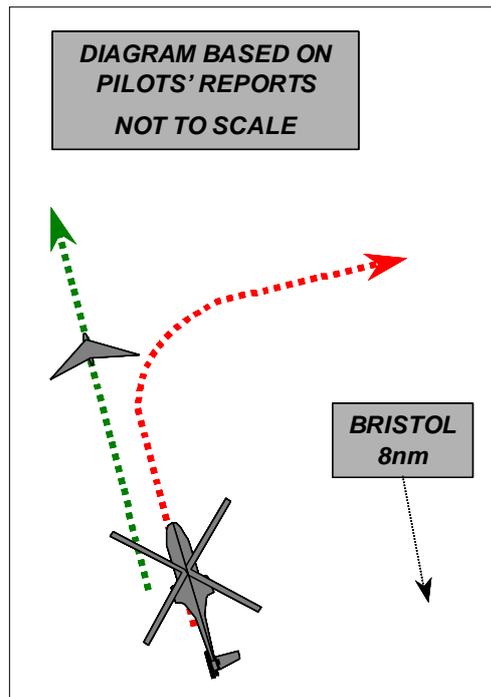
HALF TRACK

UKAB Note (2): The pilot provided a map of his route. The track was tangential to the Western edge of the Bristol CTR. The position of the Airprox was indicated as being over the Bristol Channel, 8nm NW of Bristol (the CTR is 5nm radius).
