AIRPROX REPORT No 2011036

Date/Time: 14 Apr 2011 1340Z

Position: 5054N 00002E (16nm SE Gatwick)

Airspace: LTMA (Class: A)
Reporting Ac Reported Ac

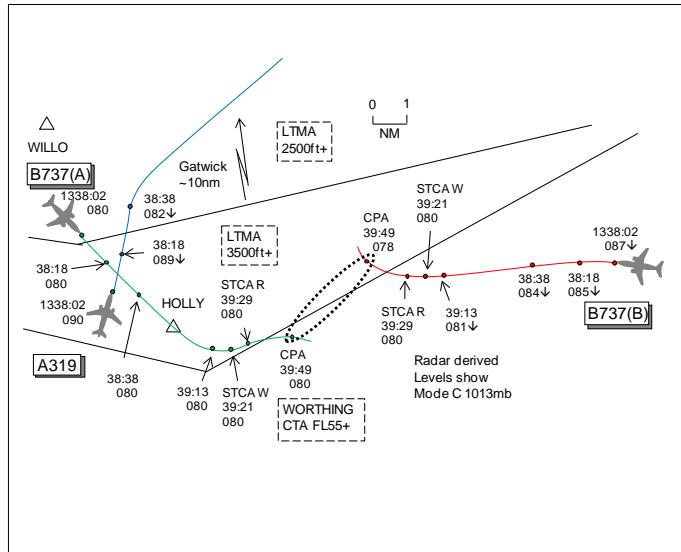
200ft V/3nm H

ATSI reports that the Airprox occurred at 1339:18 UTC, in Class A, CAS, at a position 16.5nm, to the SE of Gatwick Airport.
