AIRPROX REPORT No 2015125

Date: 23 Jul 2015 Time: 1451Z Position: 5323N 00044W Location: 2nm WSW Sturgate airfield

PART A: SUMMARY OF INFORMATION REPORTED TO UKAB

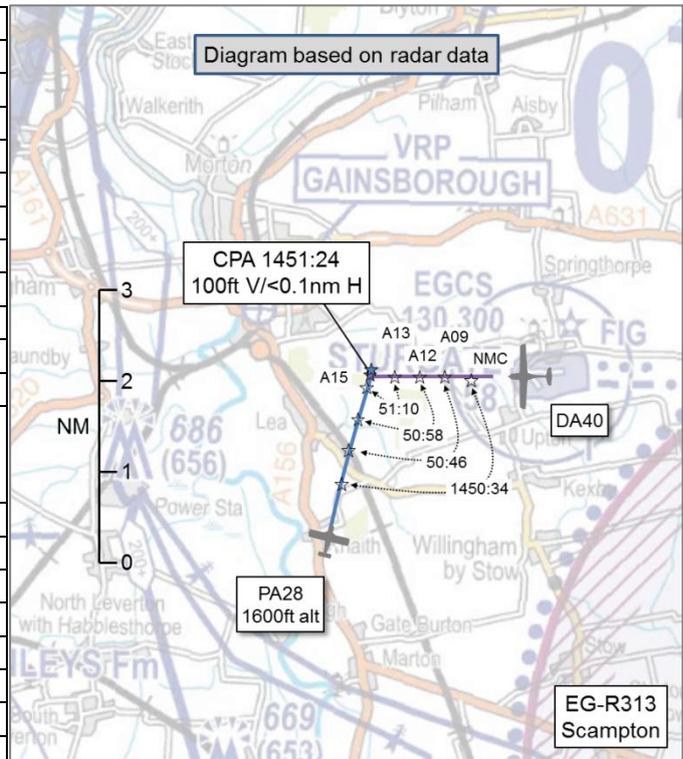
| Recorded | Aircraft 1 | Aircraft 2 |
|---|--|---|
| Recorded | 100ft V/<0.1nm H | |
