AIRPROX REPORT No 2015057

Date: 1 May 2015 Time: 18.02Z Position: 5329N 00024W Location: North Kelsey, Lincs

PART A: SUMMARY OF INFORMATION REPORTED TO UKAB

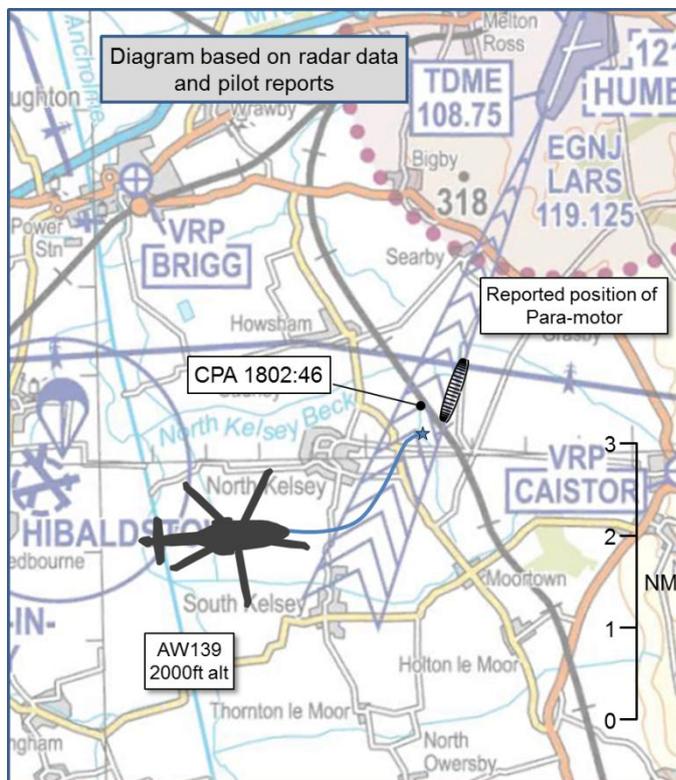
Recorded	Aircraft 1	Aircraft 2
Aircraft	AW139	Para-Motor
Operator	Civ Comm	Unknown
Airspace	London FIR	London FIR
Class	G	G
Rules	IFR	NK
Service	Traffic	NK
Provider	Humberside	NK
Altitude/FL	2000ft	NK
Transponder	A,C	NK
Reported		
Colours	White/Blue/Red	Red
Lighting	Nav, Anti-Colls	Nil
Conditions	VMC	NK
Visibility	>10km	NK
Altitude/FL	2000ft	NK
Altimeter	QNH (1012hPa)	NK
Heading	023°	NK
Speed	120kt	NK
ACAS/TAS	TCAS I	NK
Alert	Nil	Unknown
Separation		
Reported	200ft V/100m H	NK
Recorded	NK

THE AW139 PILOT reports that he had just reached the descent point for the NDB approach to RW02 when the non-handling pilot called “contact!” as he became aware of a paramotor, with a red canopy and one engine, slowly moving right-to-left across the nose of the aircraft at the range of 600m and 100ft below. The aircraft was immediately decoupled [from autopilot] and an emergency turn carried out to avoid the paramotor; they passed it 100m right and 200ft below in order to maintain visual contact at all times and in the hope that it would make him aware of their presence and his location. ATC were informed and a visual approach was carried out.
