AIRPROX REPORT No 2015093

Date: 25 Jun 2015 Time: 1307Z Position: 5109N 00146W Location: Boscombe Down

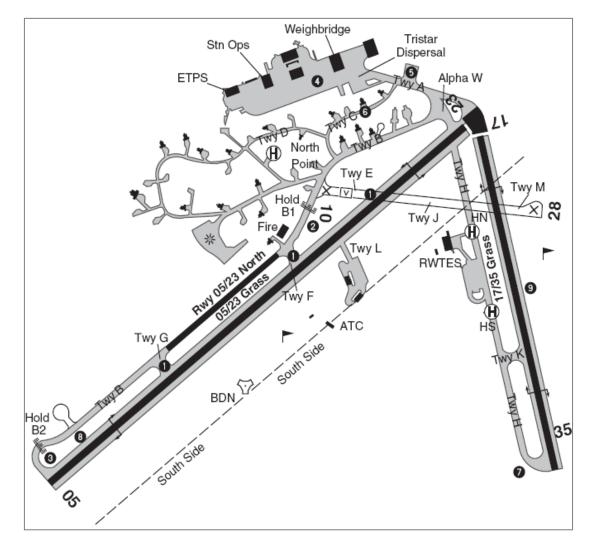
An extract from the Aerodrome chart at AD 2 - EGDM - 1 - 15, dated 12 Dec 13, is shown below:

The Board noted that the threshold of RW23 North is at about the mid-point of RW23 main, so Tutor (B) (making an approach to RW23 main) was then not in the position the Tower controller expected. When he requested Tutor (B) state his position the reply, '*just taking off runway 23*', did not conform to his situational awareness and this was probably the point at which the seed of confusion was sown. Members acknowledged that the Tower controller had requested Tutor (B) to re-position to RW23 North in order to expedite the IFR departure of the Gazelle. The Gazelle pilot had then informed the Tower controller that '*we're going to hold, there's a Tutor going for the main*' (Tutor(C), ahead of Tutors (A) and (B)) which caused growing confusion for the controller.
