AIRPROX REPORT No 2015119

Date: 18 Jul 2015 (Saturday) Time: 1352Z Position: 5302N 00034W Location: 3nm w Cranwell

PART A: SUMMARY OF INFORMATION REPORTED TO UKAB

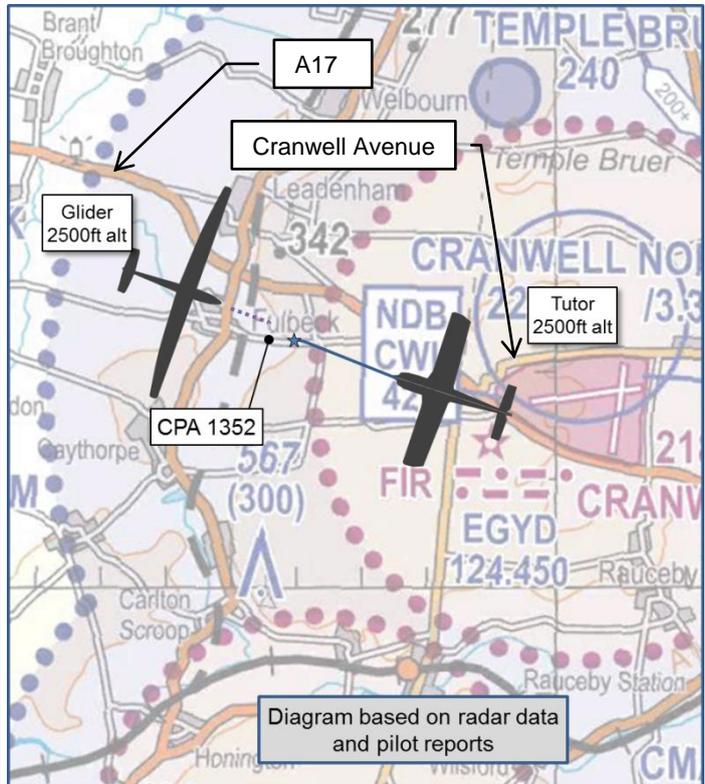
Recorded	Aircraft 1	Aircraft 2
Aircraft	Tutor	Astir
Operator	HQ Air (Trg)	Civ Club
Airspace	Cranwell MATZ	Cranwell MATZ
Class	G	G
Rules	VFR	VFR
Service	None	None
Altitude/FL	2500ft	2500ft
Transponder	A,C,S	None
Reported		
Colours	White	White/green
Lighting	HISLs Nav	Nil
Conditions	VMC	VMC
Visibility	40km	40km
Altitude/FL	2500ft	2500ft
Altimeter	RPS (1008hPa)	QFE(1008hPa)
Heading	270°	110°
Speed	75kt	60kt
ACAS/TAS	TAS	Not fitted
Alert	Nil	N/A
Separation		
Reported	0ft V/50m H	5-10m V 175m H
Recorded	NK

THE TUTOR PILOT reports he was conducting his eighth and final passenger trip of the day. He had departed from RW26 and climbed ahead; conducting look-out weaves as required. On passing 2000ft, he was clear of the Cranwell ATZ and so he set the RPS and checked in on the Cranwell quiet frequency to inform other Cranwell traffic of his intentions. RAF Waddington had closed early, and so he was unable to receive a Traffic Service from any of the local ATC units. After broadcasting his operating levels and intentions, he looked right and saw a flash of white glider raise its right wing and bank away. He immediately executed a hard left turn and searched the area for the glider. He saw it level at 2500ft with an estimated separation of less than 50m. After establishing safe separation, he switched to Cranwell Tower frequency to report the Airprox. He believed that the glider pilot had probably seen him and turned away to prevent a potential collision.

THE ASTIR PILOT reports gliding in a Cranwell glider-club aircraft. He had been soaring and operating almost exclusively within the horizontal, but above the vertical limits of the Cranwell ATZ and CMATZ for about an hour. He was operating to the north of Cranwell Avenue at all times. A few minutes before the Airprox he had been asked by the duty instructor to return and land at Cranwell north. The aircraft was configured to land, with the undercarriage down and locked, and was being flown in a gentle descent. The airspace had been particularly busy with numerous sightings of gliders, Tutors and GA aircraft. During the descent he made a fairly late sighting of a Tutor, which was about ½ a mile away on an almost reciprocal heading and appeared to be climbing. It was apparent that the Tutor would pass fairly close; but that they would not collide assuming both aircraft maintained their heading. Turning right would have caused him to cross the path of the Tutor and significantly increase the risk, so he elected to roll left with about 30° of bank to present the larger bottom plan of the aircraft before returning to wings level to remain visual with the other aircraft; he repeated this twice over a short period of time. The Tutor rocked its wings when it reached the 3 or 4

o'clock position, and passed down the starboard side by about 150-200m. He noted that he considered his look-out to be effective, and employed the recognised techniques to give himself the best chance of seeing other aircraft, but even so his acquisition of the Tutor was late and the closing speed was quite high. He opined that if both the glider and the Tutor had been fitted with FLARM then they both would have been aware of each other's presence much earlier. Although he did not consider there to be a significant risk of collision because he was aware of the Tutor just in time to take action, and was not alarmed by the encounter, he had mentioned the incident to the club duty instructor upon landing.
