AIRPROX REPORT No 2015174

Date: 15 Jul 2015 Time: 1655Z Position: 5310N 00235W Location: Ashcroft Airfield (elev 149ft)

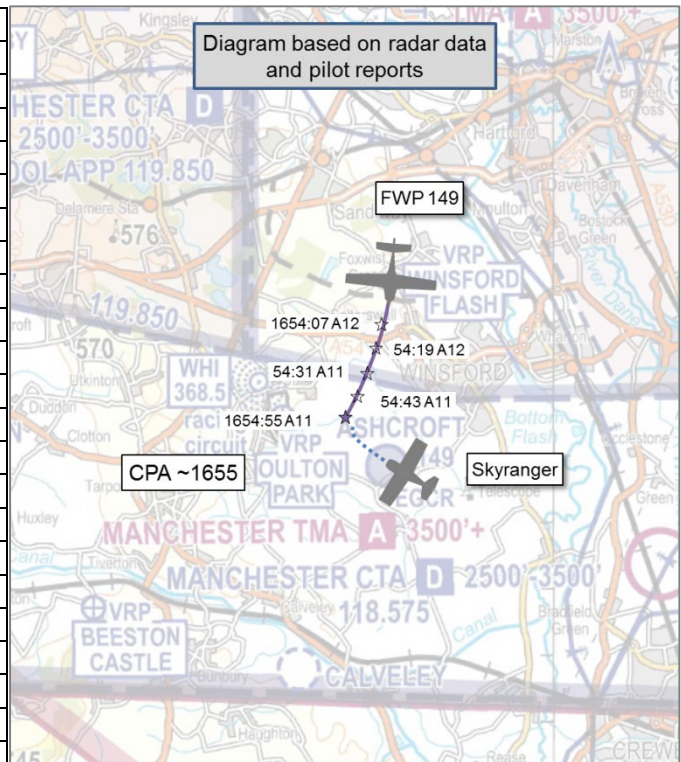
Recorded	Aircraft 1	Aircraft 2
Aircraft	Skyranger	Piaggio FW 149
Operator	Civ Pte	Civ Pte
Airspace	London FIR	London FIR
Class	G	G
Rules	VFR	VFR
Service	None	None
Provider	SAFETYCOM	SAFETYCOM
Altitude/FL	NK	1100ft
Transponder	None	A, C, S
Reported		
Colours	Red/white	Green/white/yellow
Lighting	NK	Strobe
Conditions	VMC	VMC
Visibility	>10km	NK
Altitude/FL	1000ft	1300ft
Altimeter	NK (1012hPa)	QNH (NK hPa)
Heading	310°	180°
Speed	61mph	125kt
ACAS/TAS	Not fitted	Unknown
Alert	N/A	Unknown
Separation		
Reported	150ft V/200m H	100ft V/300m H
Recorded	NK

THE FWP 149 PILOT reports in a descent about 2nm west of Ashcroft joining crosswind for RW27. As he approached the extended centreline he saw a white and red, high-wing, single-engine aircraft on his left at a range of about 300m, climbing up towards his level. He made an immediate right turn 'for separation'. He noted that he had made a call to Ashcroft on SAFETYCOM but that there was no reply. He stated that 'it was see-and-be-seen with no risk of collision' and that he did not consider the event an Airprox.
