AIRPROX REPORT No 2018058

Date: 23 Apr 2018 Time: 1308Z Position: 5141N 00110W Location: 5nm NW Benson

PART A: SUMMARY OF INFORMATION REPORTED TO UKAB

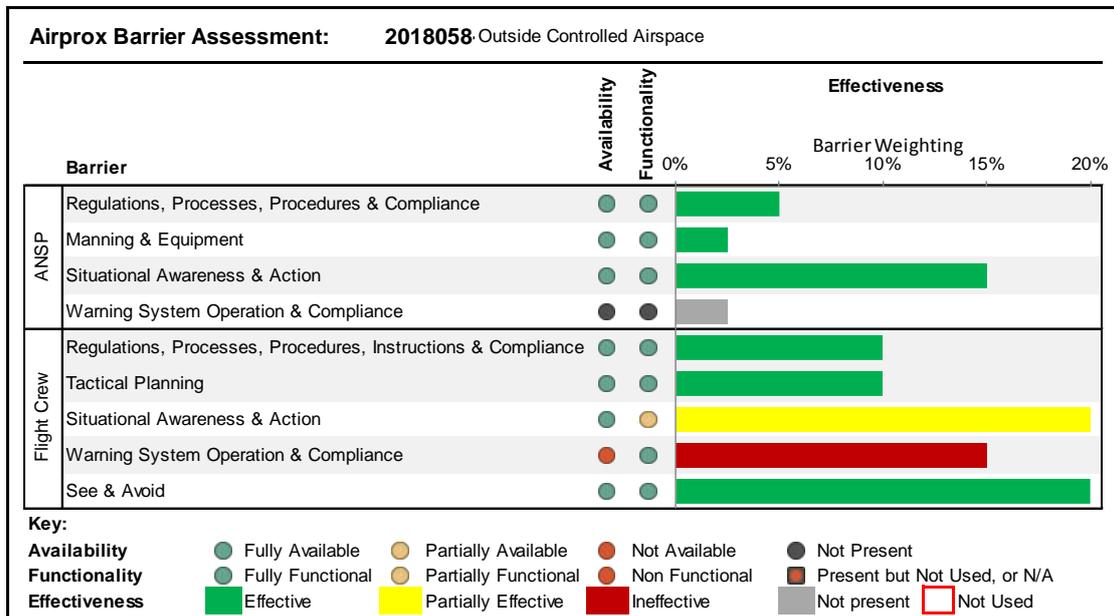
Warning System Operation and Compliance were assessed as **ineffective** because the TAS in the Chinook and the FLARM in the glider were incompatible.

See and Avoid were assessed as effective because the glider pilot took avoiding action.

⁴ The UK Airprox Board scheme for assessing the Availability, Functionality and Effectiveness of safety barriers can be found on the [UKAB Website](#).
