AIRPROX REPORT No 2018098

Date: 19 May 2018 Time: 1115Z Position: 5150N 00153W Location: 2nm west Northleach VRP

PART A: SUMMARY OF INFORMATION REPORTED TO UKAB

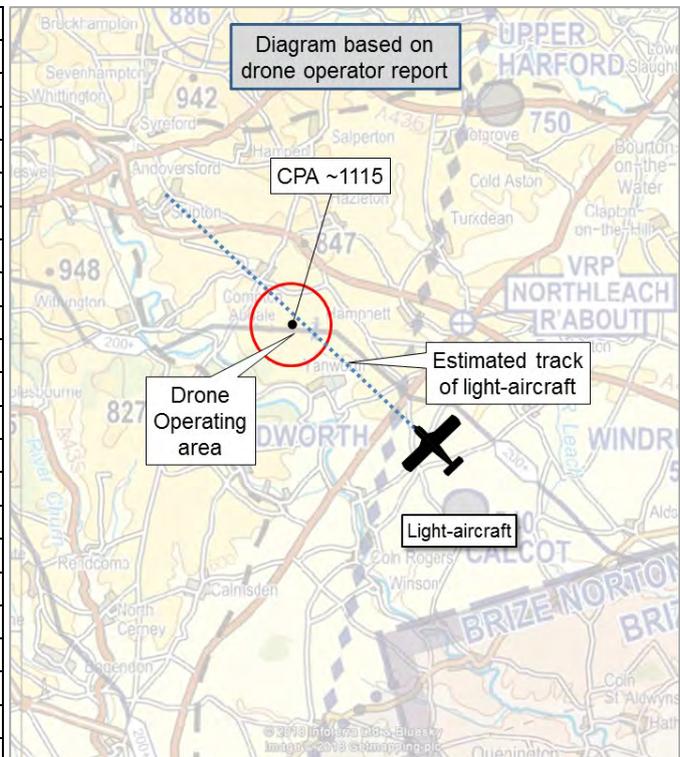
Recorded	Aircraft 1	Aircraft 2
Aircraft	Drone	Light-aircraft
Operator	Civ Comm	Civ FW
Airspace	London FIR	London FIR
Class	G	G
Rules	VFR	
Service	None	
Provider	N/A	
Altitude/FL	NK	
Transponder	None	
Reported		
Colours	Black, Red	
Lighting	None	
Conditions	VMC	
Visibility	>10km	
Altitude/FL	360ft agl	
Altimeter	NK	
Heading	030°	
Speed	20kt	
ACAS/TAS	Not fitted	
Separation		
Reported	100ft V/400m H	
Recorded		NK

THE DRONE OPERATOR reports that he advised Brize Norton ATC at 09:23 BST of his intent to fly his fixed-wing sub-7kg drone over farmland about 1 mile west of the town of Northleach at a maximum height of 400ft. He said he would notify Brize Norton ATC on completion. At 12:14 BST, he heard a light-aircraft heading towards his operating area, approximately 1km distant. He saw the aircraft visually at approx 800m, flying parallel to the pylons, at a height of 450-500ft AGL he believed. He assessed that if the aircraft stayed on its present course, it would enter the operational area of his UAV and separation would be less than 100m. He instructed the drone to roll as a visual warning to the aircraft. The light-aircraft did not appear to alter course or height, so the drone was instructed to descend rapidly to maintain separation. After descent, the drone started an automatic climb back to the programmed mission operating height (360ft), so a second emergency descent was initiated to ensure the drone remained clear of the light-aircraft; this second descent brought the drone into contact with a power-cable between the 200ft pylons and the drone was destroyed. The light aircraft then flew directly over the area where the drone had been operating and continued in a north-westerly heading.

BRIZE NORTON reports that the drone operator gave his location as approximately 2.3nm west of the Northleach VRP (a very popular VRP approximately halfway between Brize and Gloucester Airport and also commonly used by aircraft operating to and from Kemble and Rendcomb). This is in Class G airspace and therefore an aircraft operating there would not necessarily be under the control of Brize ATC. The ATC watch log had no record of the incident being reported by an aircraft pilot or the drone operator. A review of the flight strips from the day showed only one aircraft worked by Brize ATC taking a routing at that time that could possibly take it close to this location but, on viewing online photographs this aircraft was red in colour and the drone pilot reports the aircraft in question as being white. An aircraft at that location, at the estimated height by the drone operator of 500ft would most likely be

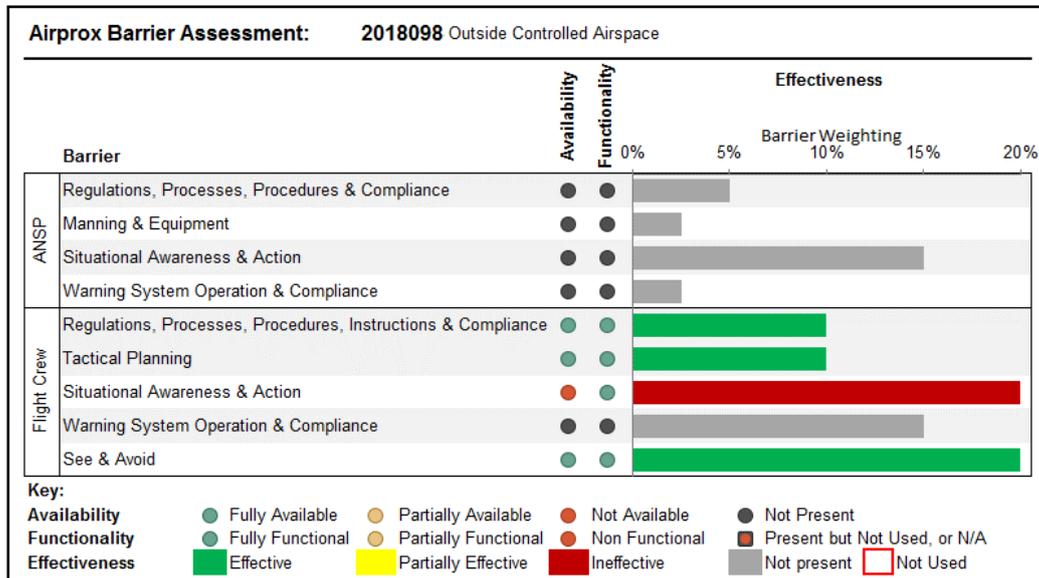
Safety Barrier Assessment²

In assessing the effectiveness of the safety barriers associated with this incident, the Board concluded that the key factors had been that:

Situational Awareness and Action were assessed as **ineffective** because the light-aircraft was not communicating with Brize Norton and therefore could not receive information about the drone operation. Neither could the drone operator attain any situational awareness about the light-aircraft.
