AIRPROX REPORT No 2018023

Date: 15 Feb 2018 Time: 1234Z Position: 5156N 00124W Location: Enstone Airfield

PART A: SUMMARY OF INFORMATION REPORTED TO UKAB

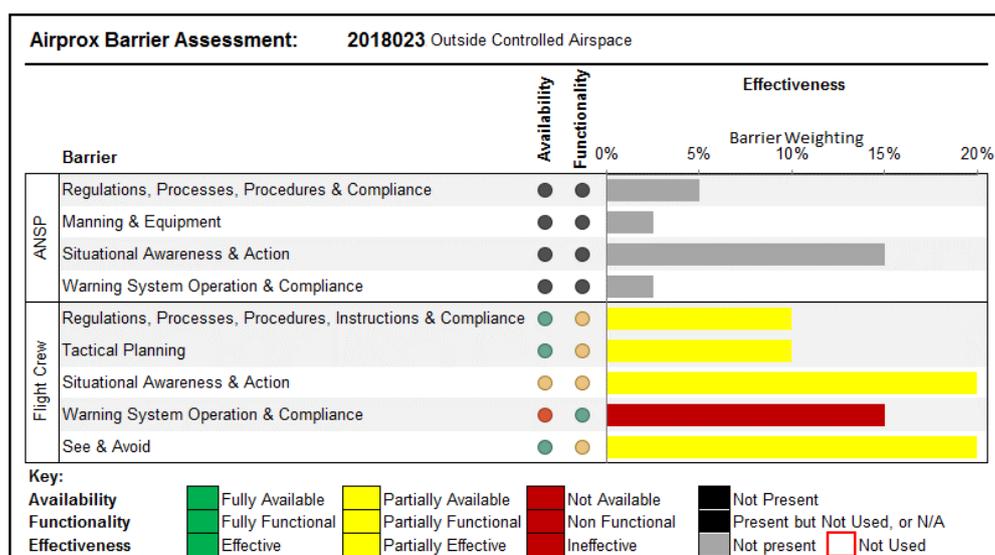
Warning System Operation and Compliance were assessed as **ineffective** because although the SF25 was equipped with FLARM, this can only alert when the conflicting aircraft is also fitted with a serviceable FLARM, therefore the Apache would not have registered on the SF25's display.

See and Avoid were assessed as **partially effective** because the SF25 pilot was visual with the Apache in a timely manner, but the Apache crew only saw the SF25 at the last minute.
