AIRPROX REPORT No 2019011

Date: 20 Jan 2019 Time: 1320Z Position: 5118N 00001W Location: Biggin Hill

PART A: SUMMARY OF INFORMATION REPORTED TO UKAB

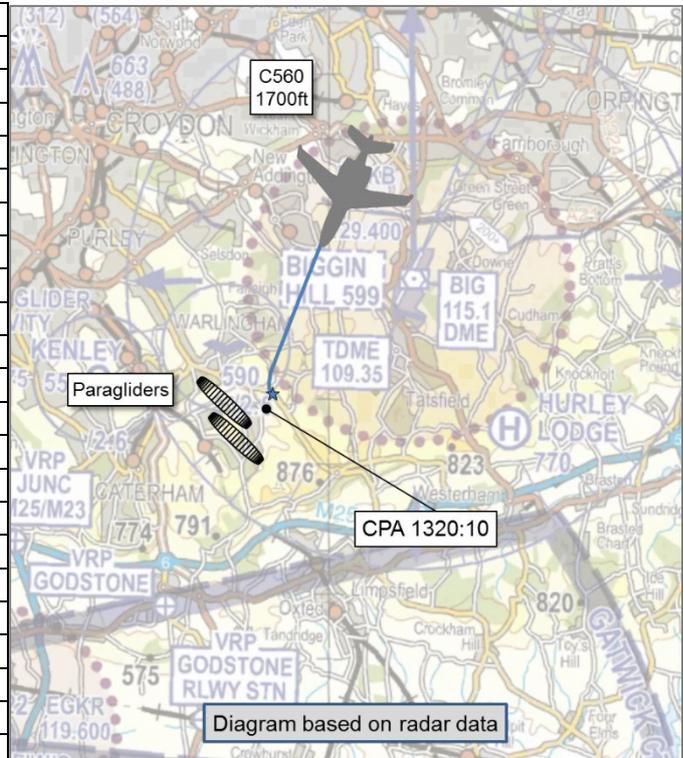
THE C560 PILOT reports that he was circling for RW03 at Biggin Hill¹ following an ILS approach to RW21. As he started the base turn for RW03, he spotted two paragliders. They were very difficult to see. To avoid them, he had to increase the bank angle to the point where he had a bank angle warning, although both pilots agreed that the bank angle was necessary to avoid a collision. Speed was stable during the manoeuvre and there was no altitude loss. He informed Biggin Hill ATC over the radio and telephoned them once on the ground to discuss the severity of the incident.

The BHPA notices that a left-hand approach for runway 03 does put Biggin Hill circuit traffic much nearer to Kenley gliding club and the BHPA school (shown by the gliding symbol on the CAA chart just beside the left hand edge of Biggin Hill's ATZ) than a right-hand approach would. The BHPA asks whether there are any specific reasons why Biggin Hill has a left-hand approach rather than a right-hand approach for 03? A right-hand approach would seem to keep traffic further away from both gliding & paragliding activities which occur very close to the western edge of Biggin Hill airfield's ATZ.

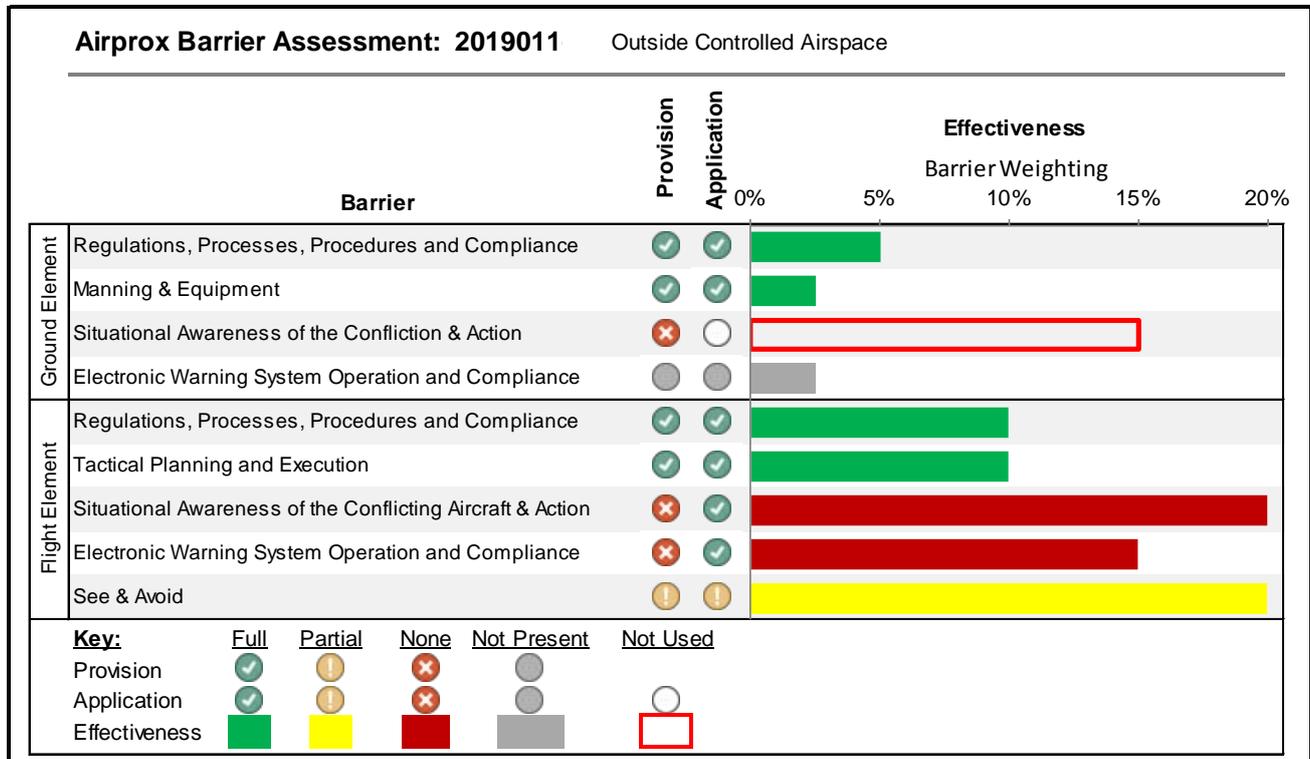
Warning System Operation and Compliance were assessed as **ineffective** because the C560's TCAS could not detect the paragliders.

See and Avoid were assessed as **partially effective** because the C560 pilot had had to take later than desirable avoiding action.
