AIRPROX REPORT No 2019233

Date: 12 Aug 2019 Time: 1059Z Position: 5334N 00333W Location: RAF Woodvale ATZ

PART A: SUMMARY OF INFORMATION REPORTED TO UKAB

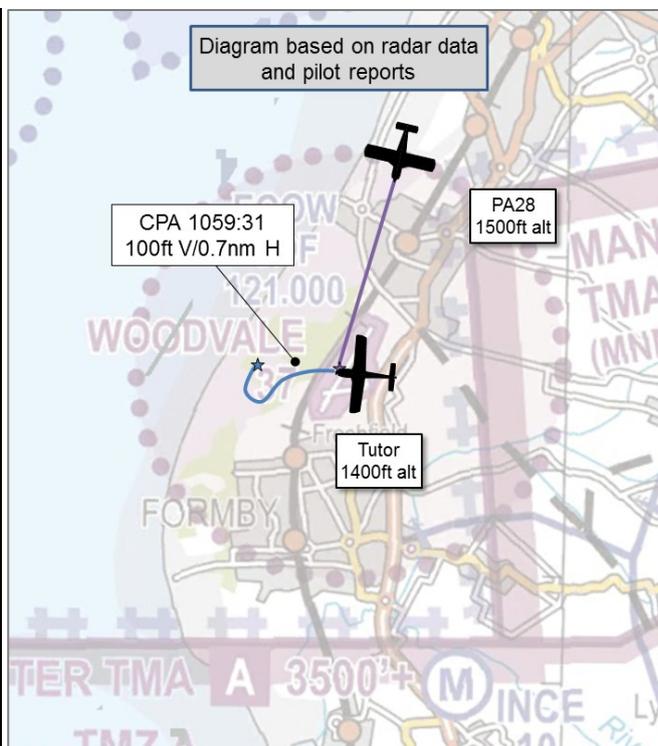
Recorded	Aircraft 1	Aircraft 2
Aircraft	Tutor	PA28
Operator	HQ Air (Trg)	Civ FW
Airspace	Woodvale ATZ	Woodvale ATZ
Class	G	G
Rules	VFR	VFR
Service	ACS	Basic
Provider	Woodvale	Warton
Altitude/FL	1400ft alt	1500ft alt
Transponder	A, C, S	A, C, S
Reported		
Colours	White, Blue	White
Lighting	Nav, Landing, Strobe	Nav, Strobe
Conditions	VMC	VMC
Visibility	>10km	10km
Altitude/FL	1500ft	1500ft
Altimeter	QFE (1013hPa)	NK
Heading	030°	200°
Speed	80kt	100kt
ACAS/TAS	TAS	Not fitted
Alert	TA	N/A
Separation		
Reported	0ft V/200yds H	Not seen
Recorded	100ft V/0.7nm H

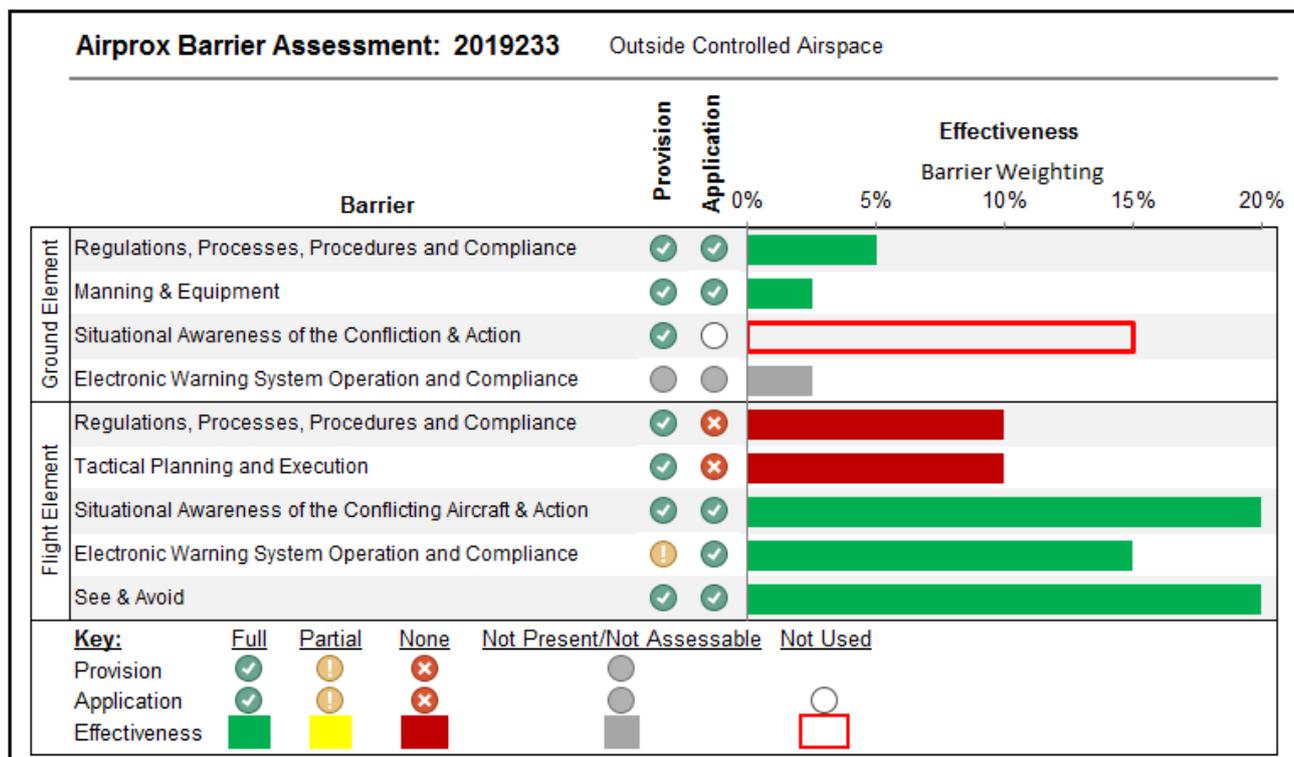
Tactical Planning and Execution was assessed as **ineffective** because the PA28 pilot did not check the operating hours of Woodvale prior to his flight and, because of this, he did not communicate with Woodvale ATC prior to entering the ATZ.

⁴ The UK Airprox Board scheme for assessing the Availability, Functionality and Effectiveness of safety barriers can be found on the [UKAB Website](#).
