AIRPROX REPORT No 2019256

Date: 24 Aug 2019 Time: 1215Z Position: 5156N 00126W Location: Enstone airfield northside

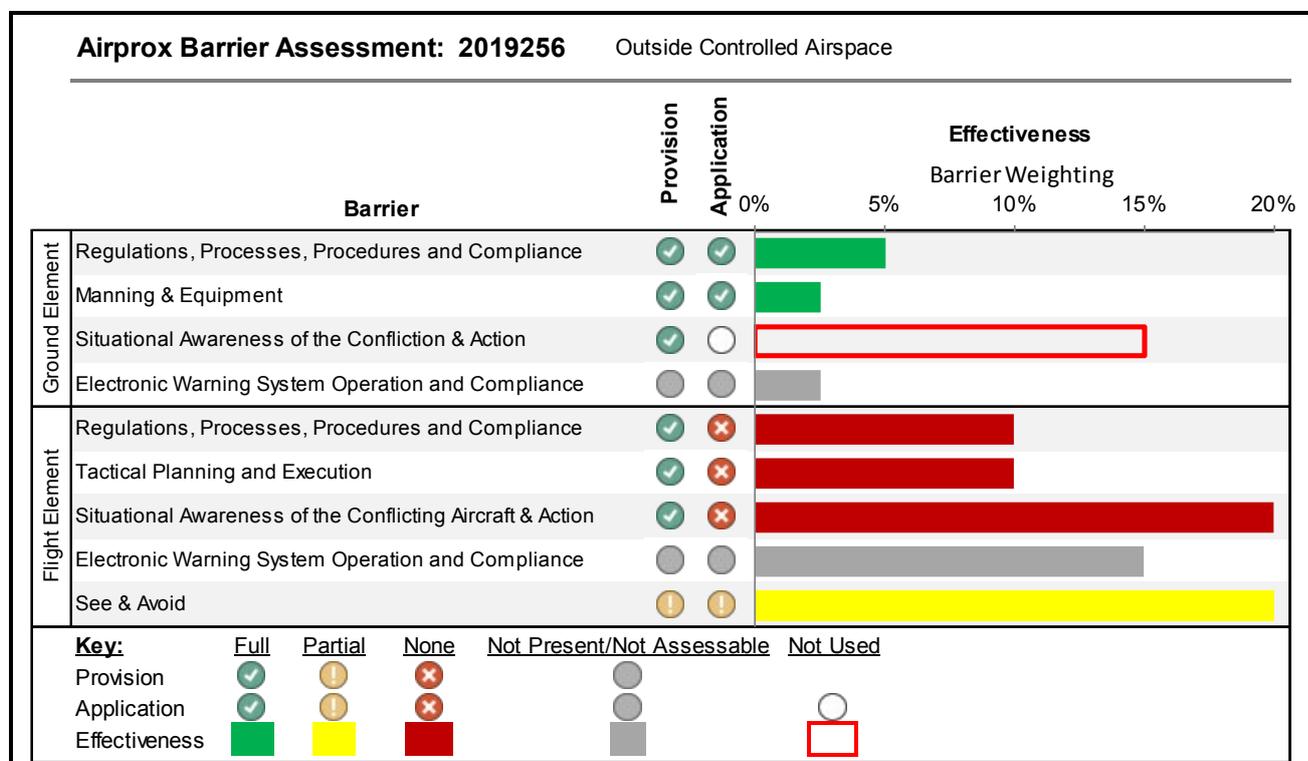
Safety Barrier Assessment⁴

In assessing the effectiveness of the safety barriers associated with this incident, the Board concluded that the key factors had been that:

Situational Awareness of the Confliction and Action were assessed as **not used** because neither pilot was operating under a service that required the monitoring of their flight by ground elements.

Regulations, Processes, Procedures and Compliance were assessed as **ineffective** because the Enstrom pilot did not give way to landing traffic.

Tactical Planning and Execution was assessed as **ineffective** because the Enstrom pilot did not take account of aircraft that might be landing on RW08.

Situational Awareness of the Conflicting Aircraft and Action were assessed as **ineffective** because neither pilot assimilated the R/T calls of the other.

See and Avoid were assessed as **partially effective** because avoiding action was only taken at a very late stage.
