**AIRPROX REPORT No 2019024**

Date: 30 Jan 2019 Time: 1125Z Position: 5155N 00044W Location: Holmbeck Farm airfield

**PART A: SUMMARY OF INFORMATION REPORTED TO UKAB**

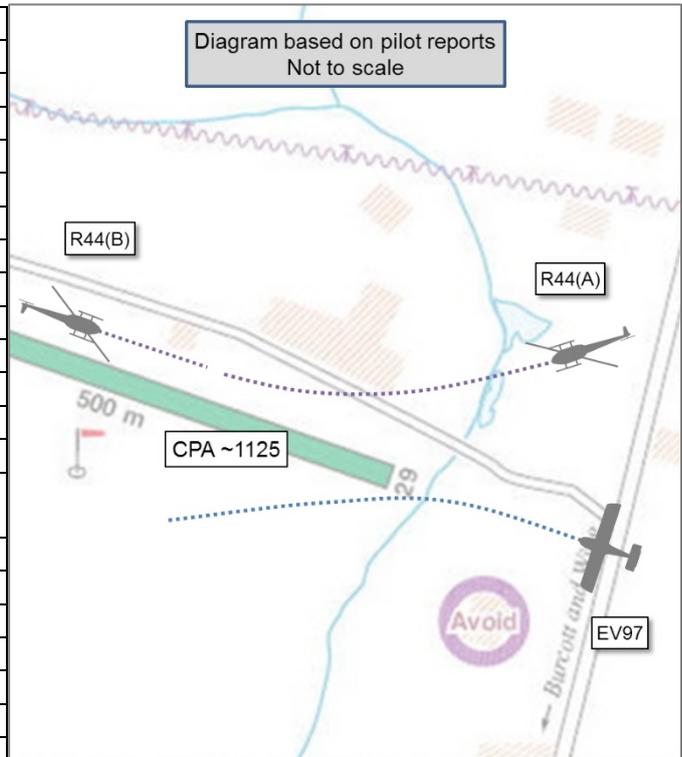
Recorded	Aircraft 1	Aircraft 2
Aircraft	EV97	R44(A), R44(B)
Operator	Civ FW	Civ Helo
Airspace	London FIR	London FIR
Class	G	G
Rules	VFR	VFR
Service	Listening out	Listening Out
Provider	Safety Com	Luton Approach
Transponder	Not fitted	A, C, S
Reported		
Colours	Silver alloy	Mainly blue
Lighting	None	Strobe anti-coll.
Conditions	VMC	VMC
Visibility	>10km	>10km
Altitude/FL	500ft agl	A=600ft/B=700ft agl
Altimeter	QFE (NK hPa)	QFE (NK hPa)
Heading	290°	A=280°/B=100°
Speed	60kt	A=60kt/B=50kt
ACAS/TAS	Not fitted	Not fitted
Separation		
Reported	200ft V/300ft H	100ft V/0.5nm H
Recorded	NK
