AIRPROX REPORT No 2019133

Date: 01 Jun 2019 Time: 1228Z Position: 5304N 00029W Location: ivo Cranwell North airfield

PART A: SUMMARY OF INFORMATION REPORTED TO UKAB

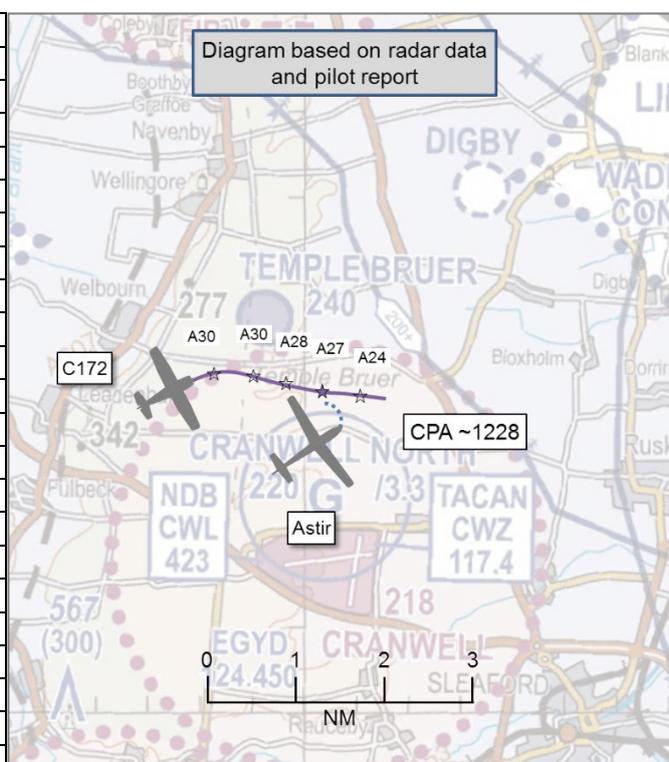
Recorded	Aircraft 1	Aircraft 2
Aircraft	Astir	C172
Operator	Civ Gld	Civ FW
Airspace	London FIR	London FIR
Class	G	G
Rules	VFR	VFR
Service	None	Basic
Provider	'Cranwell Gliders'	Cranwell Tower
Altitude/FL	NK	2800-2400ft
Transponder	Not fitted	A, C, S
Reported		Not reported
Colours	White	
Lighting	Not fitted	
Conditions	VMC	
Visibility	10km	
Altitude/FL	2500ft	
Altimeter	QFE (NK hPa)	
Heading	north (turning left)	
Speed	50kt	
ACAS/TAS	Not fitted	
Alert	N/A	
Separation		
Reported	0ft V/200m H	
Recorded		NK
