AIRPROX REPORT No 2019236

Date: 13 Jul 2019 Time: 1118Z Position: 5345N 00105W Location: Burn Gliding Site

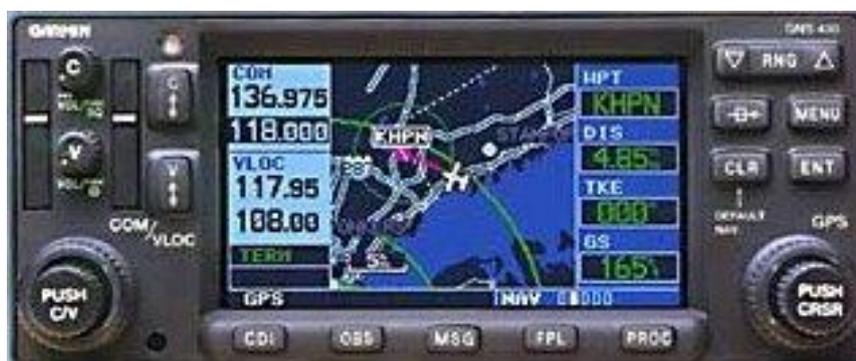
Figure 1 – Example Garmin 430 Navigational Display.¹

THE SF-260 PILOT reports that, on the day in question, he had flown to Sutton Bank, landed, and then returned. The pilot noted nothing remarkable about the day, which he described as 'just a normal flying day'. He does not recall seeing any other aircraft during his flight, nor does he recall on which flight the Airprox may have taken place. His only recollection of the weather conditions was that the gliders at Sutton Bank were all parked up at the launch point when he arrived, waiting for the weather to improve, and were still there when he departed Sutton Bank around an hour later. When contacted by the UKAB Secretariat to confirm the tools that he uses for navigation, the pilot confirmed that he carries a 1:500,000 topographical chart and that the aircraft is fitted with a Garmin 430 [see Figure 1], both of which were current.

The Board first considered the actions of the SF-260 pilot, and members wondered whether he was aware of the presence of Burn glider site on his route. The pilot had confirmed that the aircraft was equipped with a Garmin 430 and that he carried an up-to-date 1:500,000 VFR chart, so members agreed that it would have been reasonable to expect that he should have known of the location of Burn glider site and that he could have made a radio call to Burn Radio to inform them of his intentions. A GA member familiar with the Garmin 430 confirmed to the Board that this equipment is not really optimised for low-level navigation and, as such, the pilot would have needed to refer to his VFR chart to confirm the presence of sporting sites and other minor aerodromes that do not have an ATZ. Reflecting on all of this, the Board felt that, during the SF-260 pilot's pre-flight planning they should have taken the presence of Burn glider site into account and planned to avoid it by a suitable margin or otherwise have confirmed via radio that there was no activity before he overflew the site below the maximum altitude of the winch launch (**CF1, CF2, CF3, CF4**). The Board concluded that the SF-260 pilot therefore had, at best, only generic situational awareness of the possibility of there being gliders in the vicinity of Burn glider site (**CF5**) and that he had not seen the glider (**CF8**).
