AIRPROX REPORT No 2020014

Date: 04 Feb 2020 Time: 1305Z Position: 5130N 00047W Location: White Waltham

PART A: SUMMARY OF INFORMATION REPORTED TO UKAB

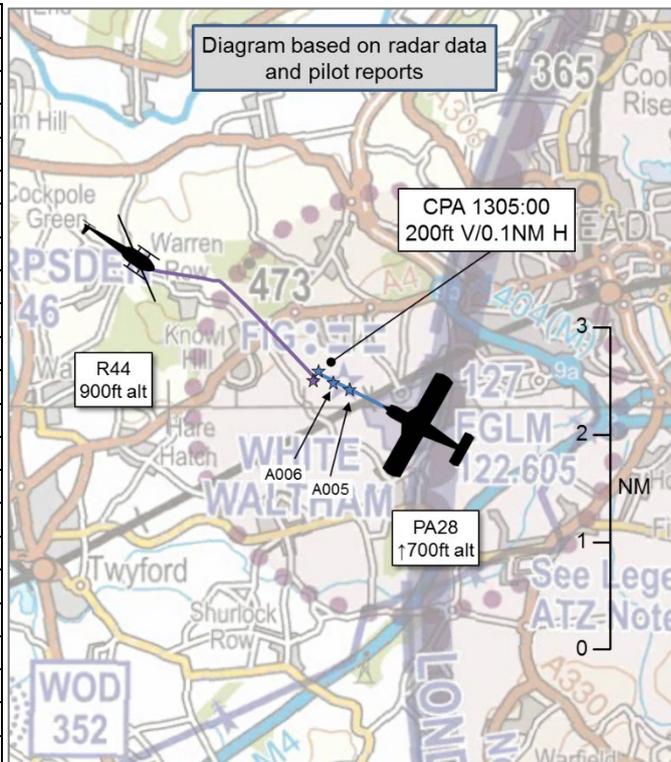
Recorded	Aircraft 1	Aircraft 2
Aircraft	PA28	R44
Operator	Civ FW	Civ Helo
Airspace	White Waltham ATZ	White Waltham ATZ
Class	G	G
Rules	VFR	VFR
Service	AGCS	AGCS
Provider	White Waltham	White Waltham
Altitude/FL	700ft	900ft
Transponder	A, C, S	A, C, S
Reported		
Colours	White, Yellow, Blue	Blue, white
Lighting	Strobes, Landing	Strobe
Conditions	VMC	VMC
Visibility	>10km	>10km
Altitude/FL	700ft	500ft
Altimeter	NK (1016hPa)	NK
Heading	285°	200°
Speed	80kt	100kt
ACAS/TAS	Not fitted	TAS
Alert	N/A	TA
Separation		
Reported	50ft V/50m H	NR V/25m H
Recorded	200ft V/0.1NM H
