**AIRPROX REPORT No 2020111**

Date: 01 Sep 2020 Time: 1321Z Position: 5211N 00028W Location: 3NM N Bedford

**PART A: SUMMARY OF INFORMATION REPORTED TO UKAB**

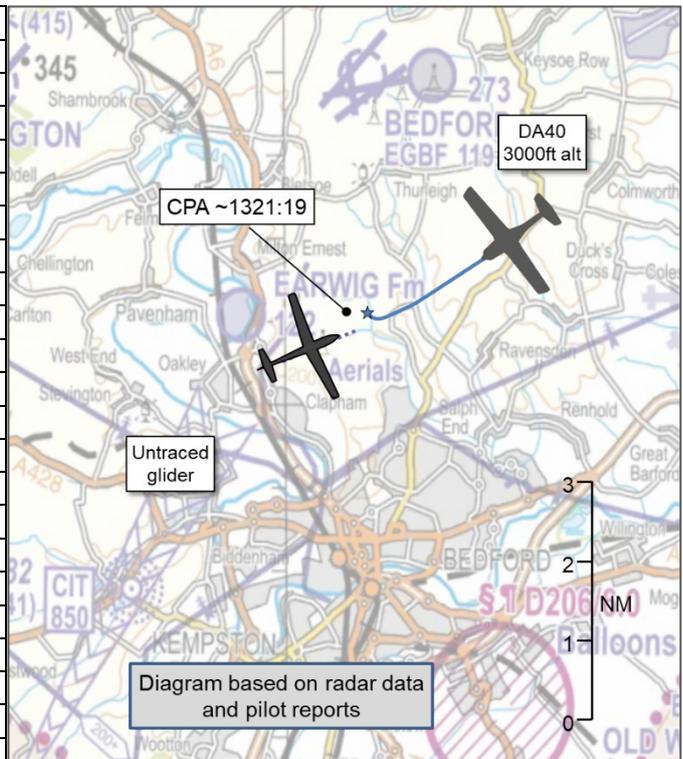
**THE DA40 PILOT** reports flying straight and level at 3200ft 3NM north of Bedford, when a glider was spotted coming directly toward, flying in the opposite direction at the same altitude, about half a mile away. A collision avoidance manoeuvre was carried out by a steep descending turn to the right. The glider was not on frequency with Cranfield Approach and no TAS warning occurred. The glider did not appear to spot the DA40 as its flight path remained completely unchanged and they initially thought it was about 50ft above, but on reflection later assessed that it passed not more than a couple of hundred feet above the DA40. A normal approach and landing was carried out at Cranfield.

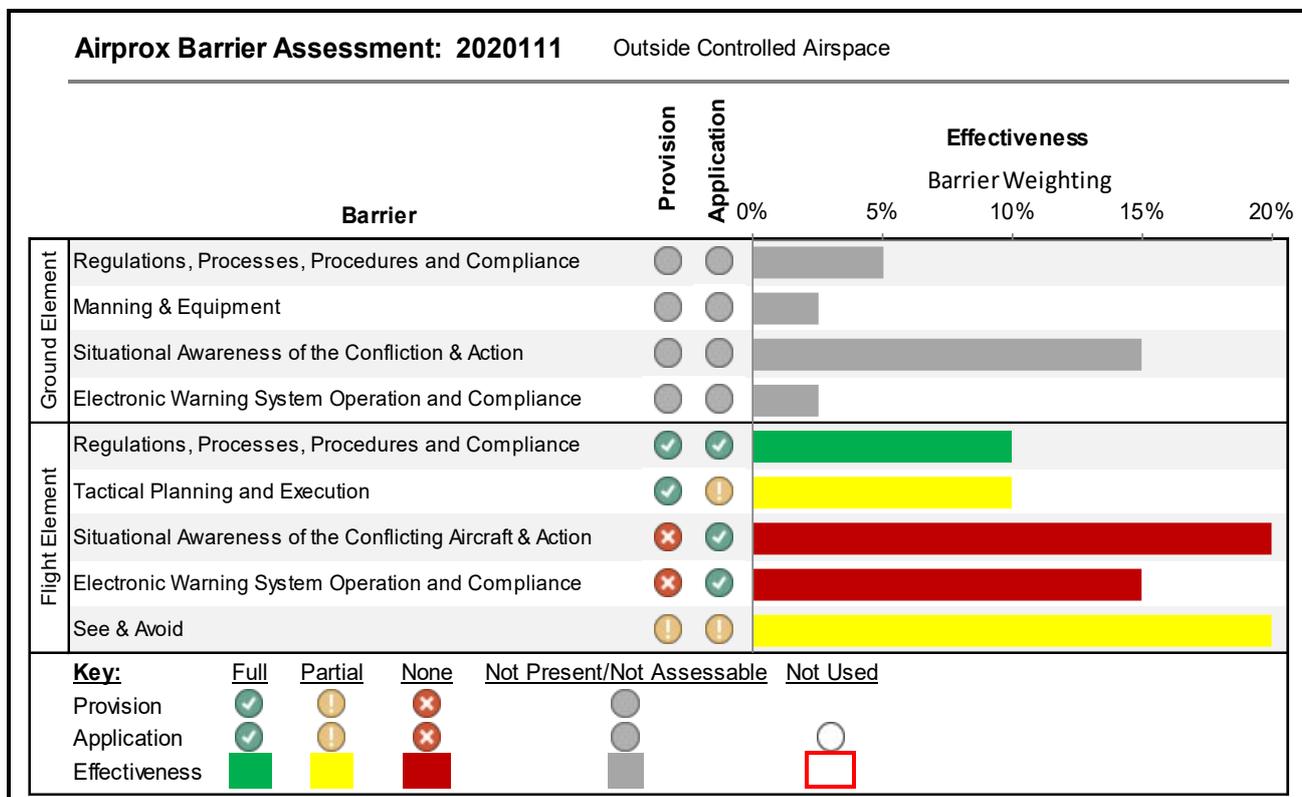
**Electronic Warning System Operation and Compliance** were assessed as **ineffective** because the TAS on the DA40 could not detect the non-transponding glider.

**See and Avoid** were assessed as **partially effective** because despite the late sighting, the DA40 pilot managed to take avoiding action.
