## AIRPROX REPORT No 2021050

Date: 19 Apr 2021 Time: 1354Z Position: 5112N 00050W Location: Challock – elev. 600ft

### PART A: SUMMARY OF INFORMATION REPORTED TO UKAB

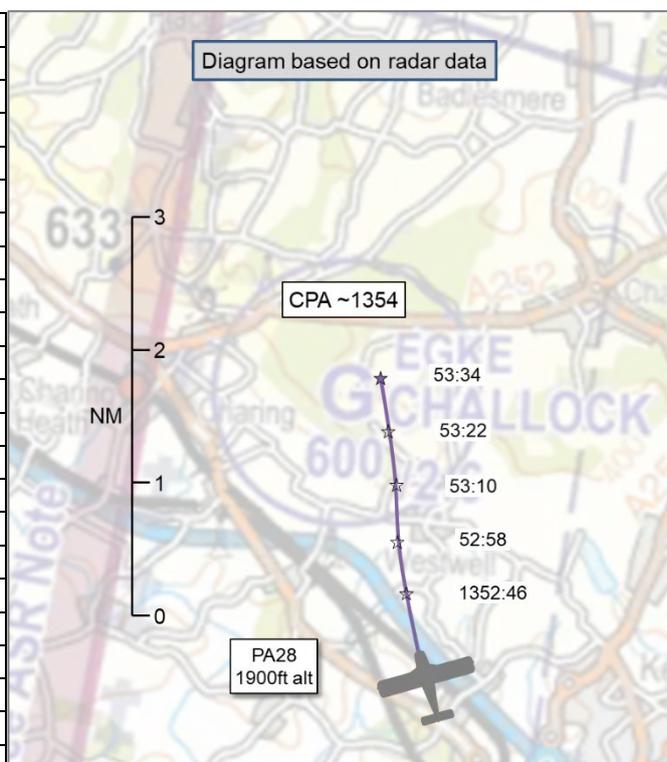
Recorded	Aircraft 1	Aircraft 2
Aircraft	SZD 51 Junior	PA28
Operator	Civ Gld	Civ FW
Airspace	London FIR	London FIR
Class	G	G
Rules	VFR	VFR
Service	Listening Out	Basic
Provider	Challock	Southend
Altitude/FL	NR	1900ft
Transponder	Not fitted	A, C, S
<b>Reported</b>		
Colours	White	White, black, red
Lighting	Not fitted	Strobes, nav
Conditions	VMC	VMC
Visibility	5-10km	NR 'Haze'
Altitude/FL	1500ft	2000ft
Altimeter	QNH (NK hPa)	QNH (NK hPa)
Heading	~360°	NK
Speed	~50kt	120kt
ACAS/TAS	Not fitted	Unknown
Alert	N/A	Unknown
<b>Separation</b>		
Reported	100-200ft V/200m H	Not seen
Recorded	NK

The SZD 51 Junior and PA28 pilots shared an equal responsibility for collision avoidance and not to operate in such proximity to other aircraft as to create a collision hazard.<sup>1</sup> If the incident geometry is considered as overtaking then the SZD 51 Junior pilot had right of way and the PA28 pilot was required to keep out of the way of the other aircraft by altering course to the right.<sup>2</sup> An aircraft operated on or in the vicinity of an aerodrome shall conform with or avoid the pattern of traffic formed by other aircraft in operation.<sup>3</sup> If the solo glider pilot winch launched to about 900ft QFE, as reported, then the aircraft would have been separated vertically by about 400ft.
