AIRPROX REPORT No 2022026

Date: 09 Mar 2022 Time: 1620Z Position: 5148N 00118W Location: 2NM S Oxford Airport

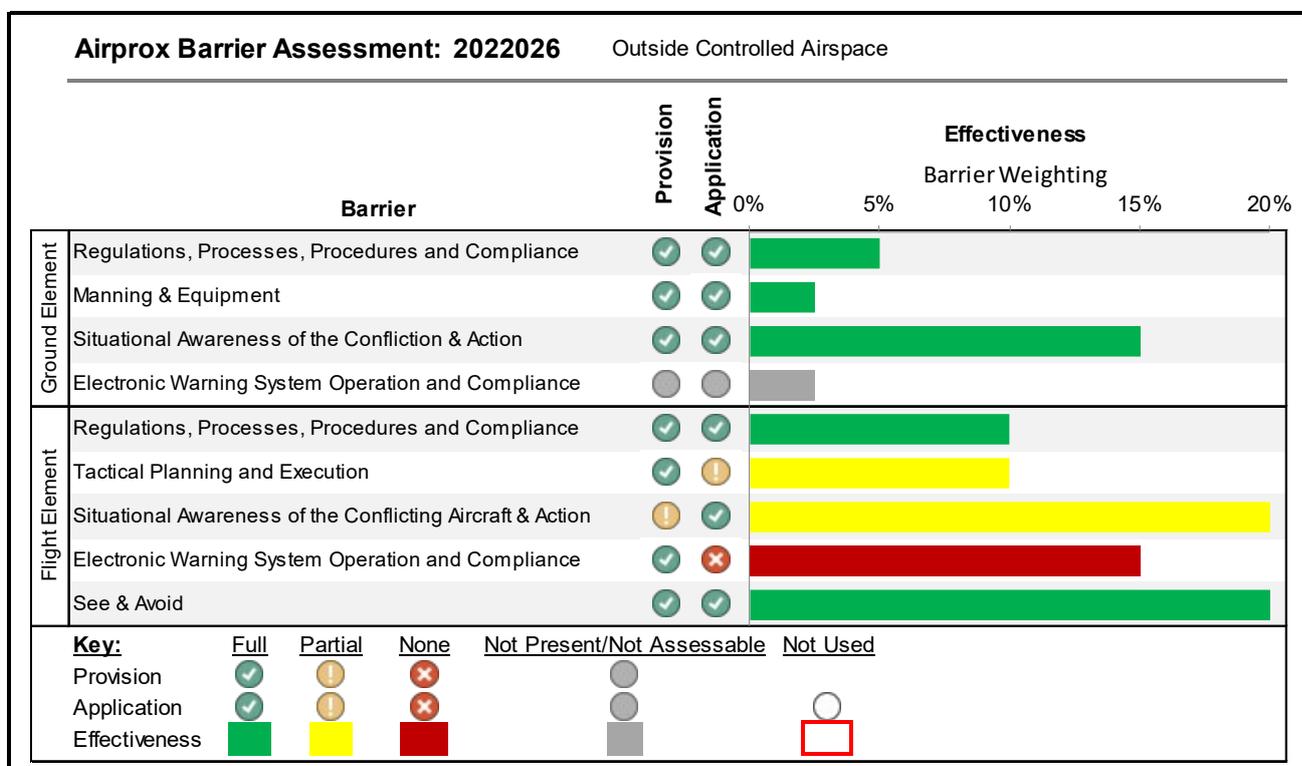
Tactical Planning and Execution was assessed as **partially effective** because the SR22 pilot departed with too little separation from the DA40.

Situational Awareness of the Conflicting Aircraft and Action were assessed as **partially effective** because the DA40 instructor only had generic Situational Awareness on the SR22.

Electronic Warning System Operation and Compliance were assessed as **ineffective** because the DA40 was not equipped with EC and the SR22 TAS did not alert at a separation where that would be expected.
