**AIRPROX REPORT No 2024290**

Date: 27 Nov 2024 Time: ~1534Z Position: 5311N 00426W Location: 5NM SE RAF Valley

**PART A: SUMMARY OF INFORMATION REPORTED TO UKAB**

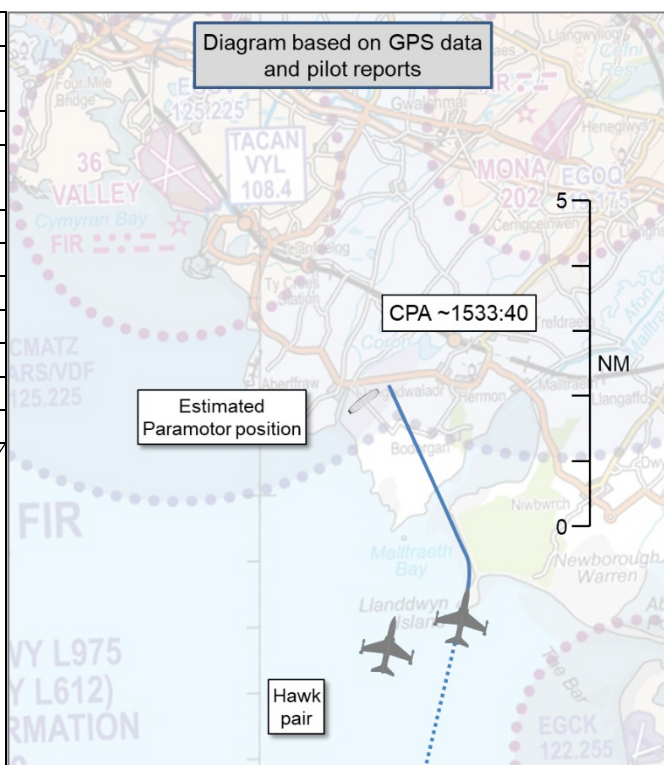
Recorded	Aircraft 1	Aircraft 2
Aircraft	Hawk formation	Unknown Paramotor <sup>1</sup>
Operator	HQ Air (Trg)	Civ Hang
Airspace	RAF Valley/Mona CMATZ	RAF Valley/Mona CMATZ
Class	G	G
Rules	VFR	VFR
Service	ACS	Unknown
Provider	Valley Tower	NK
Altitude/FL	725ft	NK
Transponder	A, C, S	None
<b>Reported</b>		Not reported
Colours	Black	
Lighting	'SOP with red strobes'	
Conditions	NR (VMC) <sup>2</sup>	
Visibility	NR (>10km) <sup>2</sup>	
Altitude/FL	800ft	
Altimeter	QFE (1017hPa)	
Heading	310°	
Speed	350kt	
ACAS/TAS	TCAS I	
Alert	None	
<b>Separation at CPA</b>		
Reported	'300ft'	NR
Recorded	NK

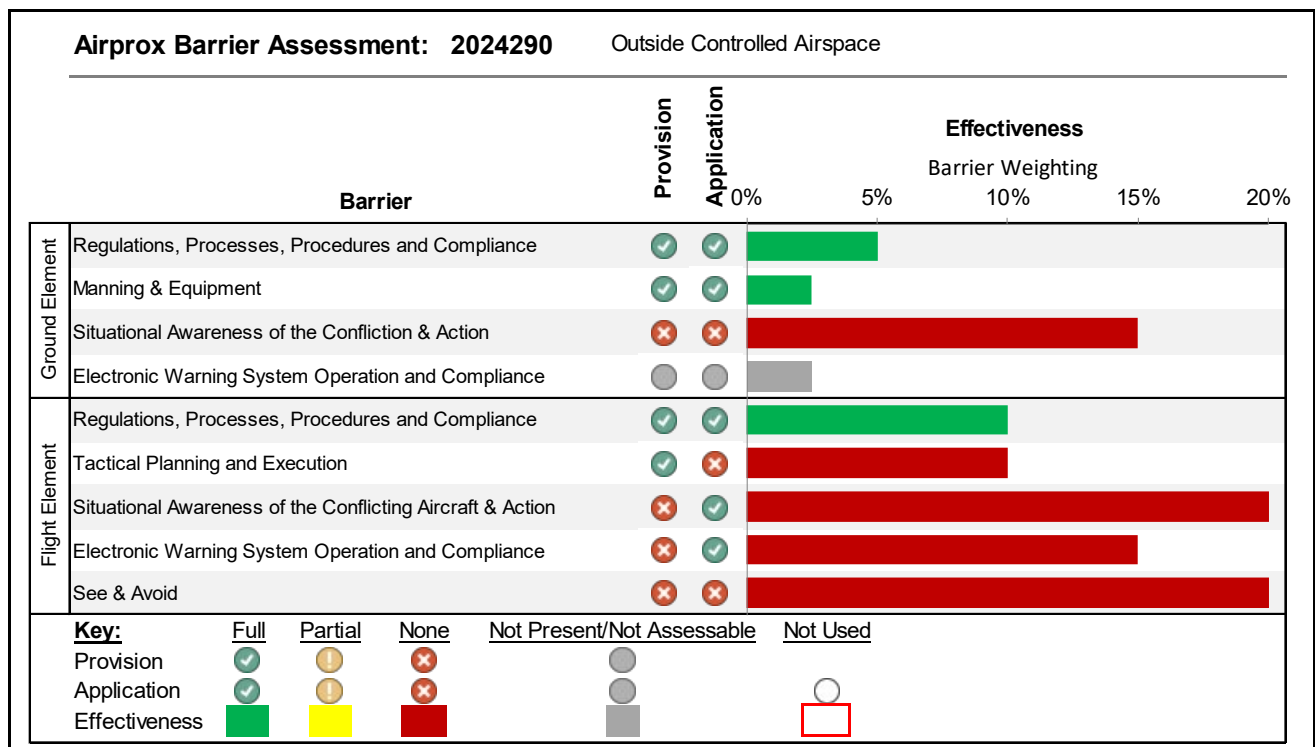
**Electronic Warning System Operation and Compliance** were assessed as **ineffective** because the paramotor had most likely not been EC equipped and could not alert the Hawks' TCAS.

**See and Avoid** were assessed as **ineffective** because the paramotor pilot likely had not seen the Hawks approaching from behind and the Hawk pilot saw the paramotor at about CPA, effectively a non-sighting.
