## **AIRPROX REPORT No 2025089**

Date: 18 May 2025 Time: 1411Z Position: 5353N 00103W Location: 6NM NE Leeds East airfield

# PART A: SUMMARY OF INFORMATION REPORTED TO UKAB

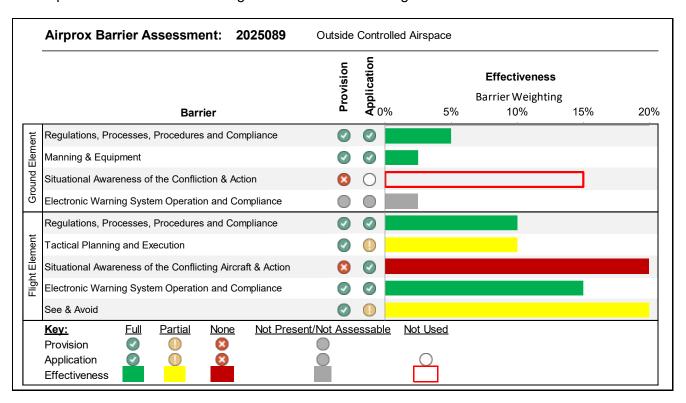
**Situational Awareness of the Conflicting Aircraft and Action** were assessed as **ineffective** because the pilot of the PA28 had not had situational awareness of the presence of the EC145 prior to sighting it.

**See and Avoid** were assessed as **partially effective** because the pilot of the EC145 had visually acquired the PA28 at a late stage and had taken avoiding action.

<sup>&</sup>lt;sup>6</sup> The UK Airprox Board scheme for assessing the Availability, Functionality and Effectiveness of safety barriers can be found on the UKAB Website.
