# JK AIRPROX BOARD

# PROX Insight DIRECTOR UKAB'S MONTHLY UPDATE

April 2025

## Circuit patterns – one of the most likely places to have an Airprox...

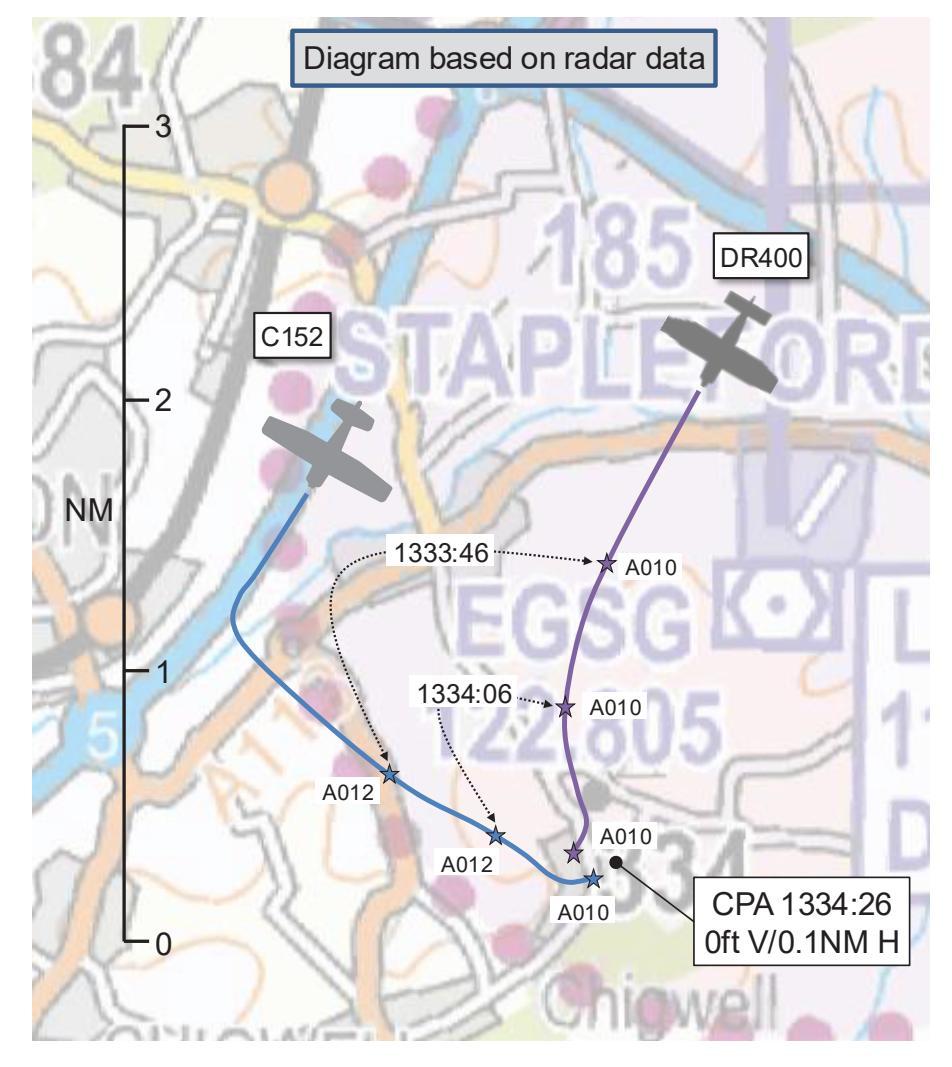
### Airprox 2024275

The Cessna pilot had joined for RW03 from the deadside, crossed the upwind end of the runway at circuit height and turned onto the downwind leg as per the depiction of the circuit pattern published on Stapleford Flight Centre's website (and in other popular flight guides).

Meanwhile, the Robin pilot had joined from the West at 2000ft, descended on the deadside of RW03, crossed the climbout lane over the M25 (about half-a-mile from the upwind threshold) at about 1200ft and then turned downwind, tracking closer to the runway than the Cessna.

When the Robin pilot was about halfway downwind, they spotted the Cessna tracking from right-to-left in front of them and were uncertain whether the Cessna was on base leg or just transiting the ATZ; the Cessna was, indeed, on base leg and

flying pretty much the base leg track as depicted in the circuit diagrams previously mentioned.

As the aircraft closed, the Cessna pilot turned onto final at which point the Robin pilot realised that the Cessna was in the circuit, so they turned to pass behind it, extended downwind and out of the Stapleford ATZ before turning inbound to land from an extended final.

The Cessna pilot, having completed a standard overhead join, had heard the Robin pilot joining and, justifiably, had expected them to have been behind them on the downwind leg. They first saw the Robin as they turned on to final and assessed it to have been almost head-on, so they rolled to the right to avoid it. The aircraft passed each other with no vertical separation and about 0.1nm horizontal separation.

Returning to this month's Airprox, during their discussions the UK Airprox Board members felt that the Robin pilot, by conducting a somewhat 'loose' overhead join, had not helped themselves from the outset. They had flown a wider than usual crosswind leg which may have led them to turning downwind far earlier than would have been expected.

Of course, the published circuit patterns are not exact tracks to be flown but, as we saw in the December article, if the pilot of an aircraft in the visual circuit flies a shorter ground track than the pilot of the preceding aircraft then, at some point, the aircraft are going to come closer to each other than would normally be the case. By flying a downwind leg closer to the runway than that flown by the Cessna, it was almost inevitable that the Robin pilot would get close to the preceding aircraft.

The second lesson here is all about communication. It's essential that pilots make accurate calls when joining and once in the circuit - it is how, primarily, other pilots build their situational awareness.

So if you are unsure whether an aircraft you have seen is circuit traffic or not, a simple call to ask the intentions of the pilot, or to confirm whether or not they are in the circuit, could save an awful lot of heartache.

The answer to that question is actually quite simple – as early as possible. Given that the visual circuit at an airfield is flown visually, and that we are required to 'conform with or avoid the pattern of traffic formed....' ((UK)SERA.3225(b)), if we aren't following the aircraft ahead and conforming with its pattern then we need to avoid it, and don't forget that leaving the circuit and re-joining with better situational awareness is always an option.

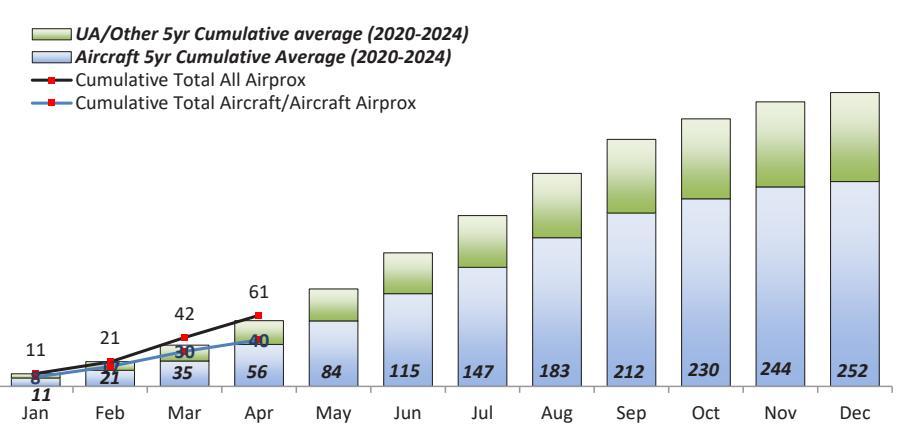
#### 2025 Airprox - Cumulative Distribution

The graphic above shows that it continues to be a pretty 'normal' start to the year in terms of numbers of Airprox reports received. However, in recent weeks we've seen a distinct increase in the number of reports coming through, no doubt largely due to some exceptional

weather conditions leading to more of us taking to the skies during April.
