AIRPROX REPORT No 2022181

Date: 08 Aug 2022 Time: 1320Z Position: 5136N 00212W Location: Westonbirt

PART A: SUMMARY OF INFORMATION REPORTED TO UKAB

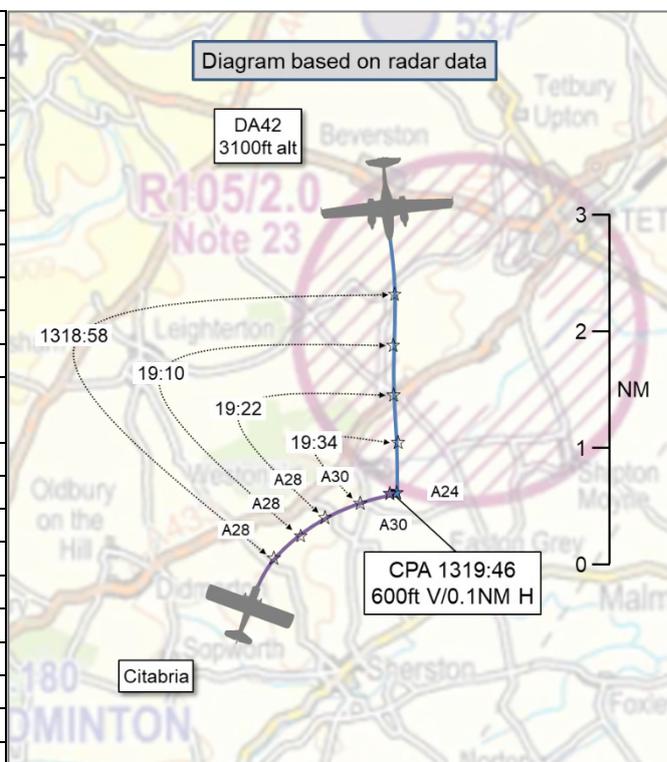
Recorded	Aircraft 1	Aircraft 2
Aircraft	DA42	Citabria
Operator	Civ FW	Civ FW
Airspace	London FIR	London FIR
Class	G	G
Rules	VFR	VFR
Service	None	None ¹
Altitude/FL	2400ft	3000ft
Transponder	A, C, S+	A, C, S
Reported		
Colours	White	Yellow
Lighting	Strobe, nav, land, taxi	Strobes, nav
Conditions	VMC	VMC
Visibility	>10km	>10km
Altitude/FL	3100ft	NK
Altimeter	QNH (NK hPa)	QNH (NK hPa)
Heading	~180°	NK
Speed	140kt	80kt
ACAS/TAS	TAS	Not fitted
Alert	None	N/A
Separation at CPA		
Reported	0ft V/500m H	200ft V/¼NM H
Recorded	600ft V/<0.1NM H
