**Avoiding collisions** – a monthly update from Director UK Airprox Board giving some learning themes for recreational pilots.

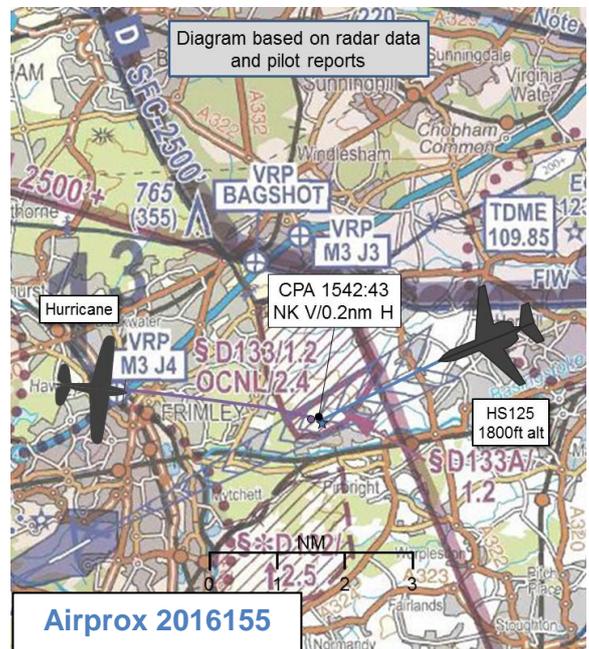
My **Airprox of the month** this month is **Airprox 2016155** which was a Category C incident involving an HS125 on approach to Farnborough and a Hurricane that was transiting through the Farnborough feathers. In a classic ‘Swiss-cheese’ scenario where numerous holes in safety barriers align to cause an incident, the scenario commenced with the Hurricane pilot having a mental aberration and mistakenly telling Farnborough ATC the wrong airfield of his departure. With ATC now looking in completely the wrong area, coupled with a late selection of transponder, not pre-notifying ATC that he was going to cross the Farnborough approach path, and departing the Blackbushe ATZ at fairly high speed (which gave Farnborough ATC precious little time to spot the conflict from his primary-only track), addressing any one of these items would probably have prevented the incident. Fortunately, the Hurricane pilot was visual with the HS125 at an early stage and so see-and-avoid was fully effective as a barrier to collision (they passed 400m apart). All-in-all, a timely reminder about thinking ahead, pre-noting intentions where possible (especially if crossing an airfield’s approach lane), and flying defensively in consideration of others. The full report can be found on the UKAB website at ([www.airproxboard.org.uk](http://www.airproxboard.org.uk)) in the ‘Airprox Reports and Analysis’ section within the appropriate year in the ‘Individual Airprox reports’ tab.
