### **AIRPROX REPORT No 2010143**

Date/Time: 22 Sep 2010 1400Z

Position: 5322N 00016W (5nm

Airspace: Lincolnshire AIAA (Class: G)

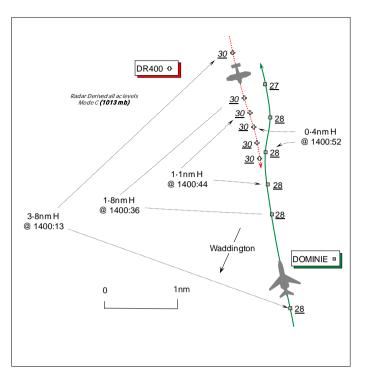
The Dominie was being vectored at 2500ft QFE (1004mb) on a wider radar pattern by DIR to avoid aerobatic ac operating from Wickenby, a local aerodrome to the NNE. At 1359:34 DIR instructed the Dominie crew to turn L onto 350° to, "try and turn inside...traffic now manoeuvring easterly bound" [which was not the DR400]. At this point, the DR400 was 7.6nm NNW of the Dominie indicating 3000ft Mode C (1013mb); the Dominie was indicating 2700ft Mode C (1013mb). The turn onto 350° brought the Dominie into confliction with the DR400.

At 1400:13, DIR passed the Dominie crew accurate TI on the DR400 stating, "[Dominie C/S] further traffic north 4 miles south bound indicating 3 hundred feet above." At 1400:25, an E3-D crew called DIR on climb-out from Waddington for a further RTC. At 1400:36 the Dominie crew requested an update of the TI, which was passed at 1400:41, DIR stating, "[Dominie C/S] Roger, north, 2 miles, 2 hundred feet above". The PA responded, "visual" at 1400:45, with the PIC estimating the acquisition range as 1nm. At 1400:46, DIR replied, "roger, with that traffic in sight, turn left heading 2-7-0°." At this point, the DR400 is in the Dominie crew's 12 o'clock at 1·1nm indicating 200ft above it. At 1400:51 the Dominie pilot advised that they were "coming hard right" with the turn evident on radar and the DR400 0·4nm NNW of the Dominie. Although the DR400 pilot reports that they acquired the Dominie visually at a range of about 1km and turned right to avoid it, this turn is not apparent on radar.
