**AIRPROX REPORT No 2024252**

Date: 05 Oct 2024 Time: 1341Z Position: 5049N 00107W Location: 3NM E Lee-On-Solent

**PART A: SUMMARY OF INFORMATION REPORTED TO UKAB**

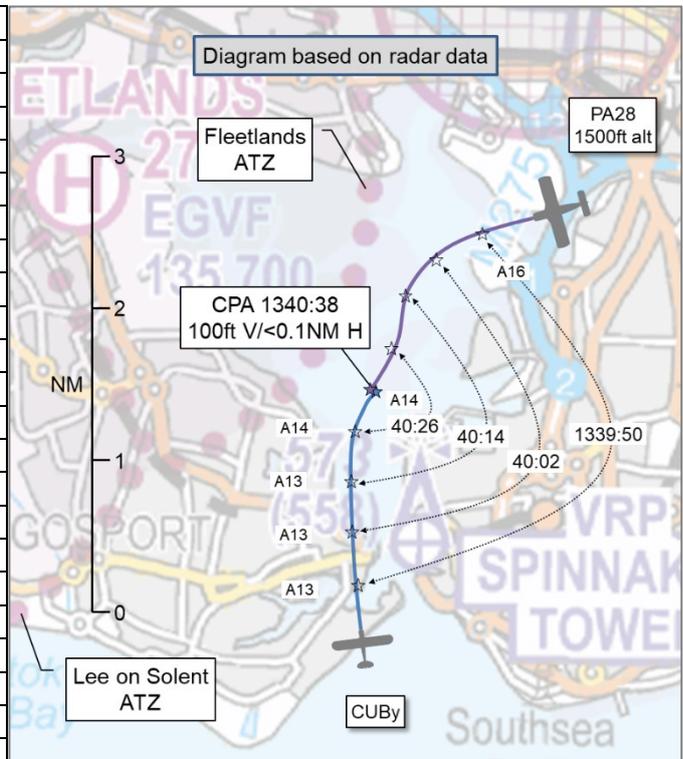
Recorded	Aircraft 1	Aircraft 2
Aircraft	Wag Aero CUBy	PA28
Operator	Civ FW	Civ FW
Airspace	London FIR	London FIR
Class	G	G
Rules	VFR	VFR
Service	AFIS	Listening Out
Provider	Lee-on-Solent	Farnborough
Altitude/FL	1400ft	1500ft
Transponder	A, C, S	A, C, S
Reported		
Colours	Yellow	White/blue
Lighting	Strobe	Nav, strobes, bcn
Conditions	VMC	VMC
Visibility	>10km	NR
Altitude/FL	1400ft	1600ft
Altimeter	QNH (1012hPa)	QNH (1012hPa)
Heading	360°	NR
Speed	85kt	NR
ACAS/TAS	PilotAware	Not fitted
Alert	None	N/A
Separation at CPA		
Reported	20ft V/5m H	100ft V/400m H
Recorded	100ft V/<0.1NM H

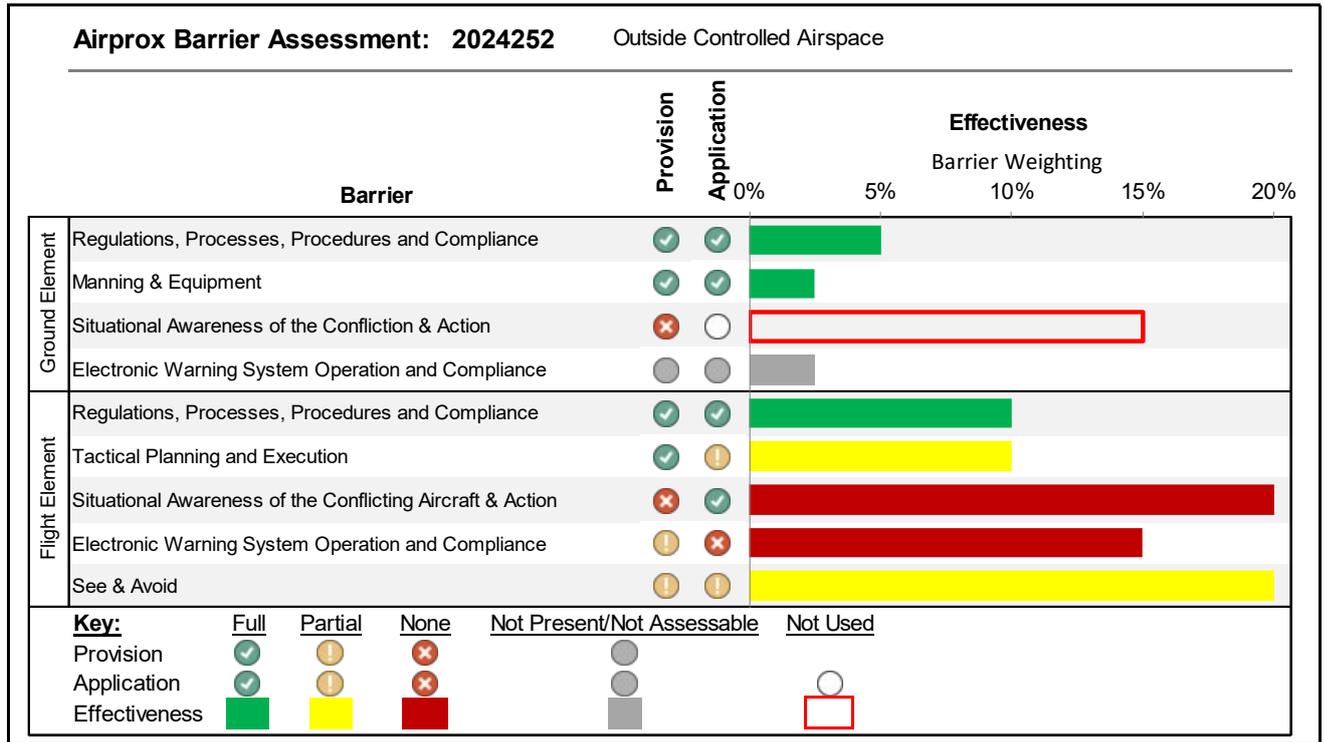
Safety Barrier Assessment<sup>3</sup>

**Situational Awareness of the Confliction and Action** were assessed as **not used** because the PA28 was beyond the visual range of the Lee AFISO and they therefore had no situational awareness of it.

**Tactical Planning and Execution** was assessed as **partially effective** because the PA28 pilot had not been in communication with Lee-on-Solent.

**Situational Awareness of the Conflicting Aircraft and Action** were assessed as **ineffective** because neither pilot had had situational awareness on the other aircraft until sighted.

**Electronic Warning System Operation and Compliance** were assessed as **ineffective** because the CUBy TAS had not alerted when expected.

**See and Avoid** were assessed as **partially effective** because the CUBy pilot had seen the PA28 at a late stage and the PA28 pilot had not seen the CUBy until at about CPA, effectively a non-sighting.
