AIRPROX REPORT No 2014152**Date/Time:** 22 Aug 2014 1208Z**Position:** 5153N 00326W
(N Pen-y-Fan)**Airspace:** Lon FIR (Class: G)**Aircraft 1** **Aircraft 2****Type:** Sea King LS6c Glider**Operator:** HQ Air (Ops) Civ Pte**Alt/FL:** 3000ft NK**Conditions:** VMC VMC**Visibility:** >10km >10km**Reported Separation:**

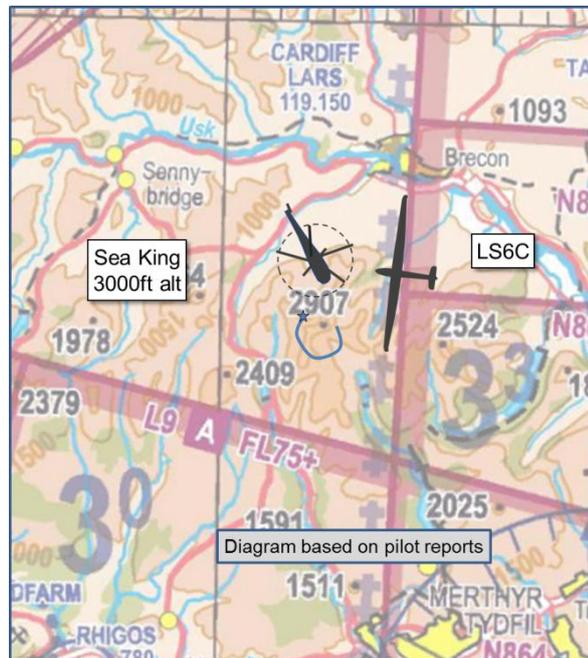
150ft V/200yds H 0ft V/300m H

Recorded Separation: NK
