# ACAS II Bulletin

## ATC Matters

February 2016 | N°19

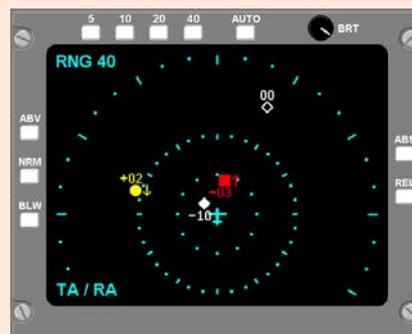
TCAS traffic display symbology and associated actions			
Symbol	Type	Pilot action	Report to ATC

<b>Other traffic</b>	Visual acquisition. Vertical speed reduction if traffic is at the level adjacent to the cleared level.	None.

<b>Proximate traffic:</b> Aircraft within 6 NM and 1200 feet of own aircraft	Visual acquisition. Vertical speed reduction if traffic is at the level adjacent to the cleared level.	None.

<b>Traffic advisory (TA):</b> Nominally generated 20-48 sec. before Closest Point of Approach (CPA)	Visual acquisition. Vertical speed reduction if traffic is at the level adjacent to the cleared level. Prepare for possible RA.	None.

<b>Resolution advisory (RA):</b> Nominally generated 15-35 sec. before CPA	Follow the RA as indicated by changing or maintaining the vertical speed.	Report the RA if it is causing a deviation from ATC clearance.

<b>Vertical trend arrow and relative altitude</b> will be shown next to each symbol (in the matching colour). The relative altitude is displayed in hundreds of feet, above the symbol if the intruder is above own aircraft and below the symbol in the opposite case.

TCAS traffic display is useful in helping pilots with visual acquisition of aircraft in the vicinity and maintaining general situational awareness. However, the traffic display can easily be misinterpreted as it provides only partial information and has limited accuracy. It has not been designed for the purposes of self-separation or sequencing, and using it for these purposes is inappropriate, and could also be hazardous.

The bearing displayed by TCAS II is not sufficiently accurate to support the initiation of horizontal manoeuvres as the reference for the traffic display is the position of own aircraft, there are neither speed vectors nor information about other aircraft intentions. All that may lead to misinterpretation of relative motion of other traffic on the display.
